Trip Report - Brookville ex-SEPTA PCC Overhaul, May 2016

5/17/2016

Joseph Flores
Kevin Sheridan

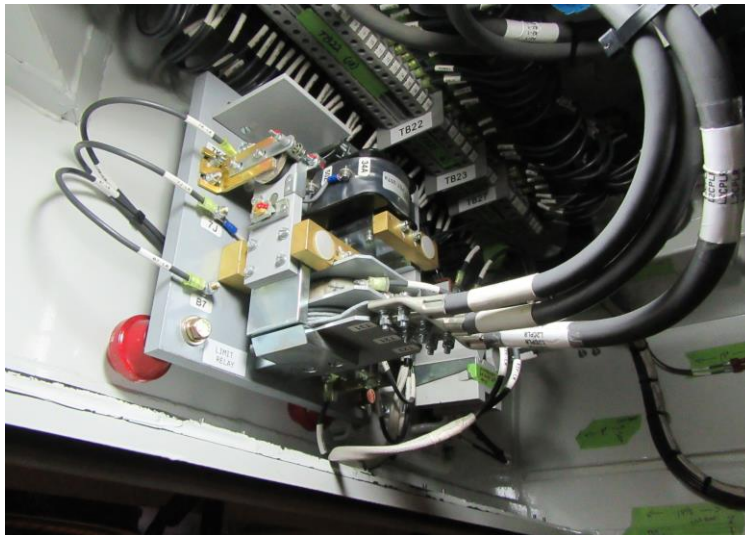
Figure 1 – Limit Relay Board

The position of the Limit Relay and connected wiring makes access to the Contactor Panel difficult. Upon discussion with Brookville staff, potential solutions include modified connectors or relocation of the limit relay. Modified connectors would allow the wire runs to come off of the Limit Relay at a 90

degree angle, which limits the intrusion of the wiring into the free space and the Contactor Panel. This connector could either be sourced from Bombardier or a manufacturer by Brookville. Relocation of the Limit Relay would move the potential obstruction toward the end of the enclosure, but clearance issues may still exist.

One suggestion was to connectorize the limit relay for easier maintenance. The Limit Relay Board is often removed and placed on a work bench for service. The current setup consists of a typical bundle of wires and terminal lugs. Replacing the bundle of leads will simplify removal and installation and ensure integrity of connections. This suggestion applies only to the leads to the Limit Relay Board, and not the Series Coil wiring.

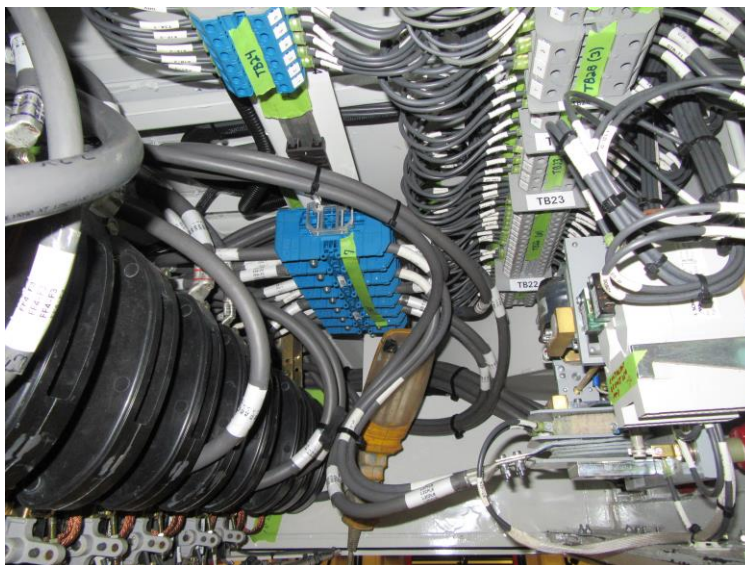
Figure 2 – Contactor Panel Enclosure Layout

Wiring of the components in this enclosure was completed, with labeling and QA checks being conducted. After the first inspection of the enclosure, several points were brought up regarding the current layout of the wiring.

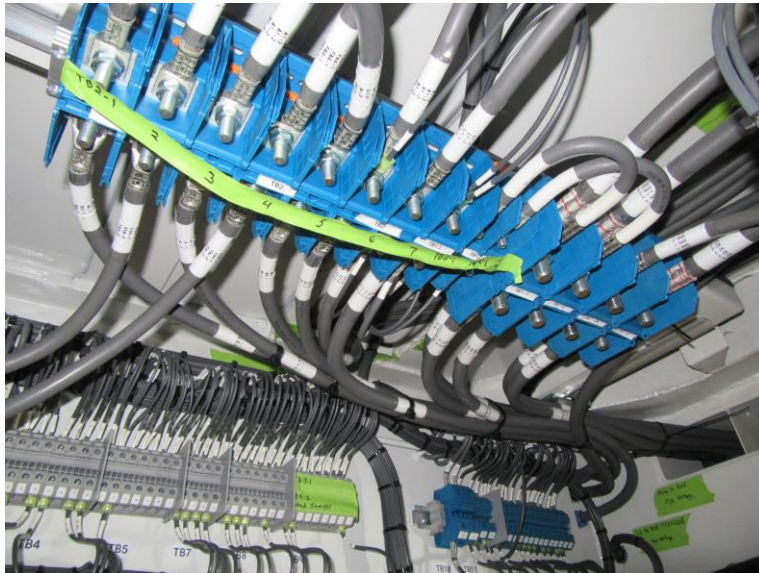
Figure 3 - High Voltage Enclosure Terminal Block

Terminal blocks were installed throughout the rebuilt car, including in the Hi-Voltage Enclosure. Some of the wiring runs were longer than usual, which brought up vibration and chafing concerns. Brookville suggested that the installation of additional tie bars would help alleviate any potential vibration and fitment issues.

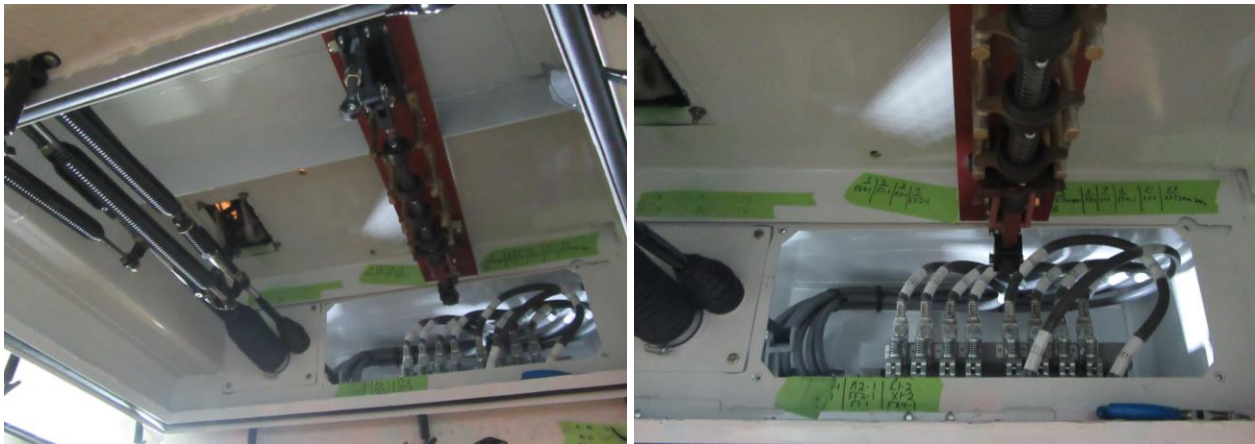
Figure 4 – Foot Pedal and Deadman Switch Assembly

The Master Controller compartment was rebuilt and moved toward the front section of the car. Wiring of the Master Controller was nearly completed, and the Foot Pedal Assembly was installed. The Deadman Switch Assembly was mounted in the enclosure for mock-up purposes during our visit. Installation is pending. Head clearance is good within the enclosure. The provided openings will allow for ease of servicing. Potential interference with life guard basket is anticipated, but this can be worked around.

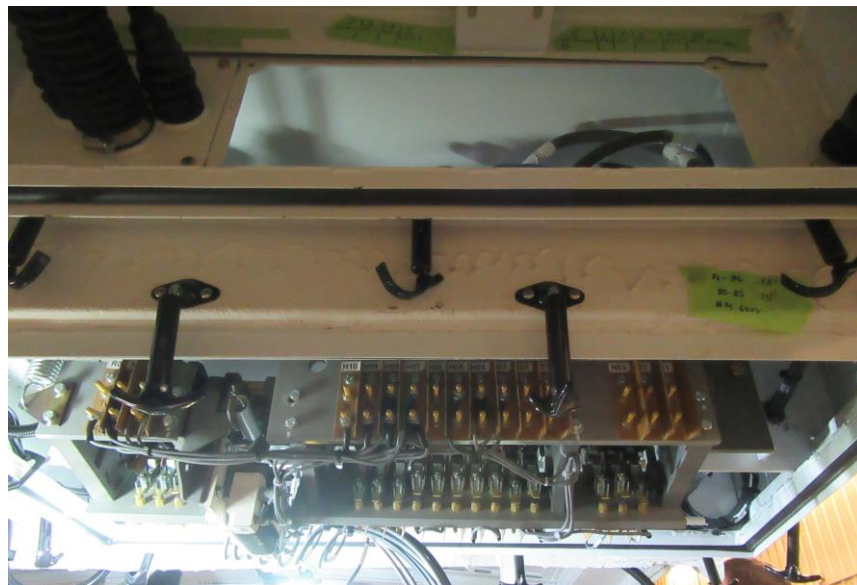
Figure 6 – Master Controller

Some of the wiring around the Master Controller were lengthy. Brookville once again suggested that the installation of additional tie bars would help alleviate any potential vibration and fitment issues.

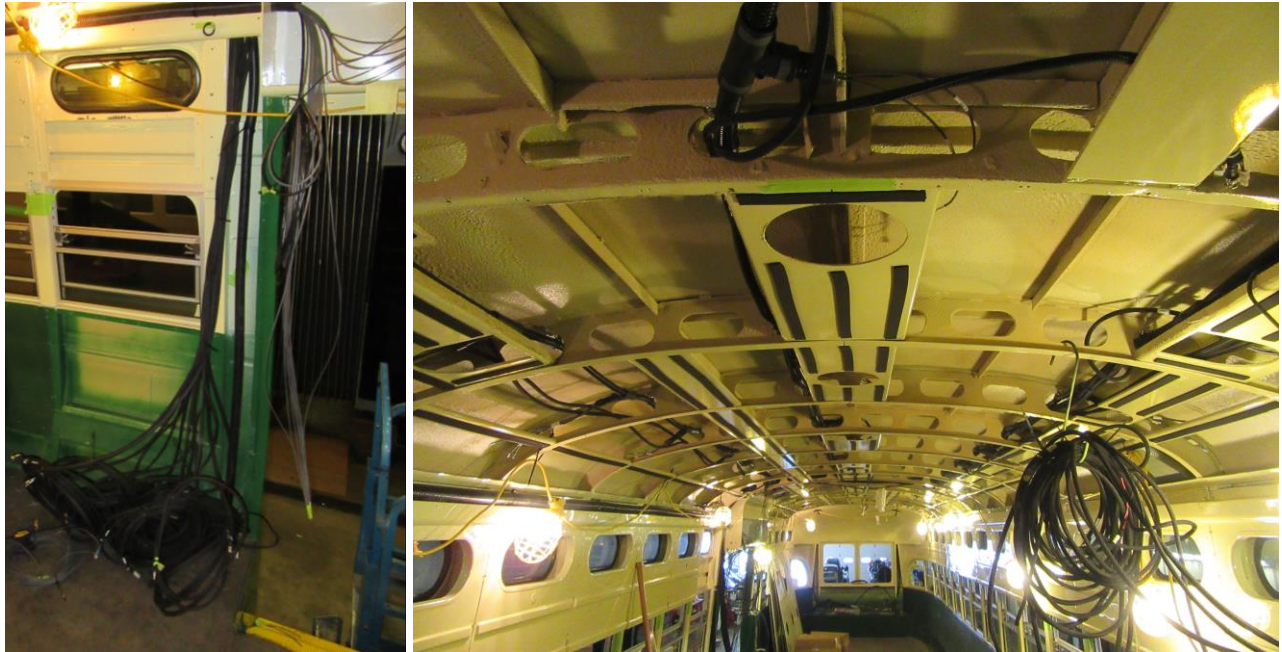
Figure 7 – Interior Wiring View

Electrical wiring in the Interior is on-going. Wire and conduit has been run through the ceiling and side walls and some paneling has been installed.

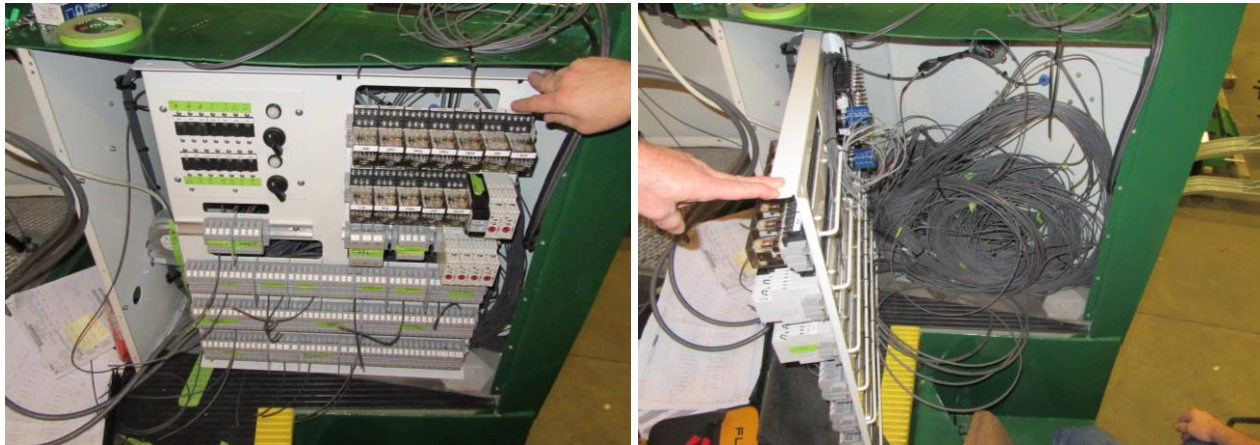
Figure 8 – Underdash Electrical Panel

Brookville advised that they planned on installing a swingout front panel for the Underdash Electrical Panel. This feature would ease replacement of any items on the panel, in addition to the components behind the panel such as the wiper motor and heater ducting.

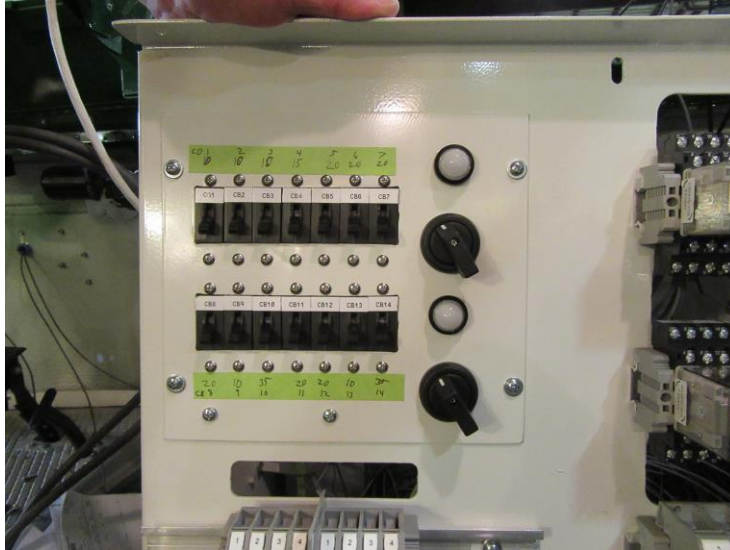
Figure 9 - Underdash Electrical Panel Removal Panel

The swingout panel also feature a removable panel for access to circuit breakers, door bypass, and blower bypass switches and indicator lights. This will facilitate maintenance activities, since these items are replaced more often than other parts located on this panel.

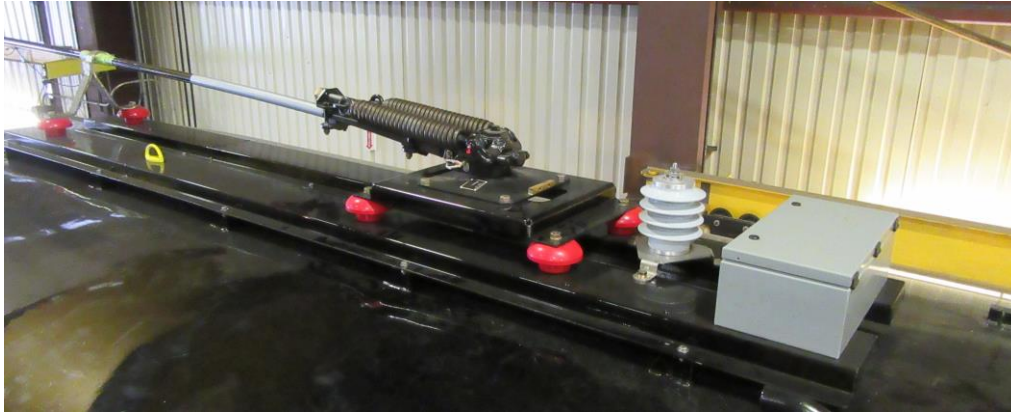
Figure 10 - Trolley Pole

The trolley pole and base are both installed on the roof. The trolleyboard is now constructed of metal, with red insulators observed. Roof grit will be applied after final painting.

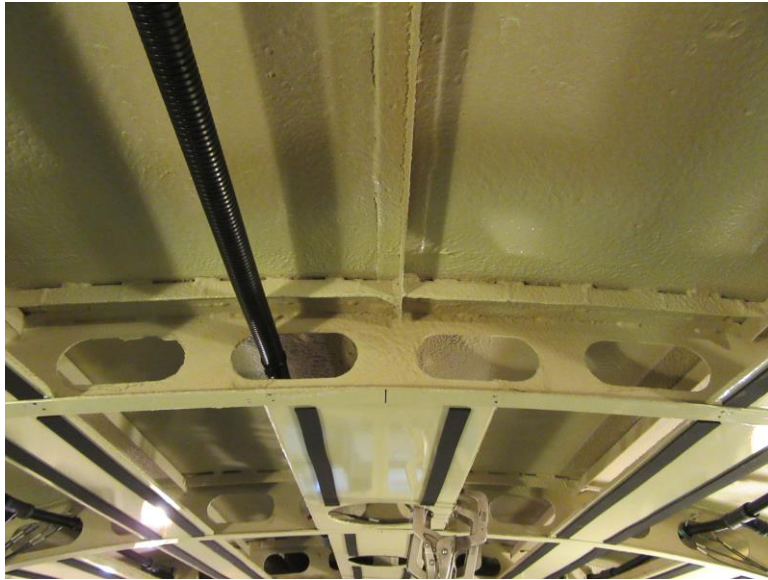
Figure 11 – Ceiling reinforcement

The interior roof was reinforced with additional metal bars adjacent to the carlins to prevent excessive flexion and cracking.

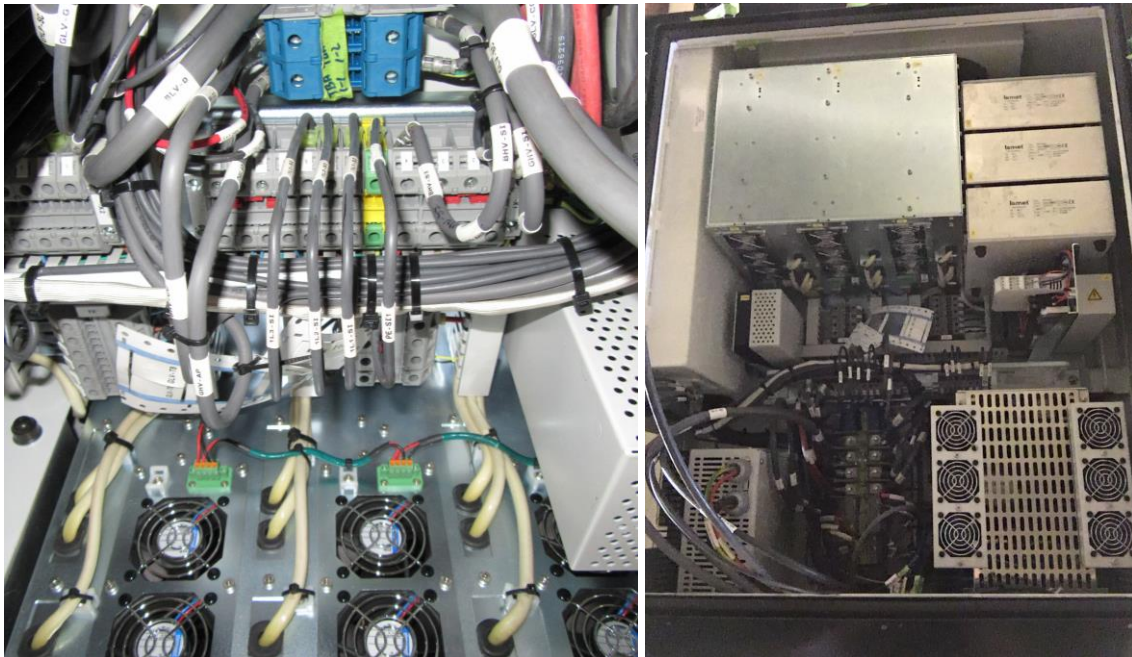
Figure 12 – LVPS Wiring

Wiring of the components in this enclosure was completed, with labeling and QA checks being conducted.

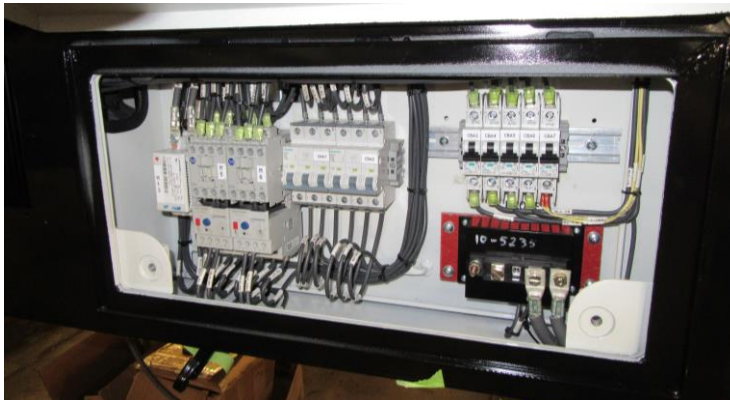
Figure 13 – LVPS Access Panel

The LVPS enclosure features a new access panel to the rear of box for circuit breakers and overload trips. This panel allows access without the need to drop the bottom pan. This can be useful when dealing with any electrical issues during road calls.

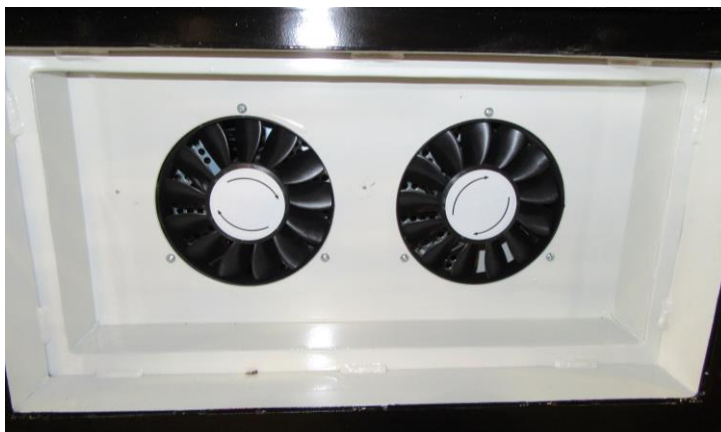
Figure 14 – Ventilation Fans

Two fans are now installed on the LVPS enclosure to provide greater airflow to address overheating concerns.

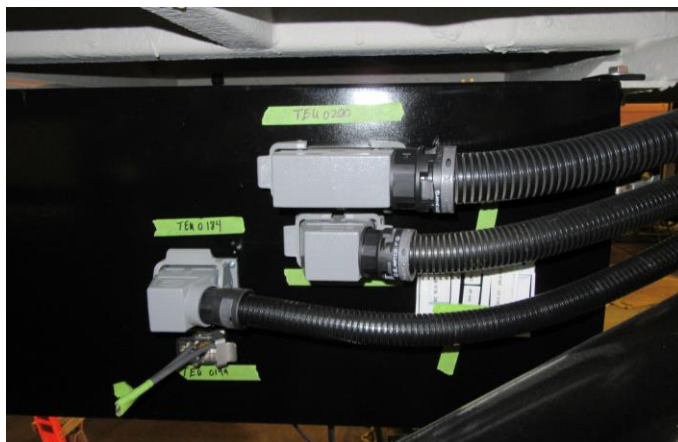
Figure 15 – Connectorized LVPS Enclosure Electrical Connections

Connectorized leads were added to the LVPS Enclosure to allow for easier removal and servicing.

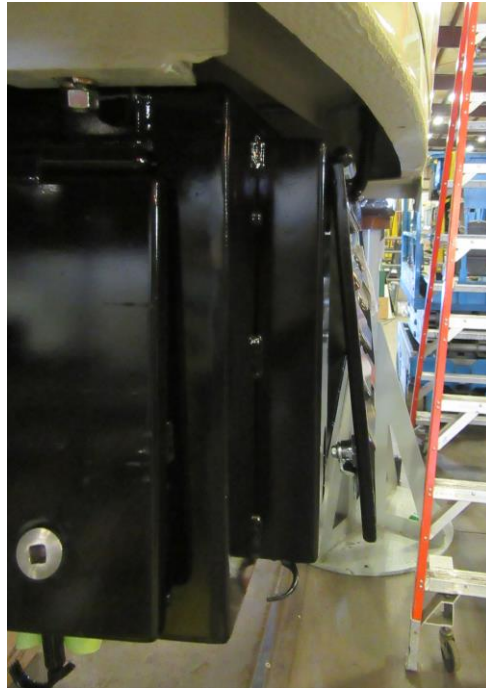
Figure 16 – LVPS Filter Cover

The Filter Cover was redesigned to allow drop in replacement of the filter. However, there is a potential filter cover clearance issue with the side skirt. There is just enough room to allow the filter to be changed, but the fasteners are currently configured to require a tool for opening and closing. This issue was discussed with Brookville, and the idea of using a fastener that doesn't require any tool was brought up.

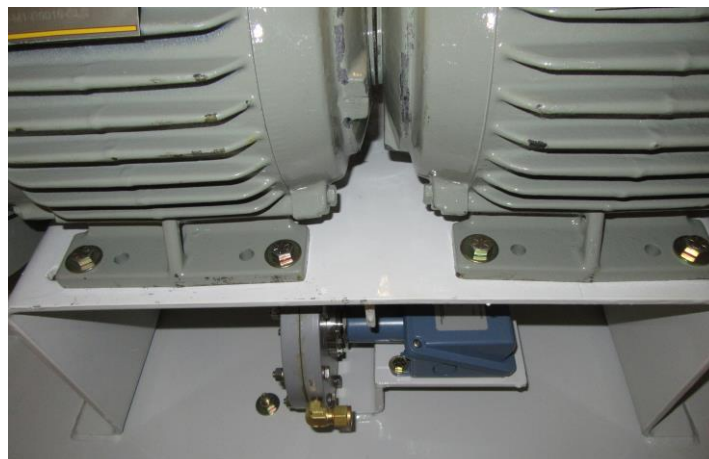
Figure 17 – Propulsion Blower Pressure Switch

The Pressure switch has been relocated to a position inside of the enclosure, where it's protected from elements and dirt. Another potential benefit is a better pressure signal since the sensor is now closer to the fan ducting.

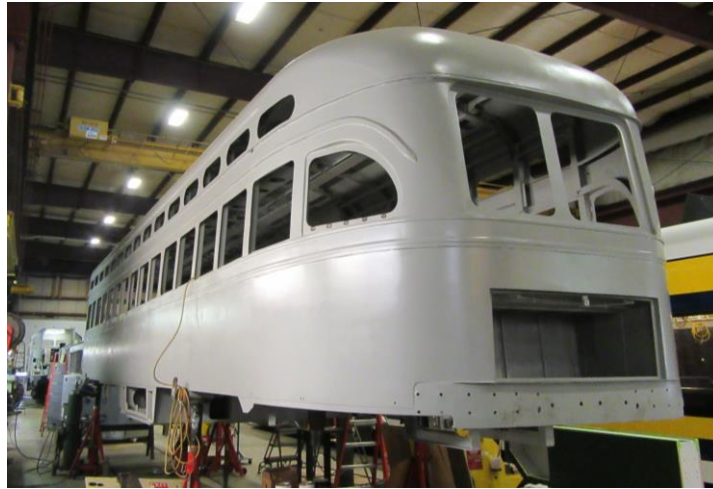
Figure 18 – #1051 Overall View

Body repair and all major metal work has been completed on this car. Primer has been applied and the car has been leak tested. Minor leaks were found during this test and have been repaired. Minor metal working is being done based on findings from Car #1. This work includes the addition of bracketing for wiring and modifications to the Rear Teardrop window to ease window installation.

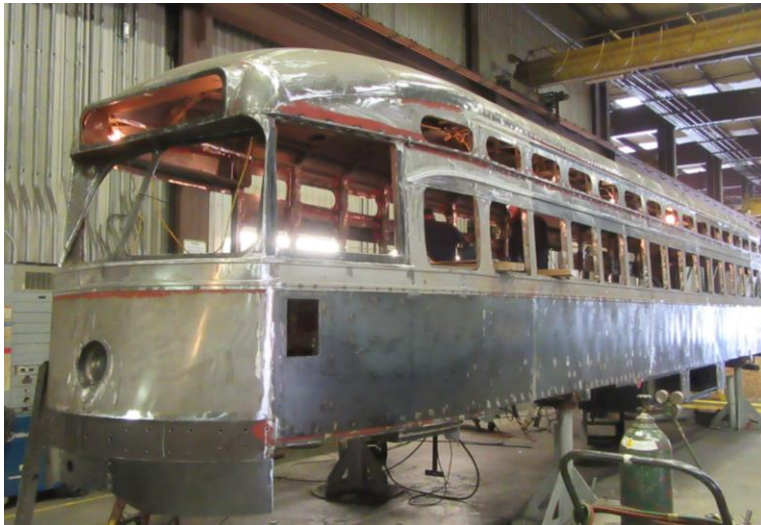
Figure 21 – #1060 Overall View

Body repair metal work is nearly completed on this car, with work on the floor progressing.

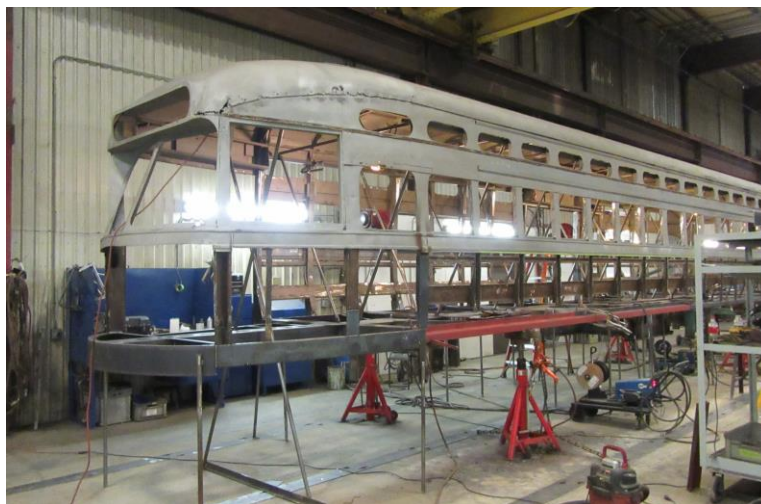
Figure 22 – Side Wall Post Bottoms Replaced

Body repair metal work is progressing. The roof and side panels have been removed, and work is underway to replace the lower portions of the side, including the side rails and the lower portion of the posts that connect the side walls to the floor.

These side posts appeared to have been replaced during the previous overhaul done by Morrison Knudsen, and appear to have deteriorated prematurely.

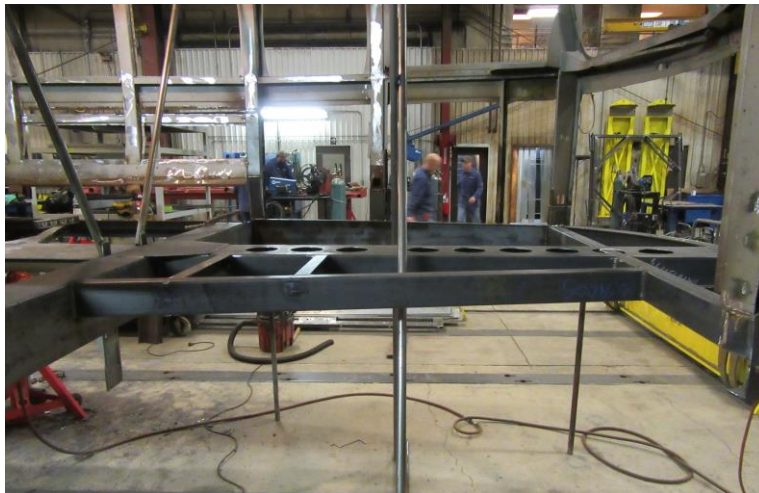
Figure 24 – Front End Replaced

Crash damage was found that Brookville states wasn't previously indicated. The entire lower Front section ahead of front door portal, including front spine and nose, were all replaced.

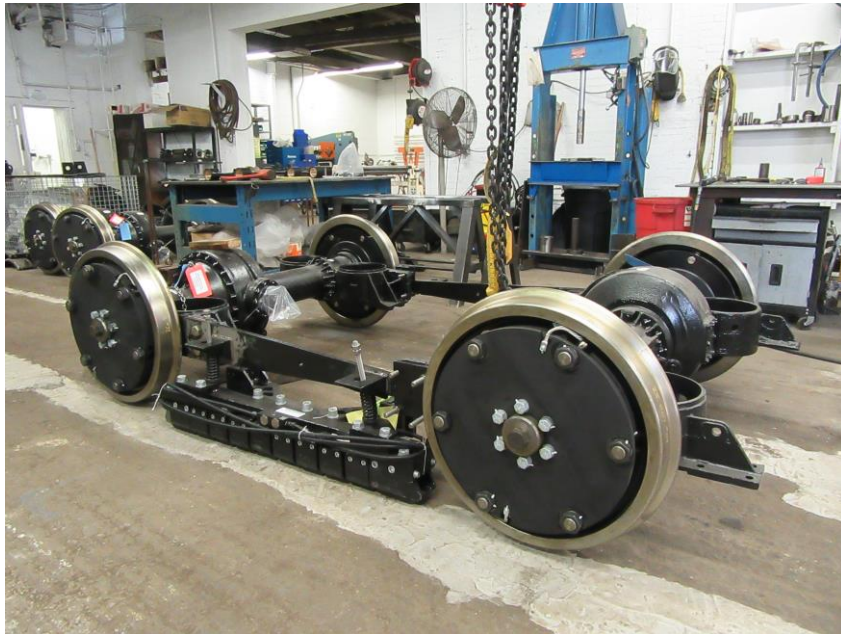
Figure 25 – Rebuilt B2 Truck

Trucks are being rebuilt at Brookville's shop facilities located close to downtown Brookville. The first truck is currently assembled and is awaiting the installation of the traction motors and track brakes. These trucks were observed to have the Vulcanite rubber sandwiches installed on the wheels, not the Lord blocks which were previously noted to be installed.

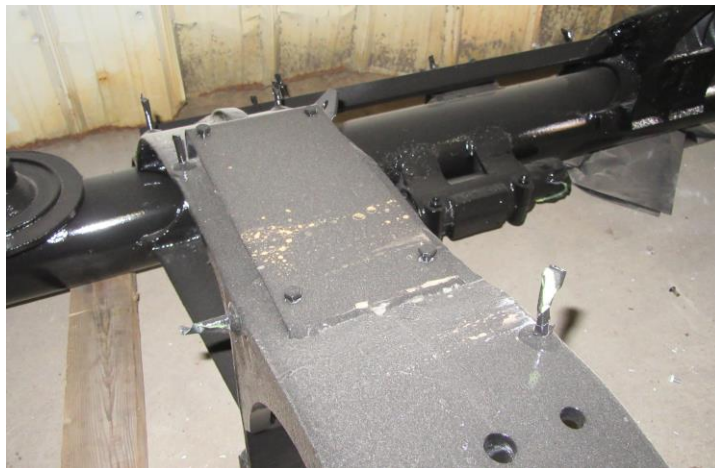
Figure 26 – Location of Track/Shaft brake Terminal Block

The rebuilt trucks will feature a new terminal block, which will allow the wiring to the Track and Shaft brakes to be easily disconnected from the main carbody when the truck is dropped.

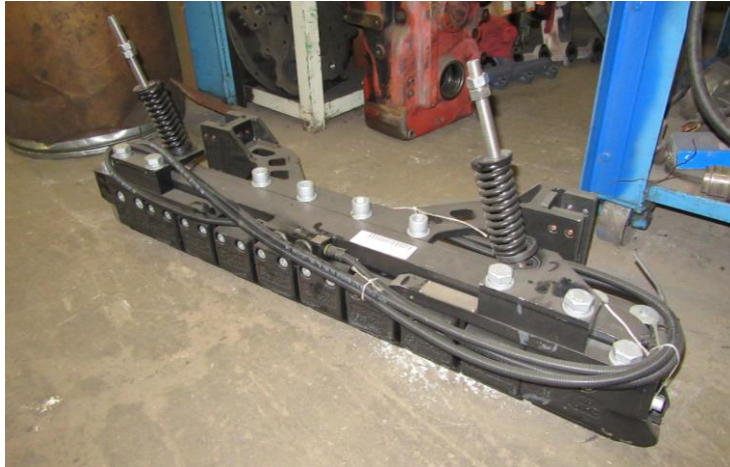
Figure 27 – Union Track Brake

The Union track brakes were not yet installed on the trucks at the time of our visit.

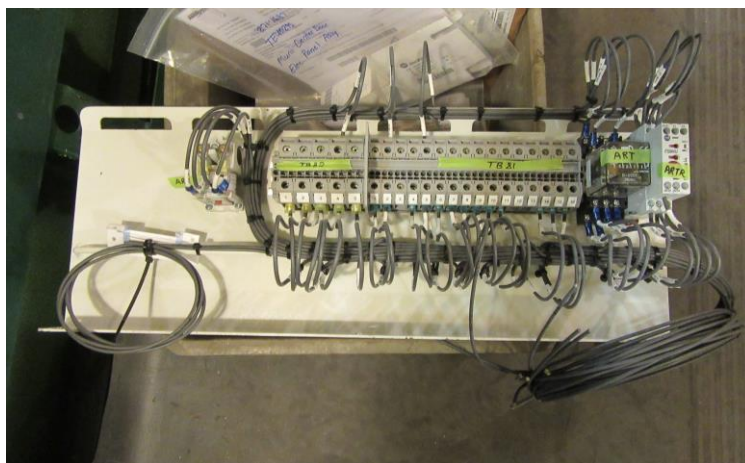
Figure 28 – Rear Door Relay Panel

Door System manufacture and final design is ongoing. Manufacture of the door motor header plates and linkages was occurring during our visit. We discussed our experiences with system components during our ongoing Rotary Door drive retrofit, particularly with the door motor cam, linkage, and pivot arms. We also discussed the current configuration of the door chime alarm, in particular the operation when the doors are closed but sensitive edge is activated. It was suggested that the wiring be modified to match the current configuration, which consists of the alarm sounding when the sensitive edge is activated when the door is closed.

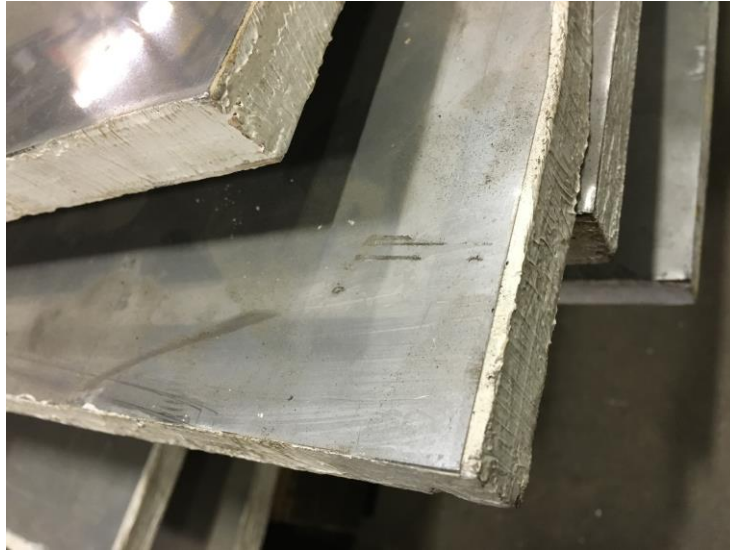
Figure 29 – Plymetal Board Material

The plymetal doors were waiting to be manufactured, with the plymetal material prestaged on the shop floor.

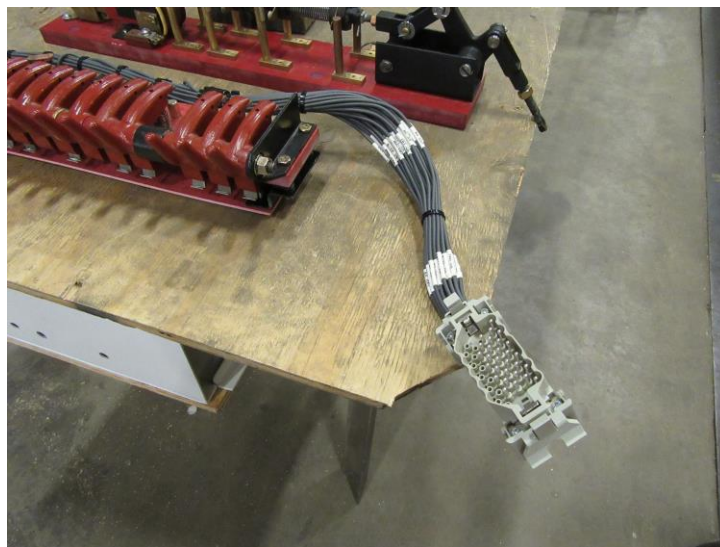
Figure 30 – Connectorized Gang Switch Assembly

The Gang Switch Assembly has been rebuilt and is ready for installation. The whole unit now features a connectorized wiring harness, which will ease installation, removal, and maintenance. The Sander switch also now utilizes relay control, which will improve reliability due to the removal of high voltage.

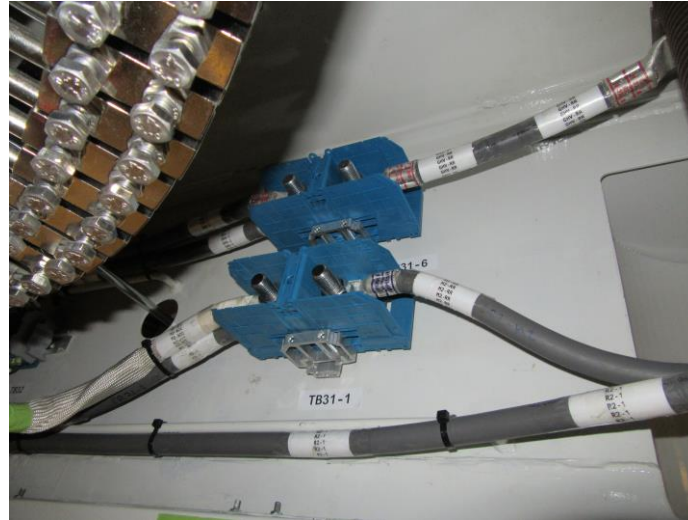
Figure 31 – Accelerator Drum Terminal Blocks

Terminal blocks have been added in multiple locations. This will allow for easier maintenance by removing long wire runs, providing points for diagnostic testing, and making removal and installation of components easier.

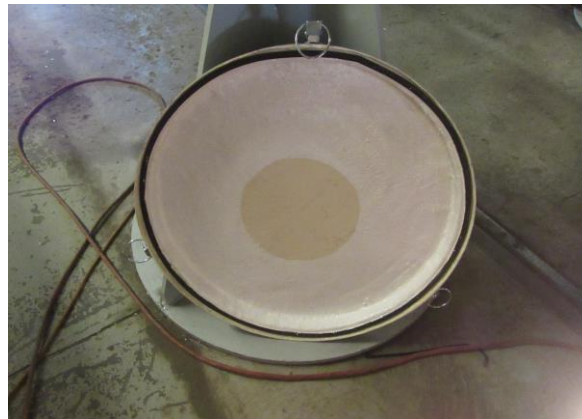
Figure 32 – Accelerator Drum Fiberglass Cover

Brookville plans to install a fiberglass Accelerator Drum cover. They spoke of the issue of arcing found on the metal Accelerator Drum pan, and came up with this solution in order to prevent future instances of arcing. Bonding straps were not installed at time of visit, but will be installed on the Accelerator Drum Enclosure Cover and all other undercar propulsion enclosure covers. Feedback was given to Brookville to make removal of these pans easier for road calls.

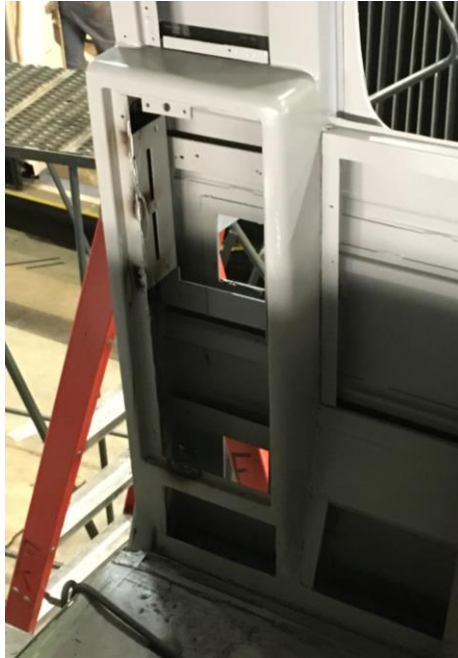
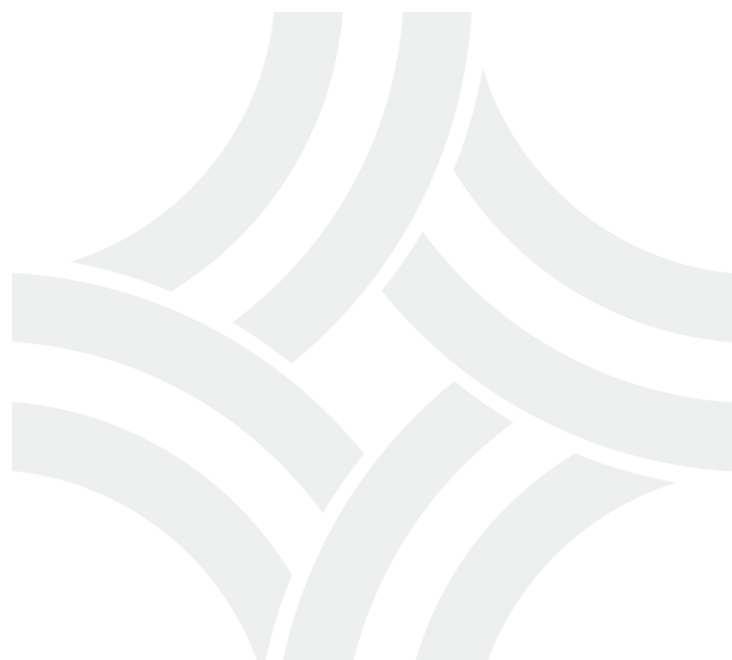
Figure 33 – New Resistor Compartment

Acceleration and braking resistors are now located in a new enclosure next to the #4 door. This new enclosure will ease maintenance activities where these resistors have to be adjusted. Previously these resistors had to be accessed from under the car, which could be especially difficult.

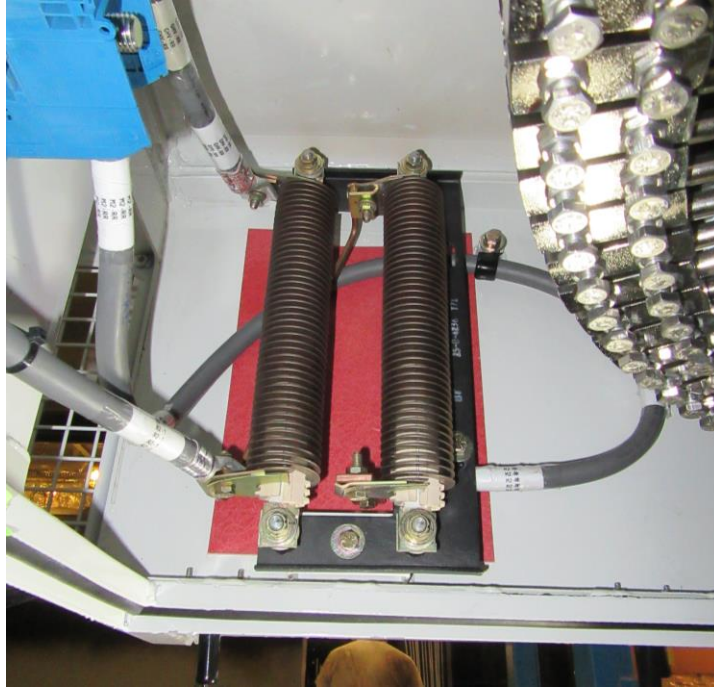
Figure 34 – R1 and R2 Resistors

R1 and R2 resistors are now located in the Accelerator Drum Enclosure.

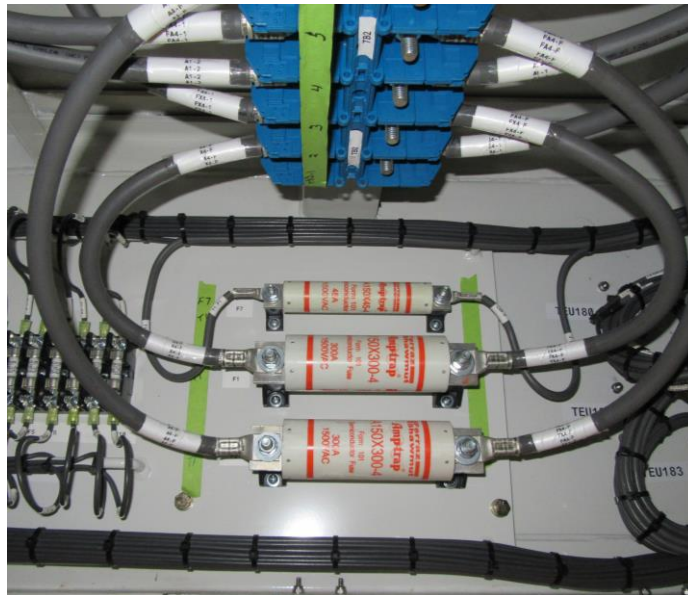
Figure 35 – Traction Motor Fuses

Traction motor fuses are now located in the Hi-Voltage Enclosure.

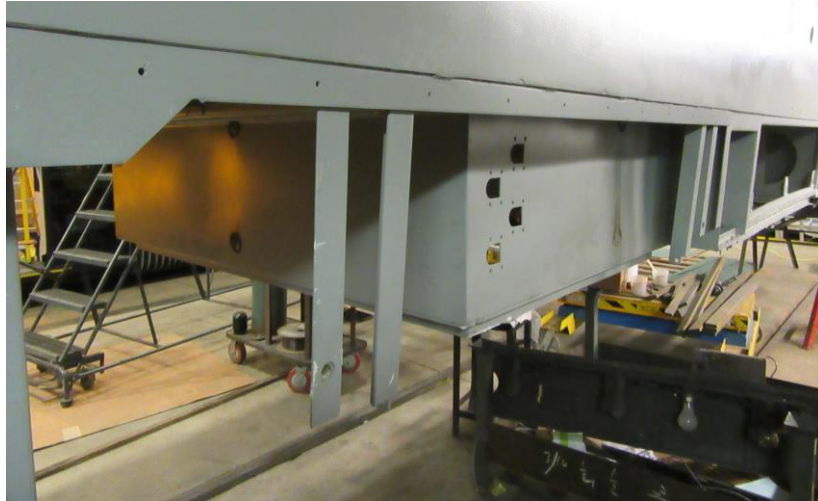
Figure 36 – Side Skirt

A flip-up side skirt is located at the former location of the Master Controller. The flip function of this skirt has been questioned since there doesn't seem to be any equipment that requires access in this area. Brookville stated that this skirt can be used to inspect the truck or remove obstructions.

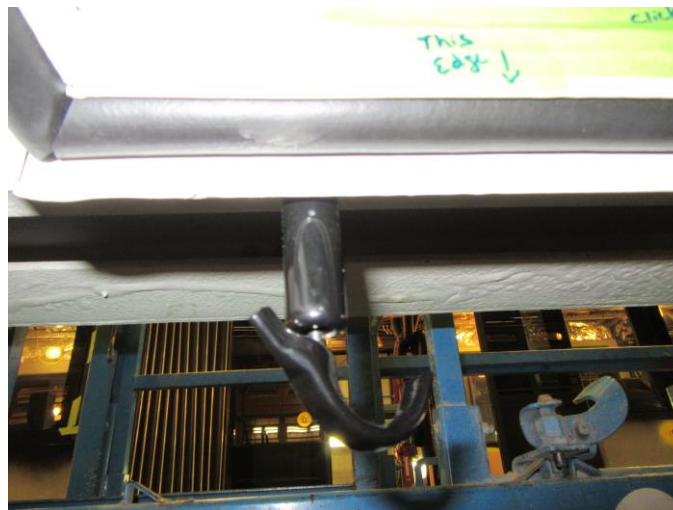
Figure 37 - Undercar Enclosure Lid Seal and Latch

New lid seals are softer and more pliable, so will improve seal between lid and enclosure. Latches changed from rubber to steel springs to also help improve seal and water tightness.

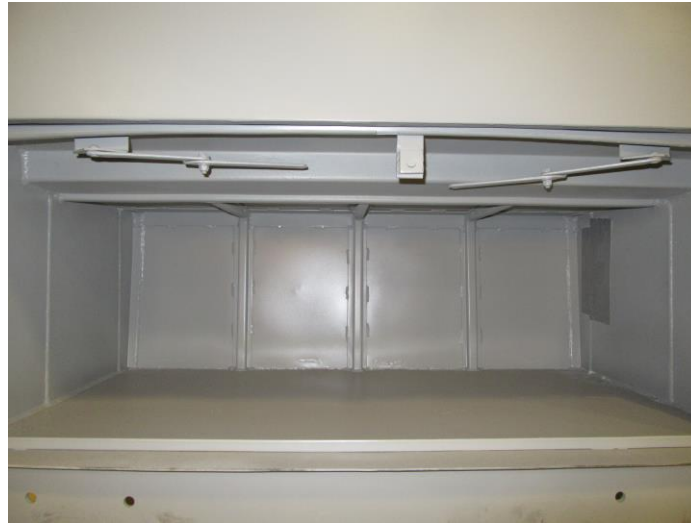
Figure 38 – Battery Compartment

The Battery compartment is subject to flushing and washing by the PCC shop, which can allow water to collect in the compartment. This issue was brought up with Brookville, who stated that this feature might be something to add on later builds, subject to internal approval.
