SFMTA

Rail Operational Challenges during COVID

SFMTA Board

September 1, 2020

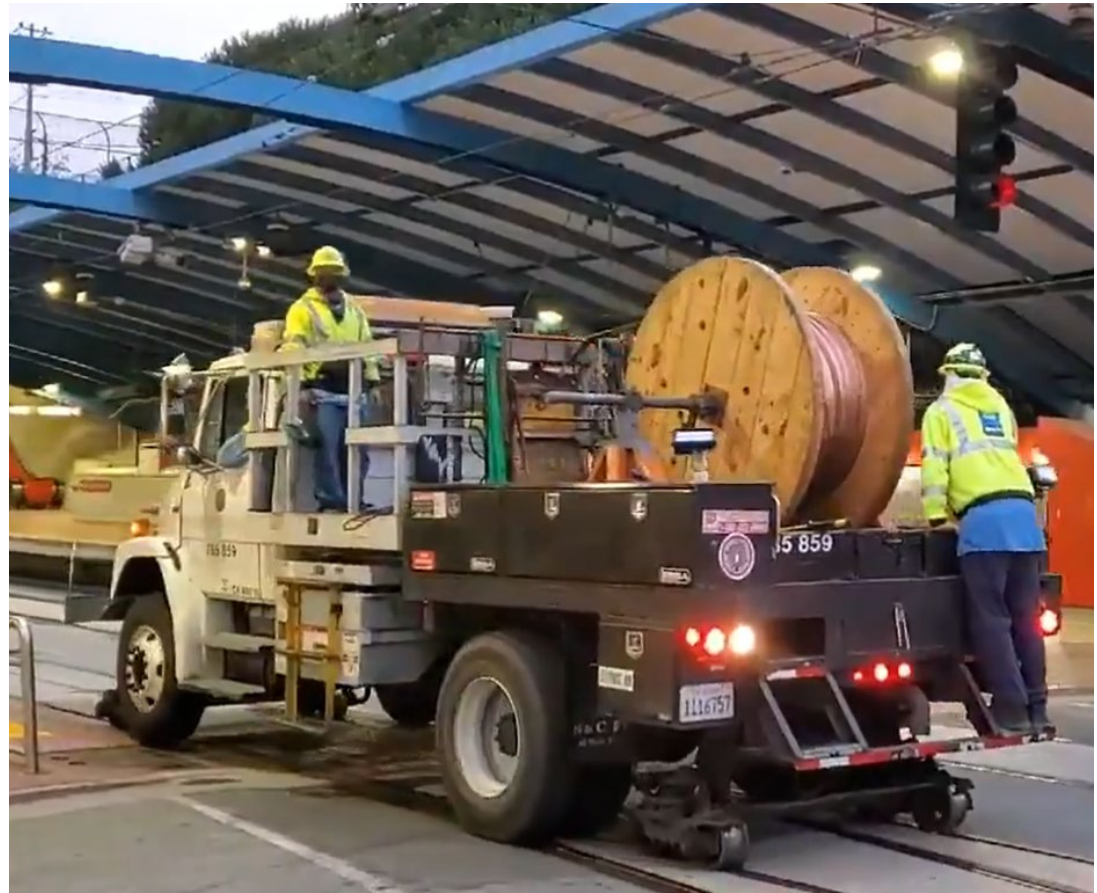
- Overhead wire came down at Castro (pre-start up) and on Monday at Forest Hill
- OHL team responded quickly and discovered both were a failed splice
- Provided bus substitutions

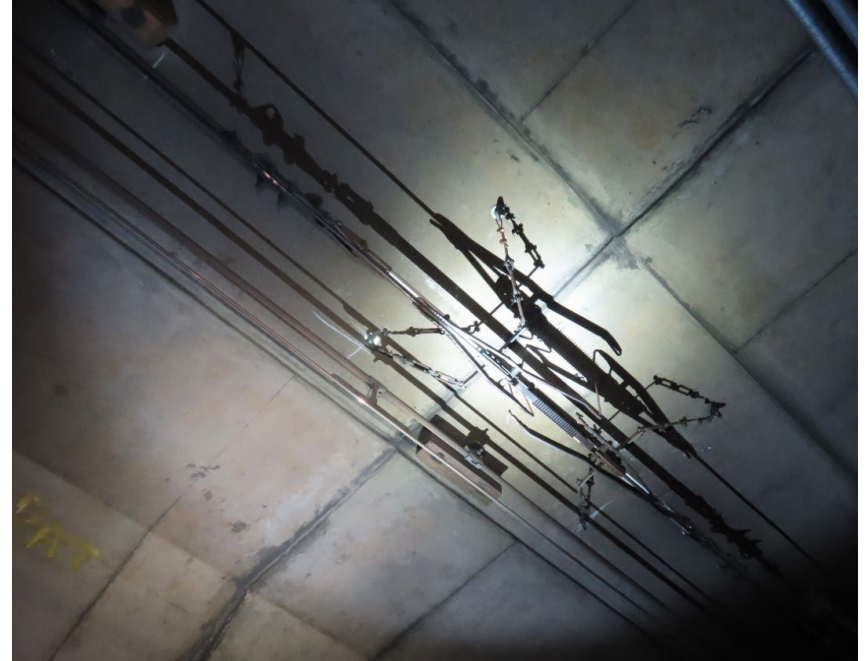
Photo shows section of the subway near Van Ness Station with a slow zone because the height and design need to be modified, this issue is not related to the splice failure, but can be addressed during the shutdown

- During shutdown, other challenging areas that are unrelated to the splices will also be addressed
- In many locations, splices will be removed instead of replaced by running new wire – 45 splices removed to date during extended maintenance shutdowns
- Staff also working to develop quality assurance program – including outside parts testing and implement new video technology to improve the early detection of issues that cannot be spotted with naked eye before they become failure
