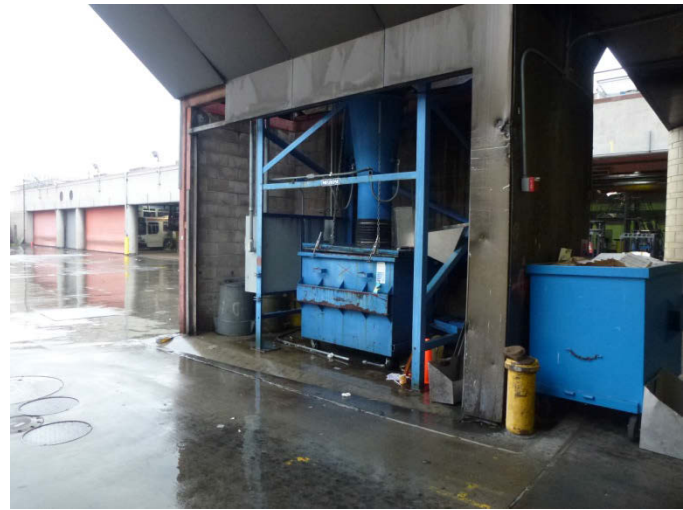
Interior Vacuum System

- a. Demolish inoperable Vacuum System and compactor/dumpster area allowing the west bay of Light Repair to be used.
- b. Add new centralized vacuum system with 2 hose drops per fueling position, one at each door location.

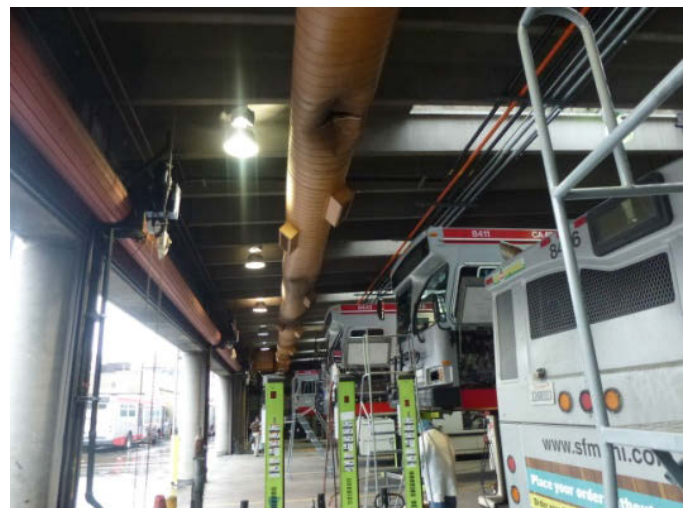
Damage to Air Ducts in Maintenance Bays

- Aging T12 fixtures in fueling station, former classroom, and parts areas
- Damage on ductwork from vehicle collisions
- Two (2) relatively new Laars Pennant forced draft boilers, 1,000 MBH each
- Two (2) constant speed hot water pumps
- Two (2) aging penthouse air handling units presumably serving the upper floor
- Lights left on (manual switch) in the paint booth
- ~25kWdc Rooftop Photovoltaic system (~100 panels)

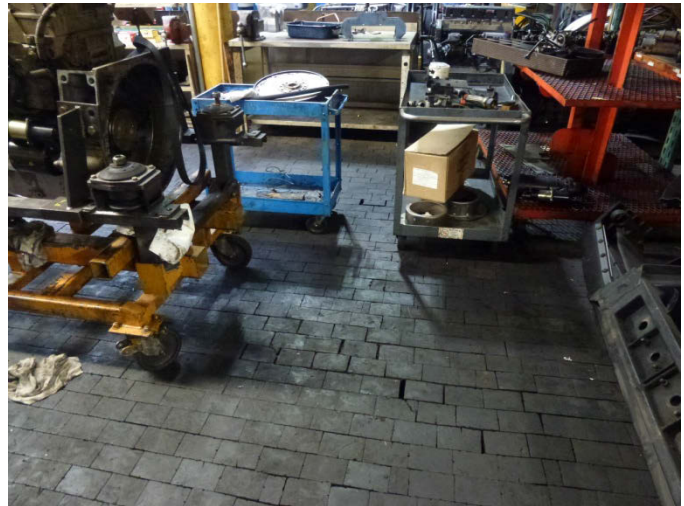
- 10. Brake Shop
 - a. 2 lathes and a bridge crane. Insufficient dust collection.
- 11. Machine Shop
 - a. Wood block floor floats during heavy rain. Unclear if this is from low water table or ceiling leaks.
 - b. Poor lighting
 - c. Staffing: Day 8, Swing 2, Graveyard 3
 - d. 8 jib cranes on first floor
 - e. Store fully assembled motor/trans/cradle here and individual components in store room
 - f. Welding area is shielded by curtain and vented with fume extraction arms
 - g. 2 engine workstations, 2 differential workstations, 5 transmission workstations
 - h. Fabrication materials are stored in a caged area

Machine Shop Wood Block Floors

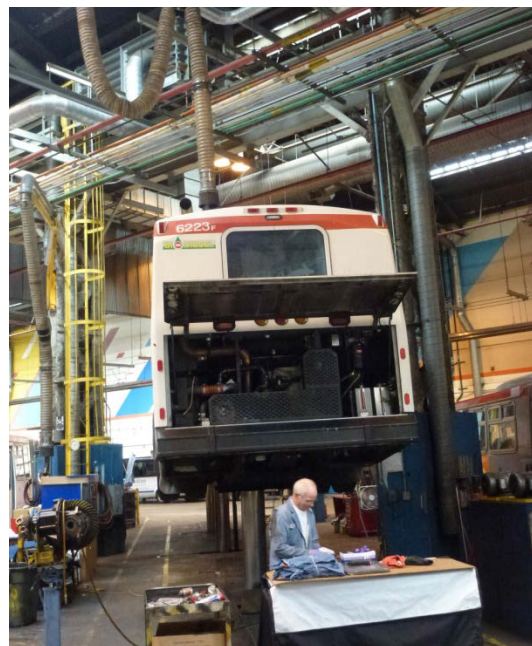
Vehicle Exhaust System Poorly Located

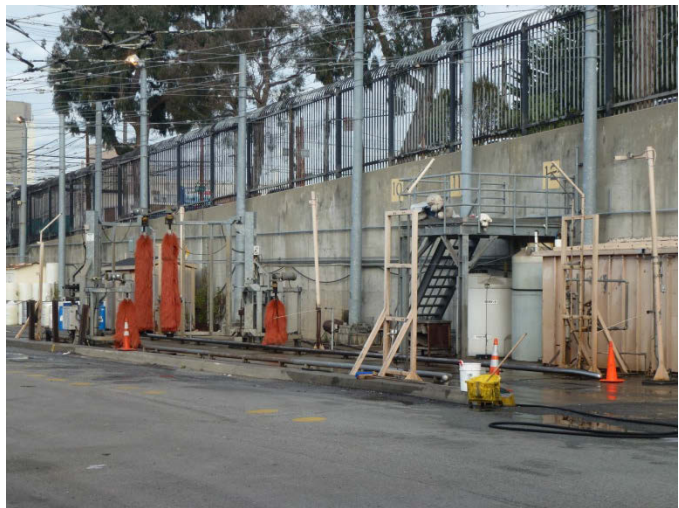
- a. Cyclone vacuum system near the wash area – does not work well and crews must wipe down the bus interior after use to clear the displaced dust – system is often down and requires a great deal of maintenance
- b. Vehicle washer is not ideal for electric trolley buses – brushes routinely get tangled in the trolley apparatus and the system has issues with damaging the mirrors on these vehicles
- c. Brushes on the bus washer have not been replaced in over 10 years

Bus Washer

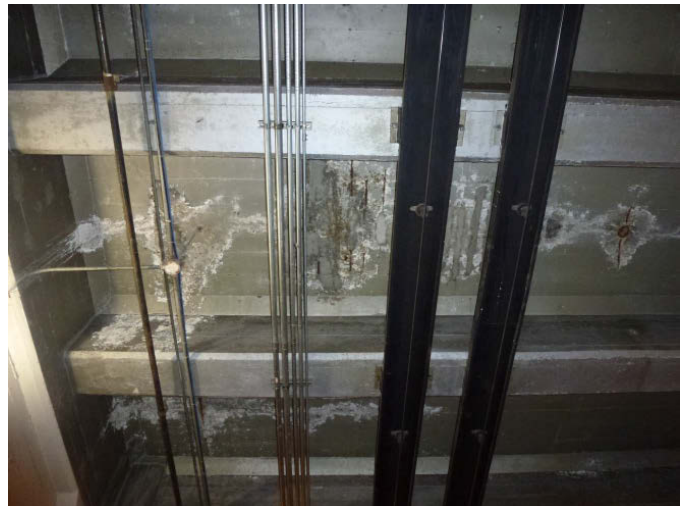
9. Major roof leaks which have caused damage to the building (spalling) and flood the pits on a regular basis
10. Parking Area

Concrete Spalling above Overhead Lines

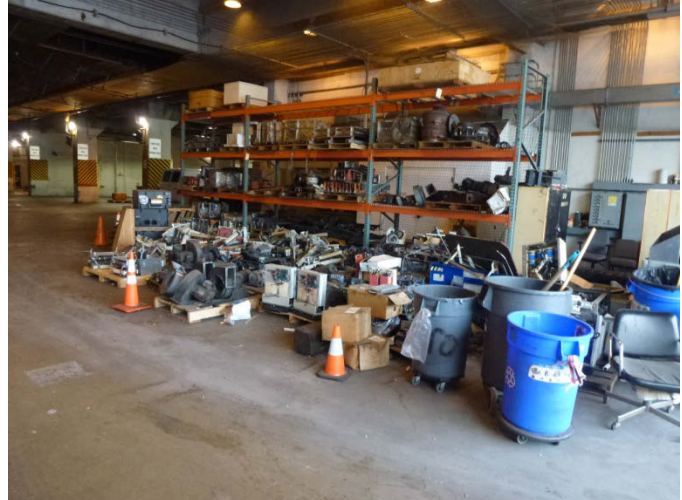
Parts Storage on Shop Floor

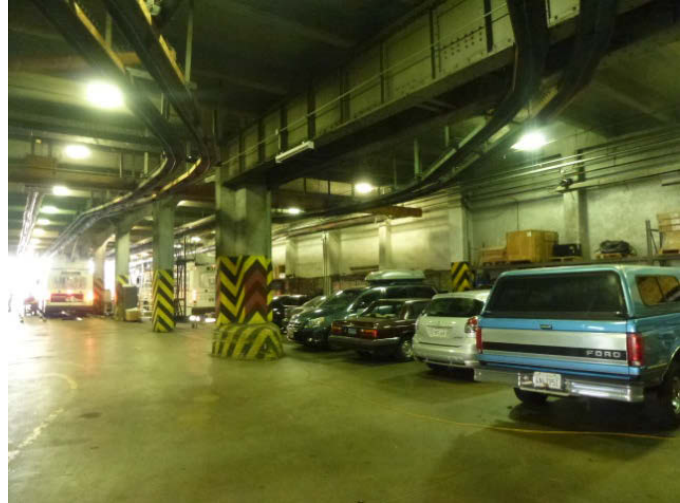
Employee Vehicles Parked in Maintenance Areas

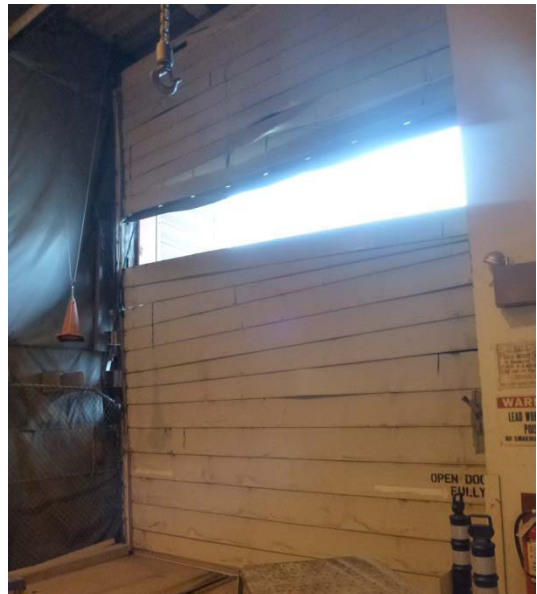
Damaged Overhead Door
