SFMTA

Tunnel Structure Program At CP&C

Twin Peaks Tunnel Inspection

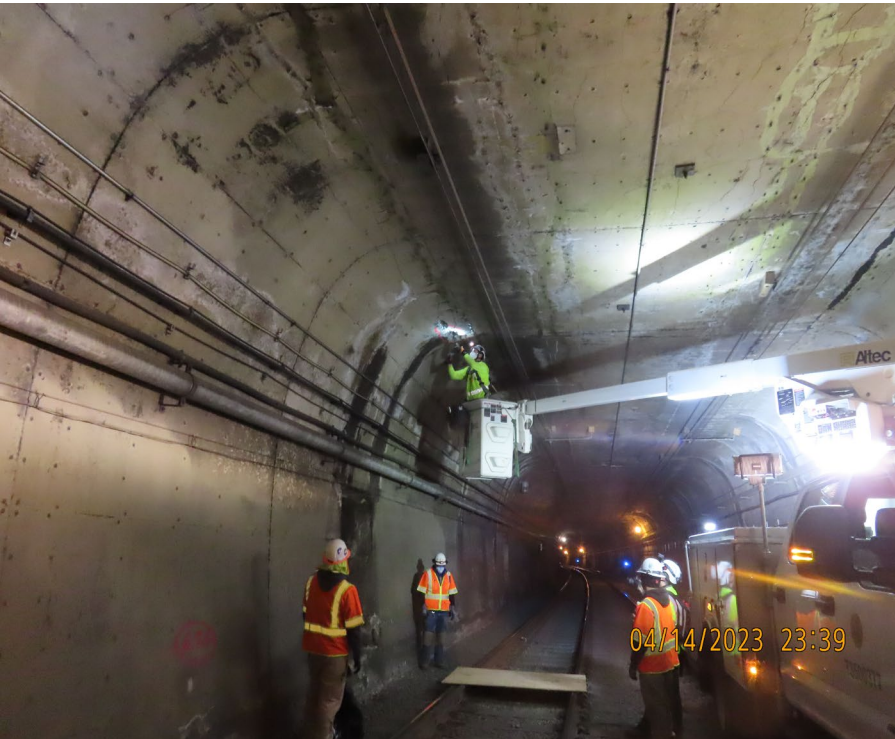
- One of the key findings of the inspection: over the 100-year life span of the tunnel, pressure due to ground water in the soil has caused movement in two identified critical sections of the Tunnel between West Portal and Forest Hill Station.

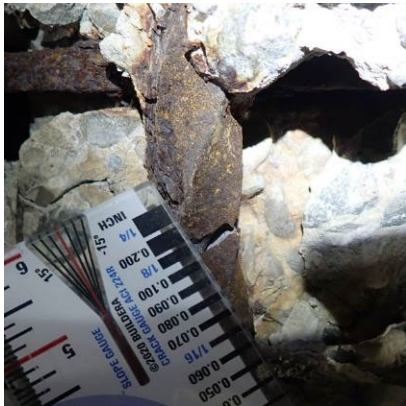
✕ 09+65 – Fractured Bar

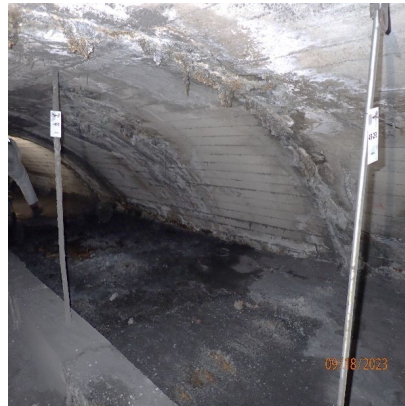
● 48+27 – Leak @ 60 drops/min.

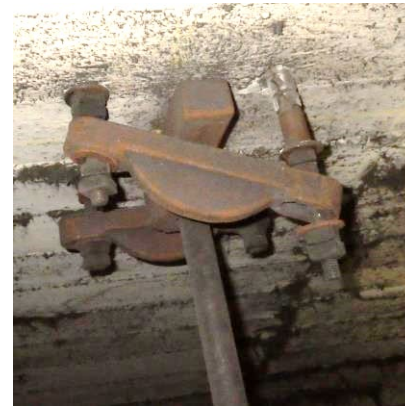
+ 61+90 – Hanger not secure

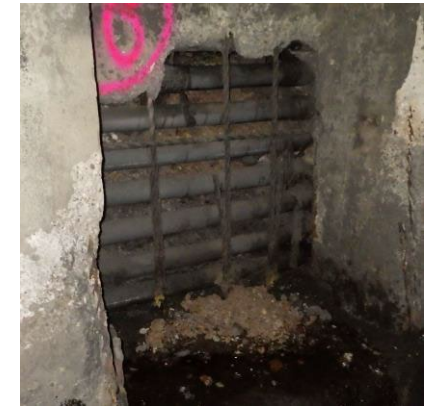
□ 90+90 – Hole in Niche 94

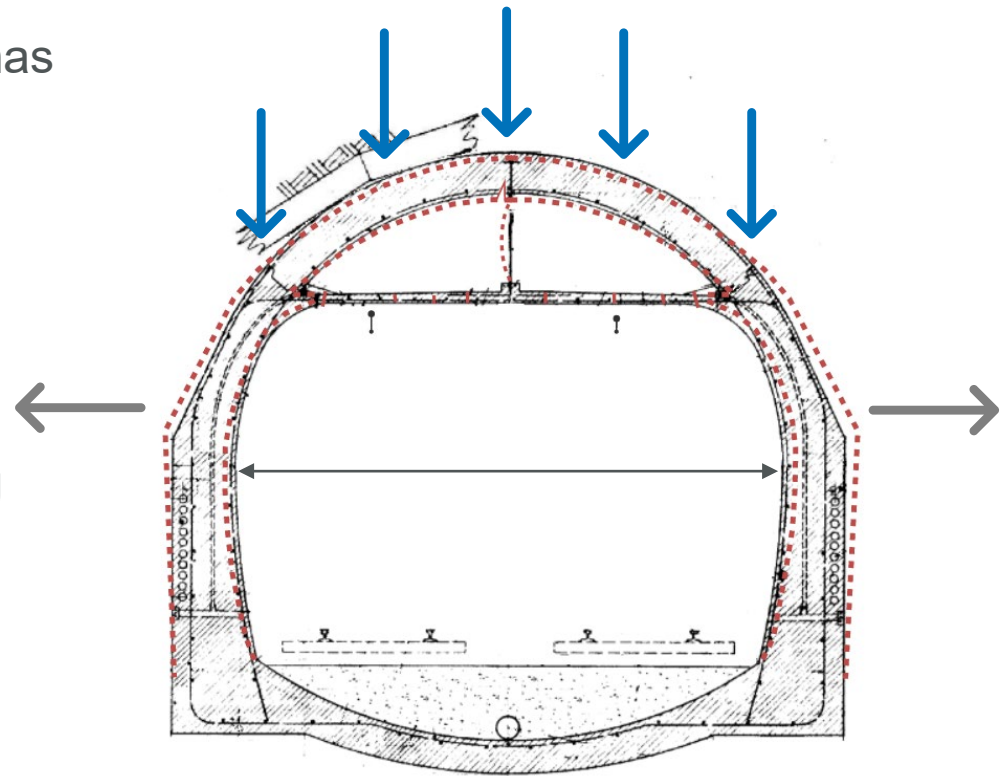
- Tunnel liner has distorted over time.
- Likely predates the 1970's and has progressed since then.
- Voids are likely a contributing factor.
- Visible signs include:
 - Measured width
 - Longitudinal cracks on ceiling
 - Fractured transverse rebar at ceiling
 - Longitudinal crack on crown
 - Distorted hanger rods
