Transit Performance Update Next 90 Day Plan

Julie Kirschbaum, Director of Transit

SFMTA Board of Directors

June 18, 2019

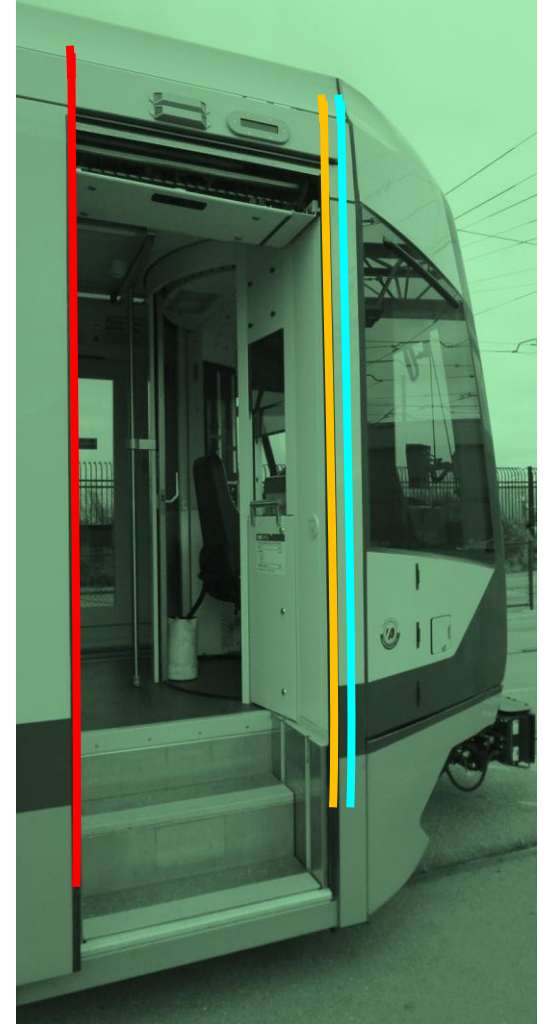
LRV4 Modifications On Track

Door Sensitive Edge Modifications

- 35 cars completed as of June 11
- All cars on track for June 30

Couplers

- End stops removed and shear bolts replaced for units without damage will be complete by June 30
- This will allow return of LRV4 Two-car Revenue Service operations without restriction by end of June as forecast
- For couplers with bearing housing damage, removal and replacement of the affected parts to be completed by July 31

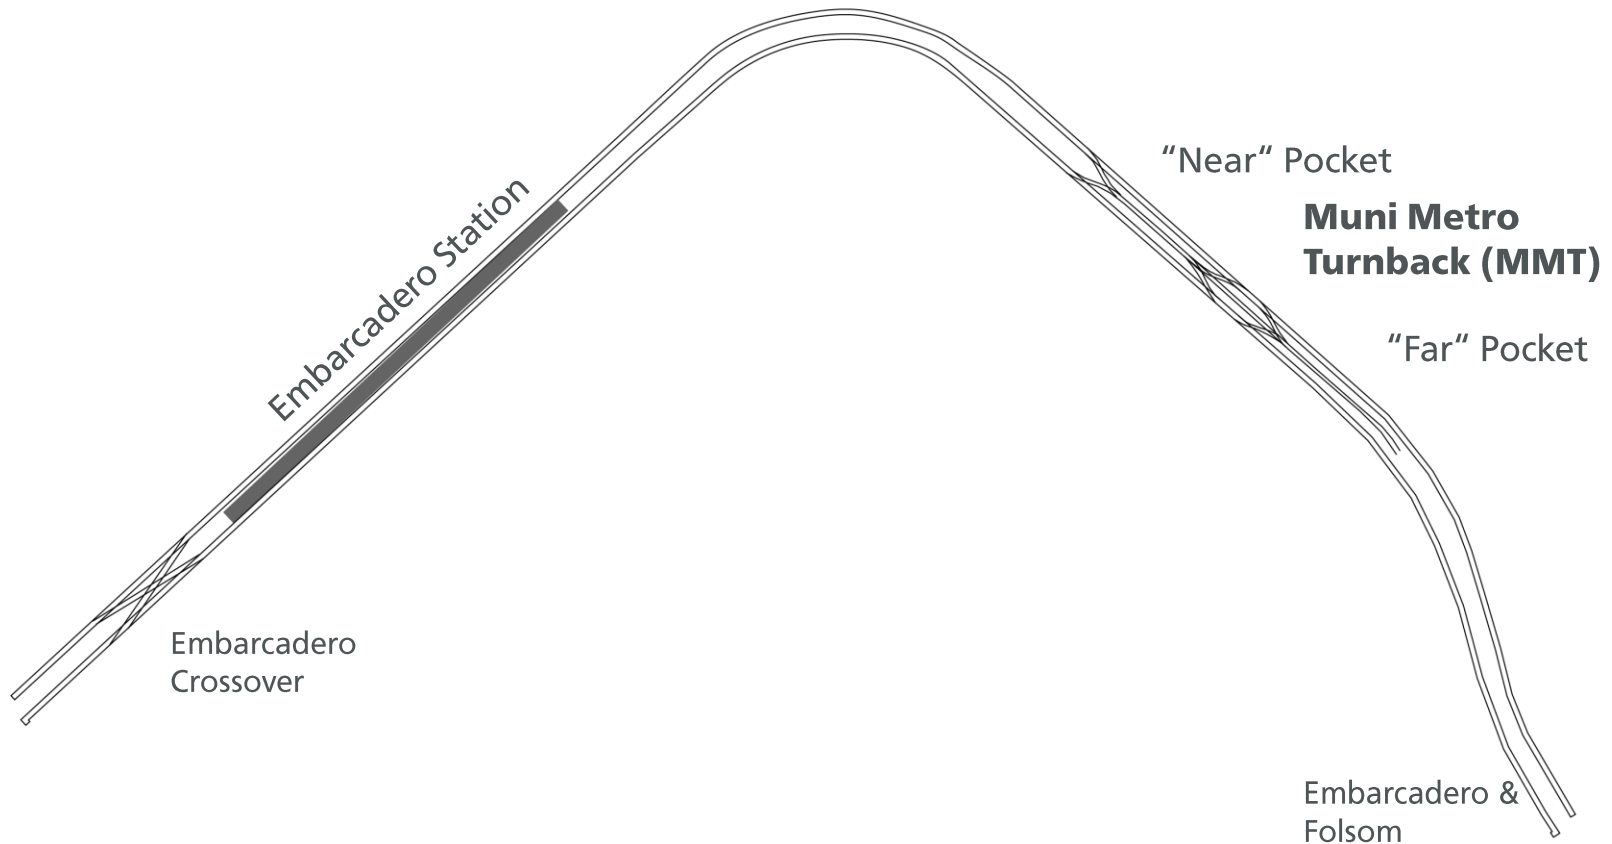
Weekday Actual vs Scheduled Subway Throughput

Request: Investigate the effectiveness of using the Embarcadero crossover to turnback lines at Embarcadero

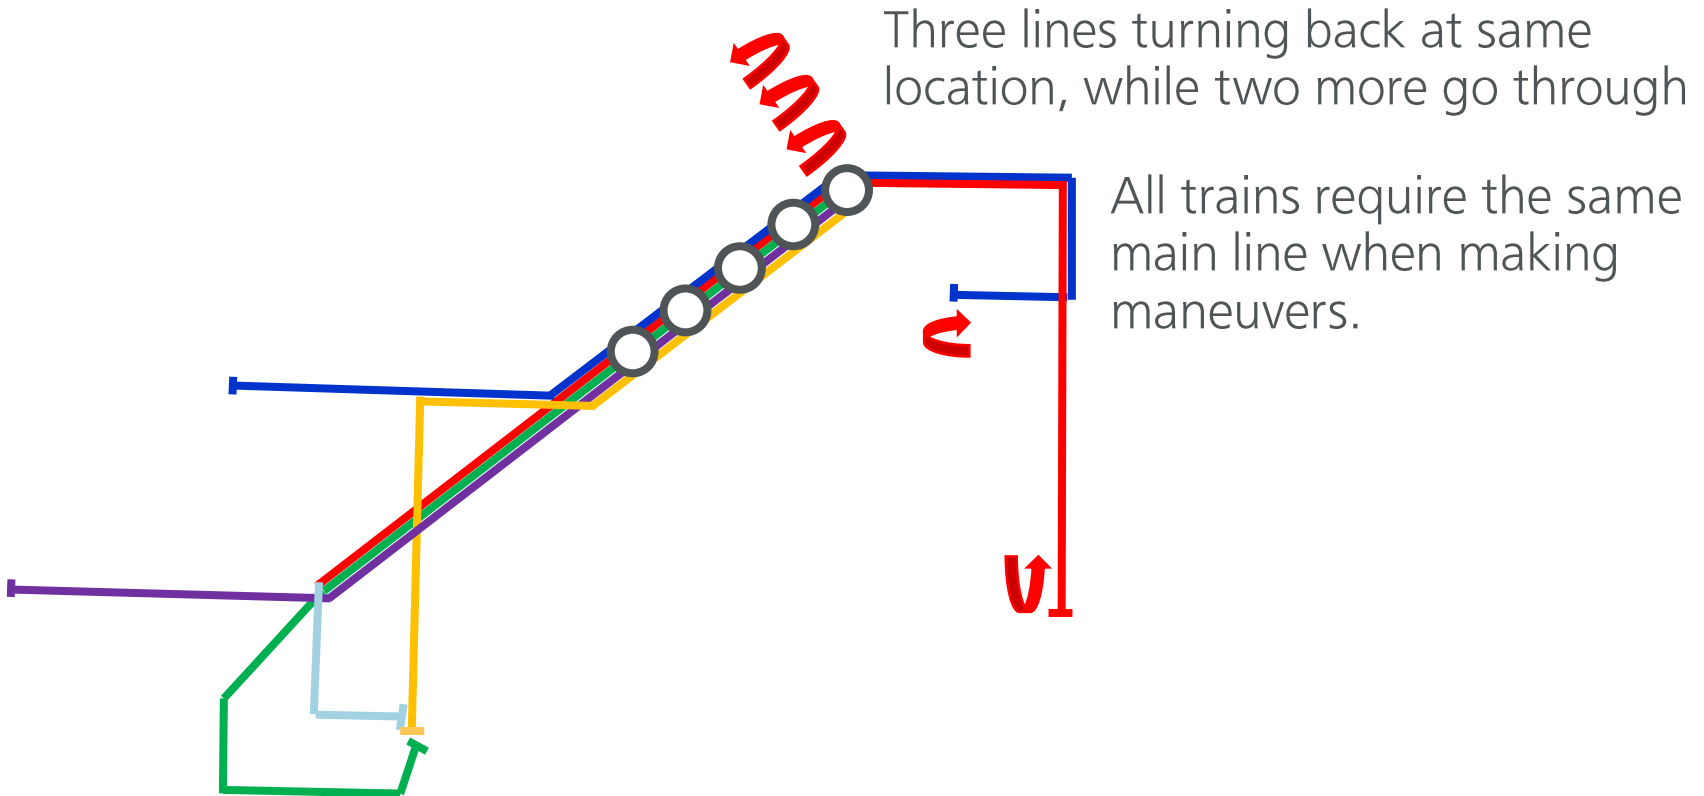
Muni Subway Today

2 Turnbacks

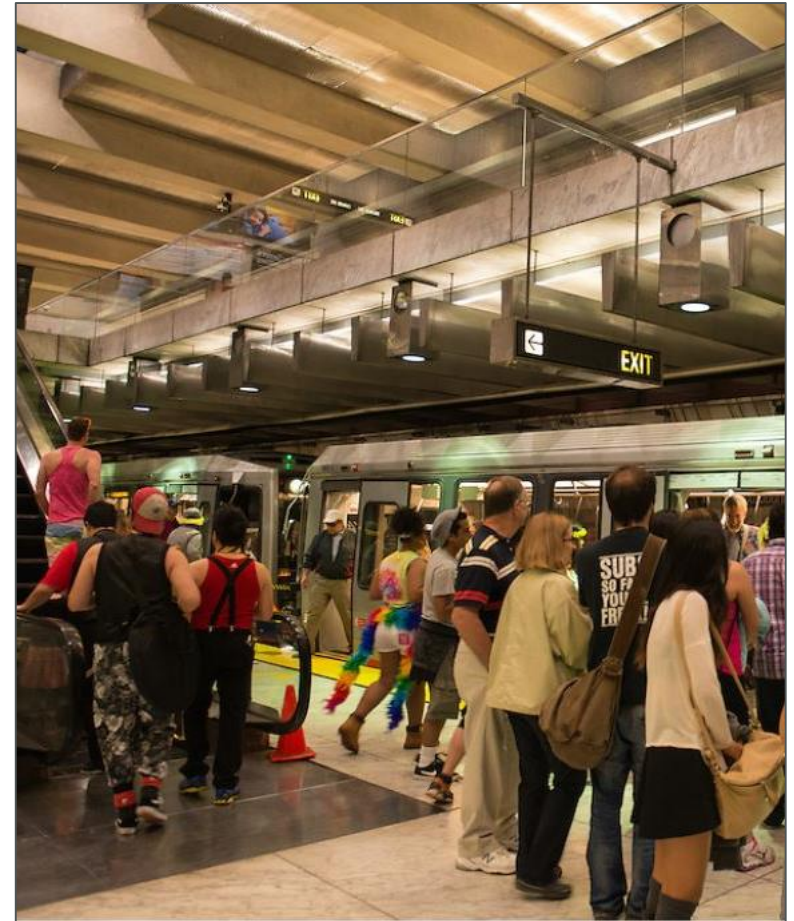
Embarcadero Crossover

- Turnbacks on mainline reduce subway capacity because they block train movements in both directions for 3 to 4 min
- Embarcadero crossover is critical for managing incidents and gaps in service (similar to Castro)
- Current functionality of crossover limited, but will be enhanced as part of upcoming 90 day plan
