Eureka Compromise Joint Replacement Project

Summary of Work

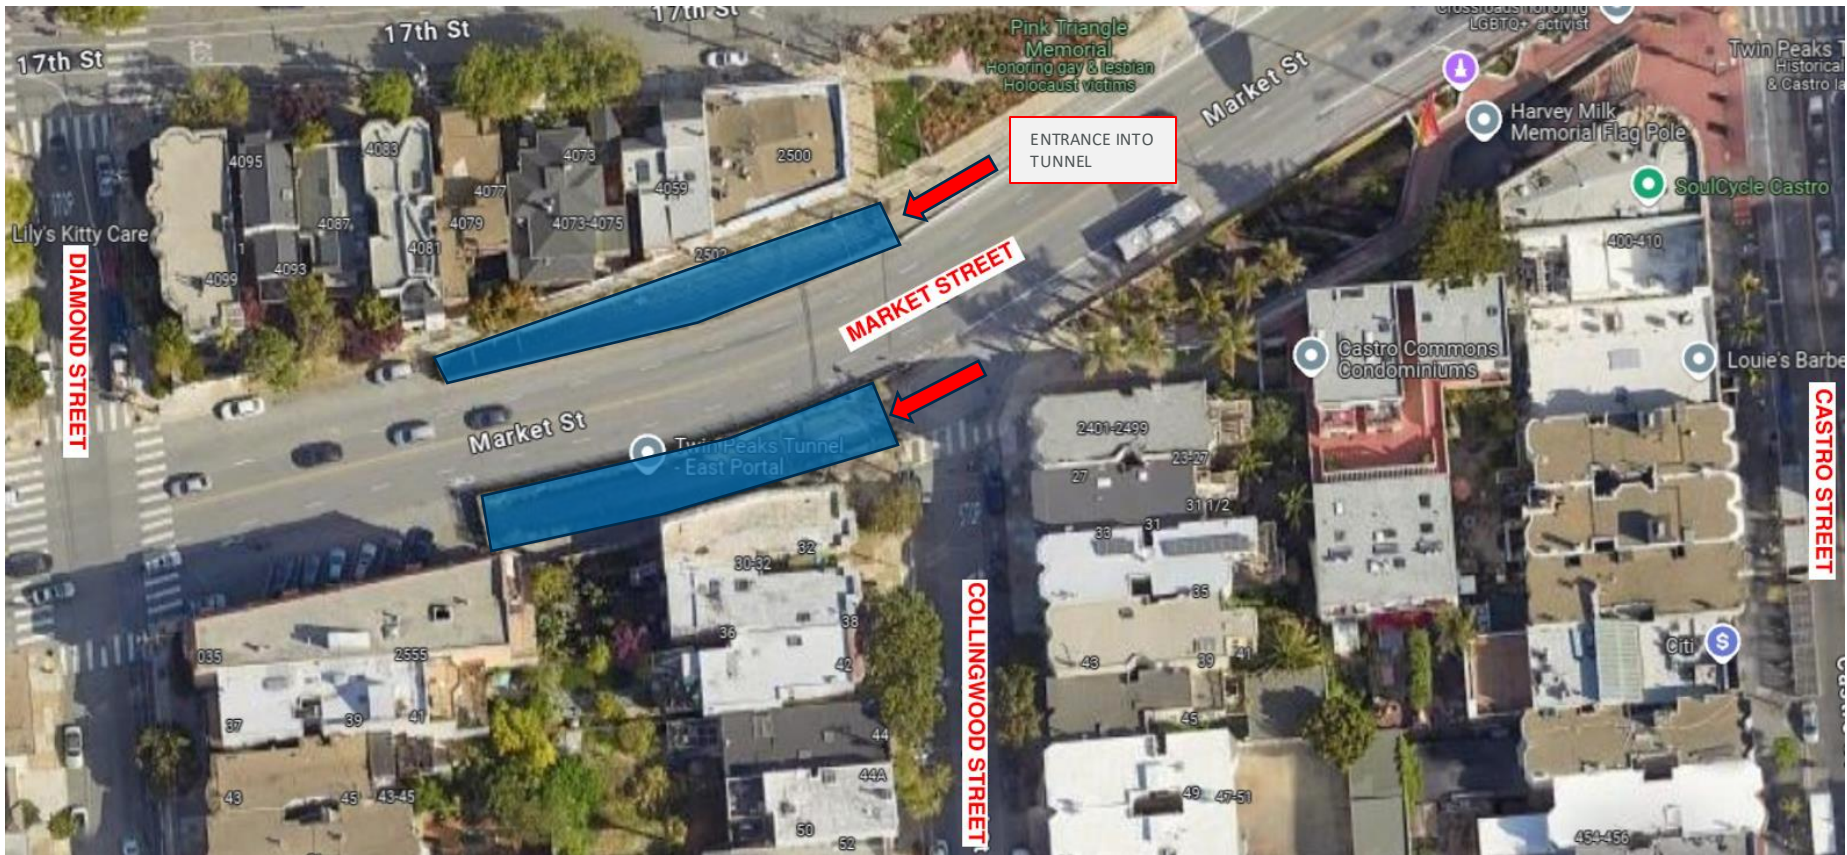
Surface Portal Entrance

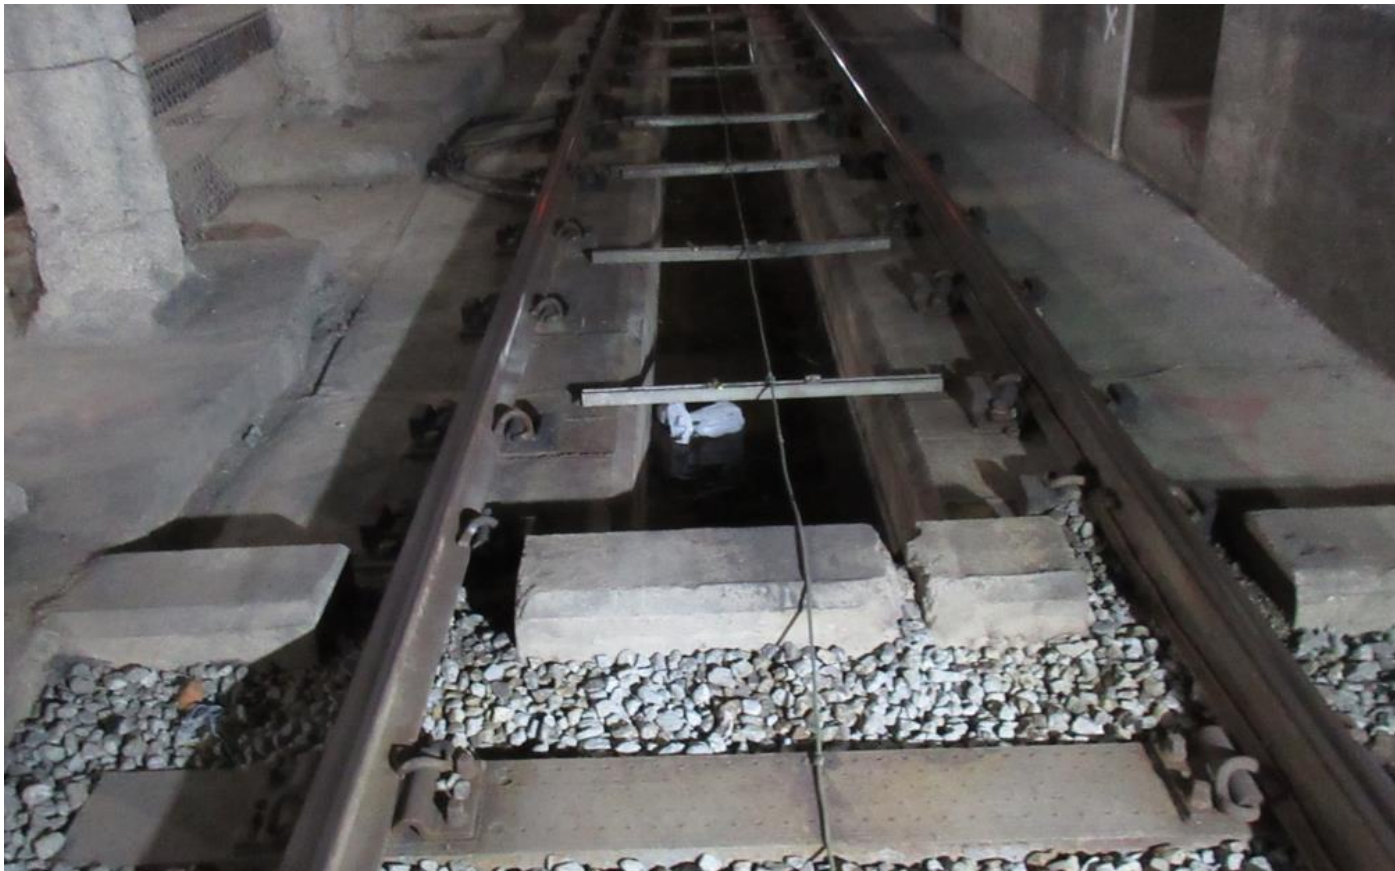
Concrete Direct Fixation

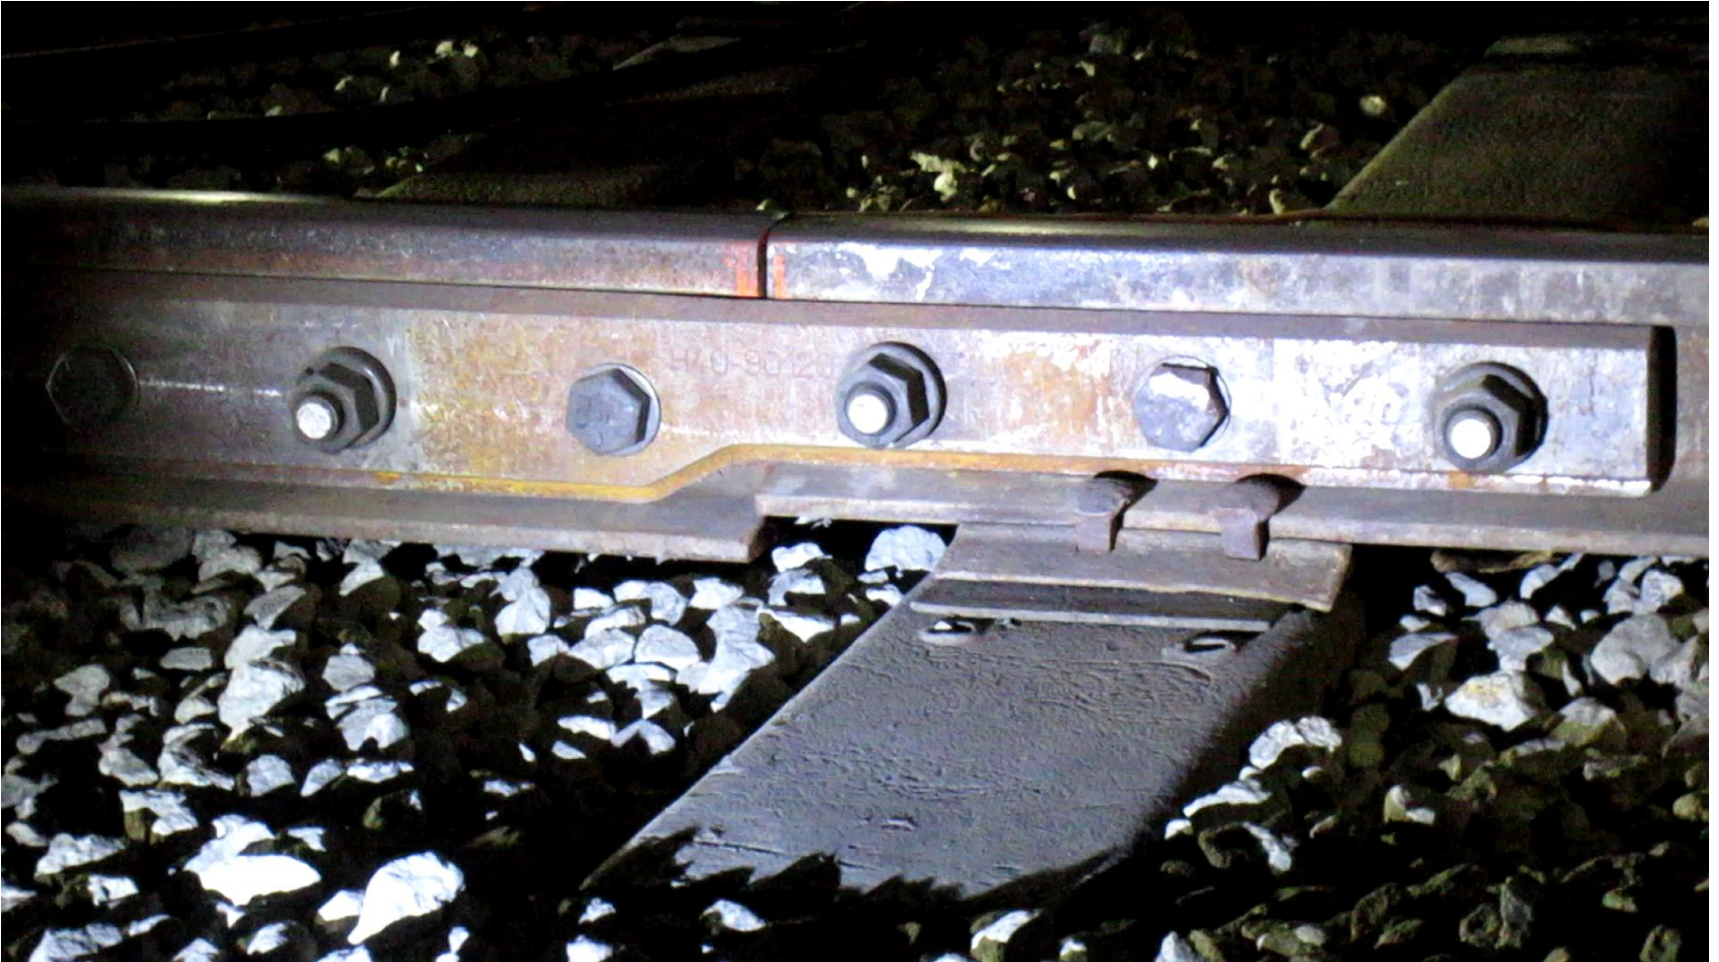
Movement of Rails

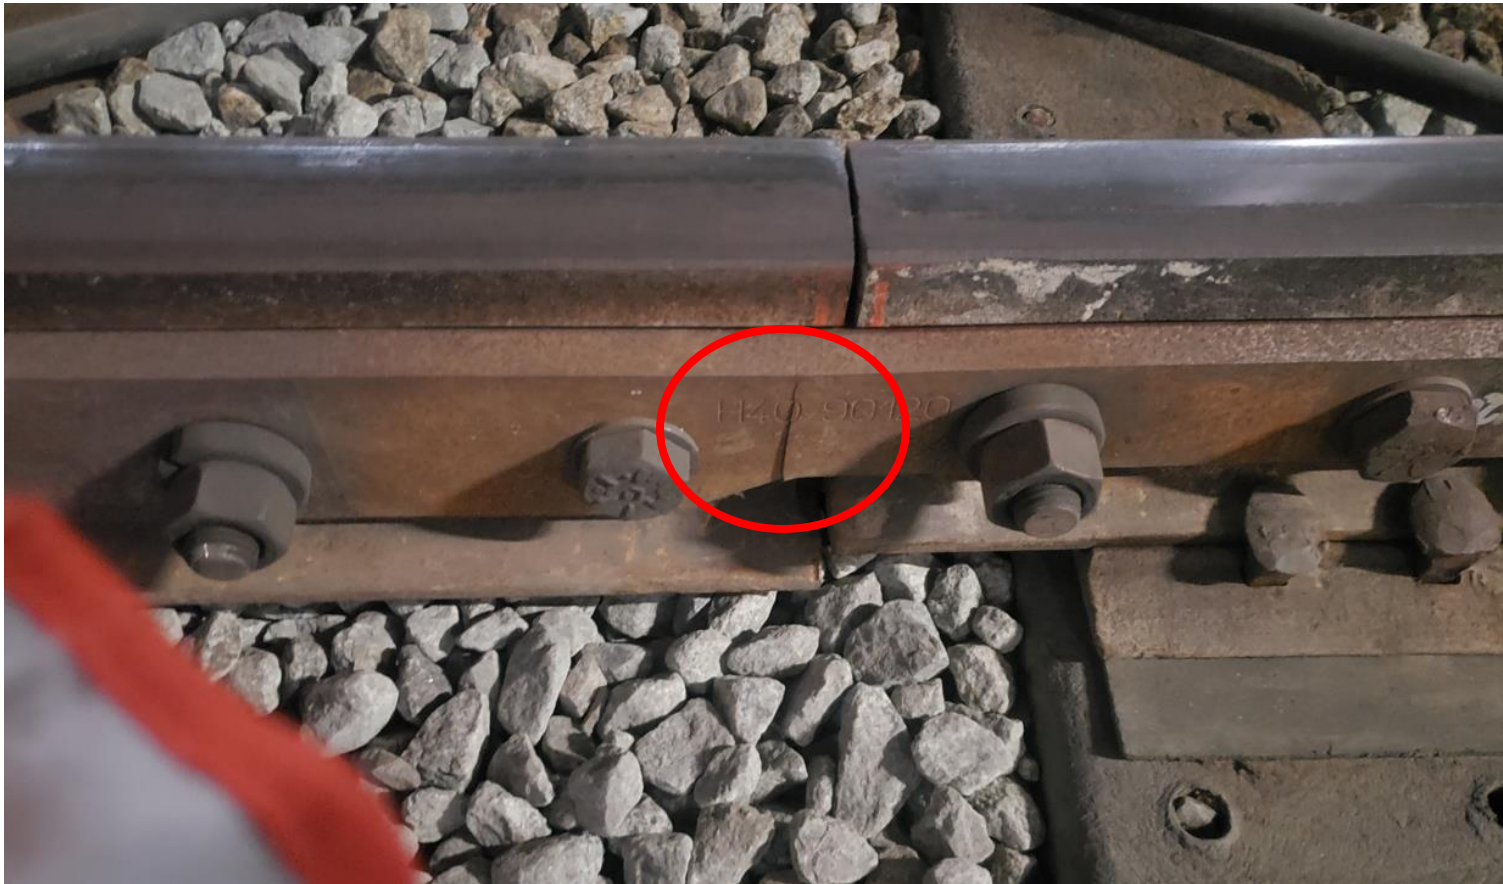
Cracked Compromise Joint

- I. Install new compromise joints on concrete direct fixation
 - A. Cut existing 100# rails and remove
 - B. New fasteners for 115RE rail in concrete direct fixation
- II. Install new 115RE rail
 - A. Weld new 115RE rails to existing
- III. Improve stability at tie & ballast
 - A. Add ballast as needed and tamp

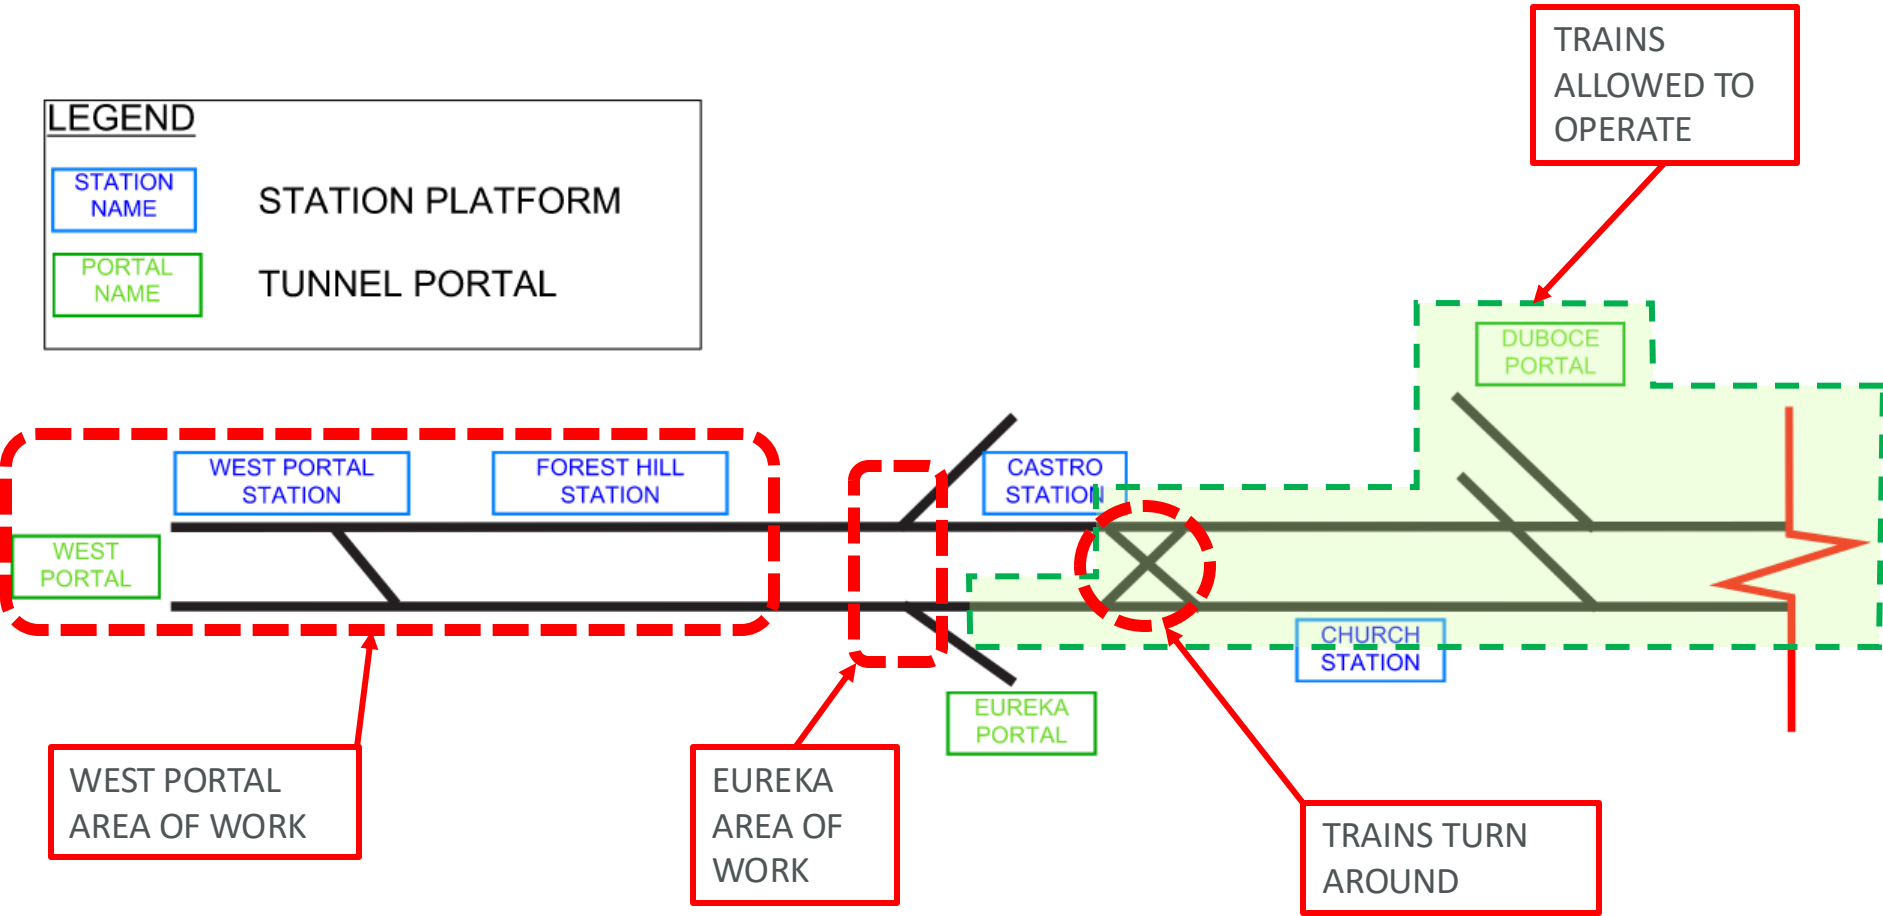
Transit Operation during construction

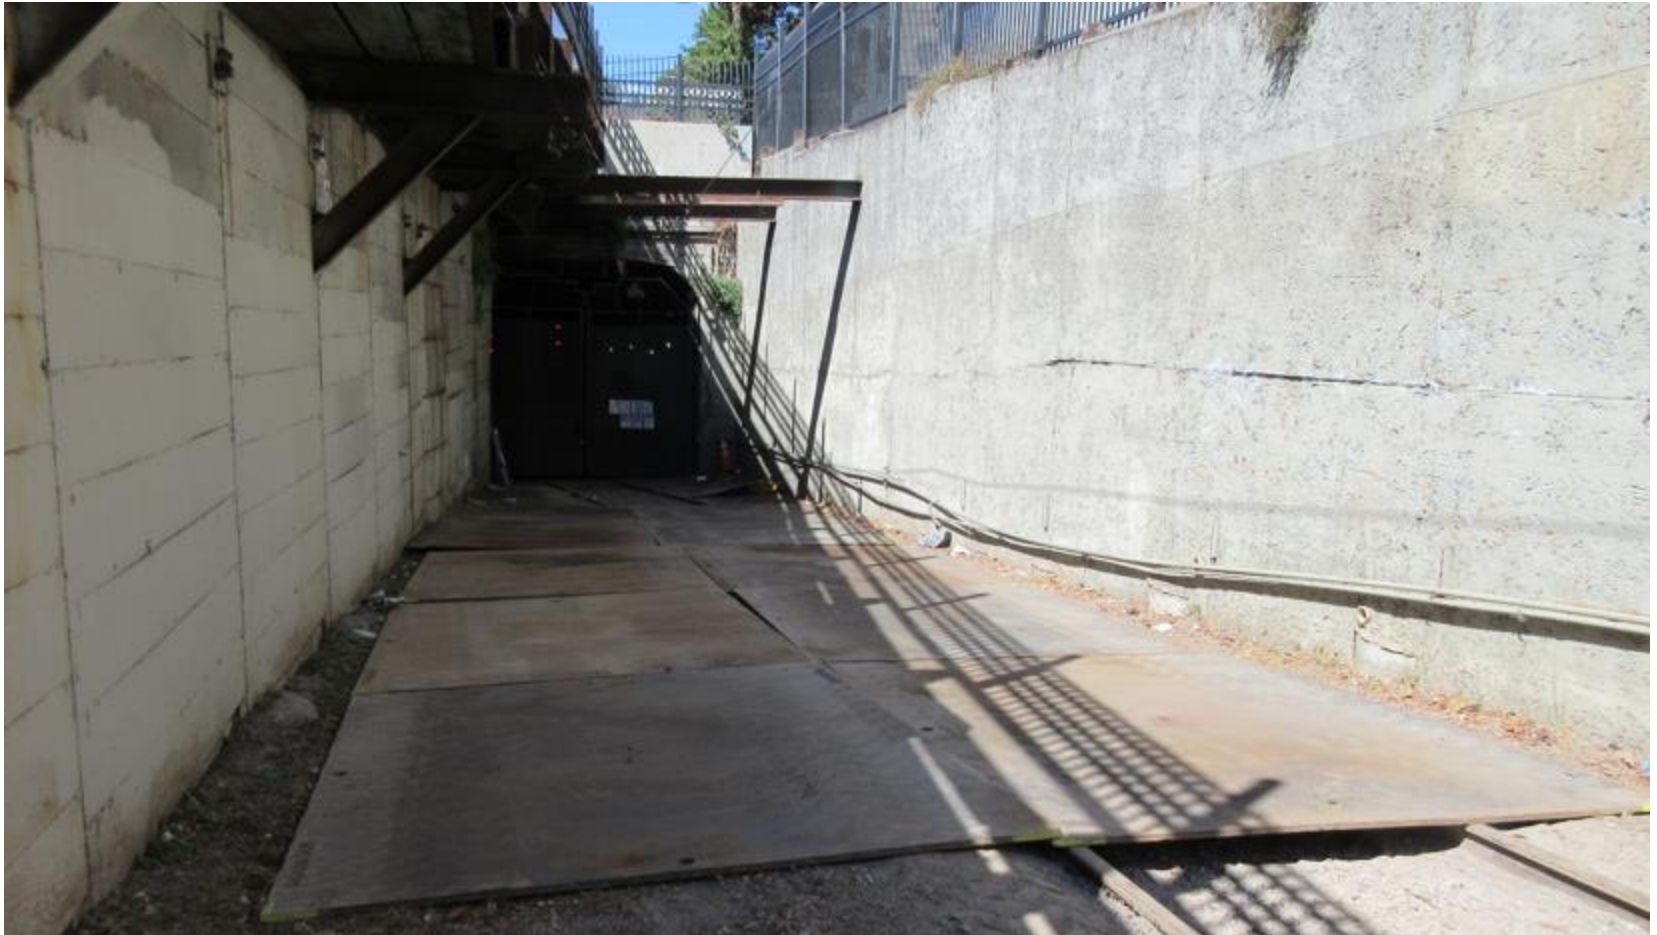
Ingress/Egress into tunnel

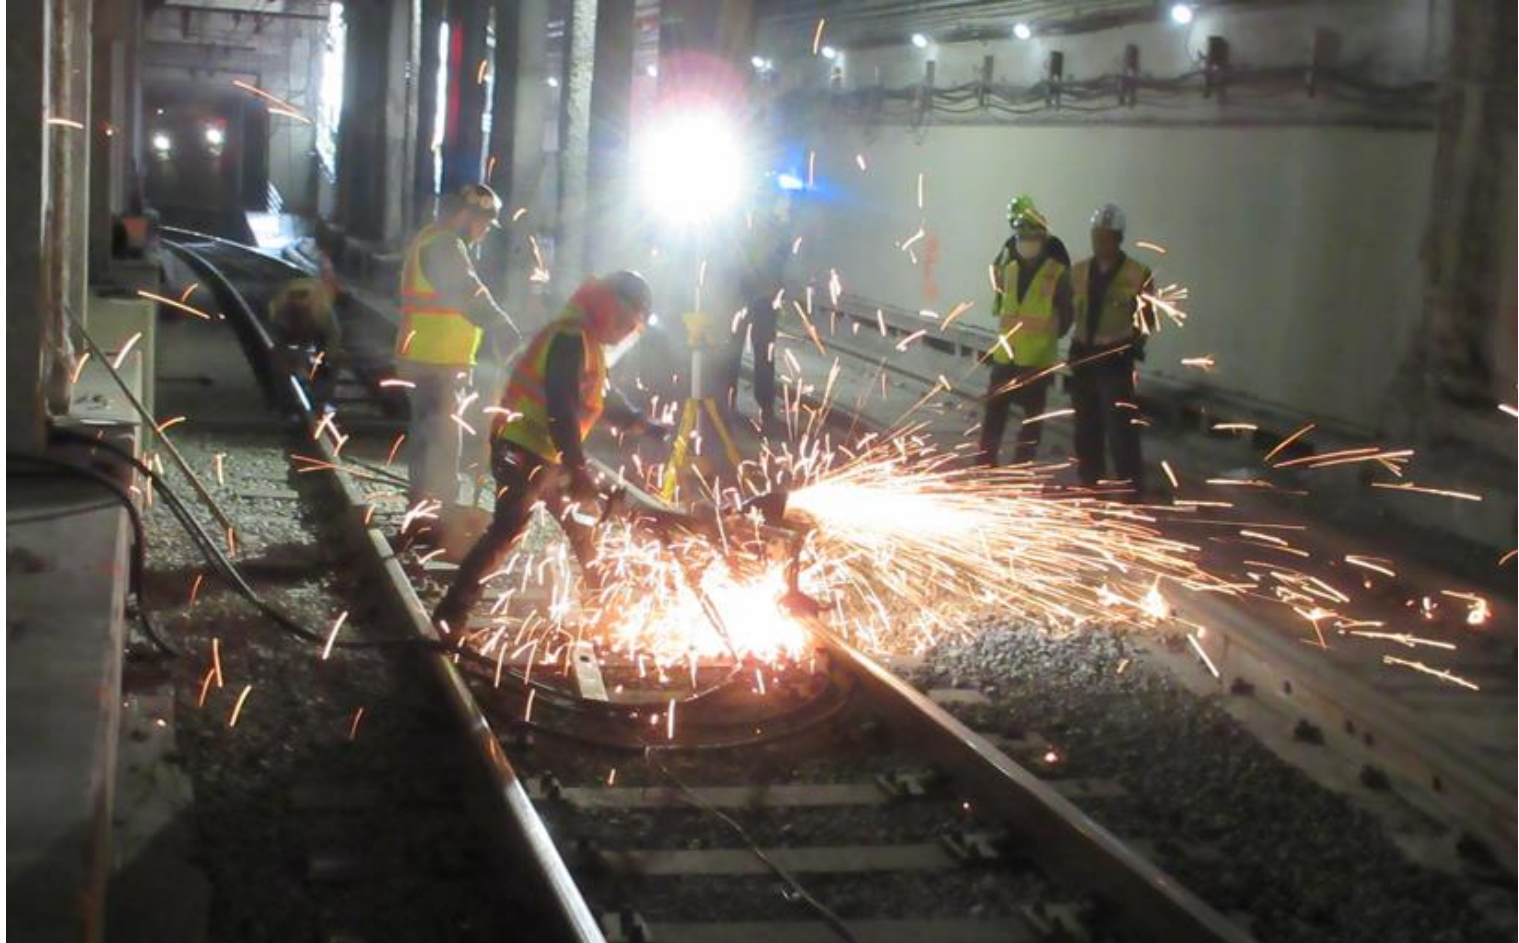
Cutting Rail

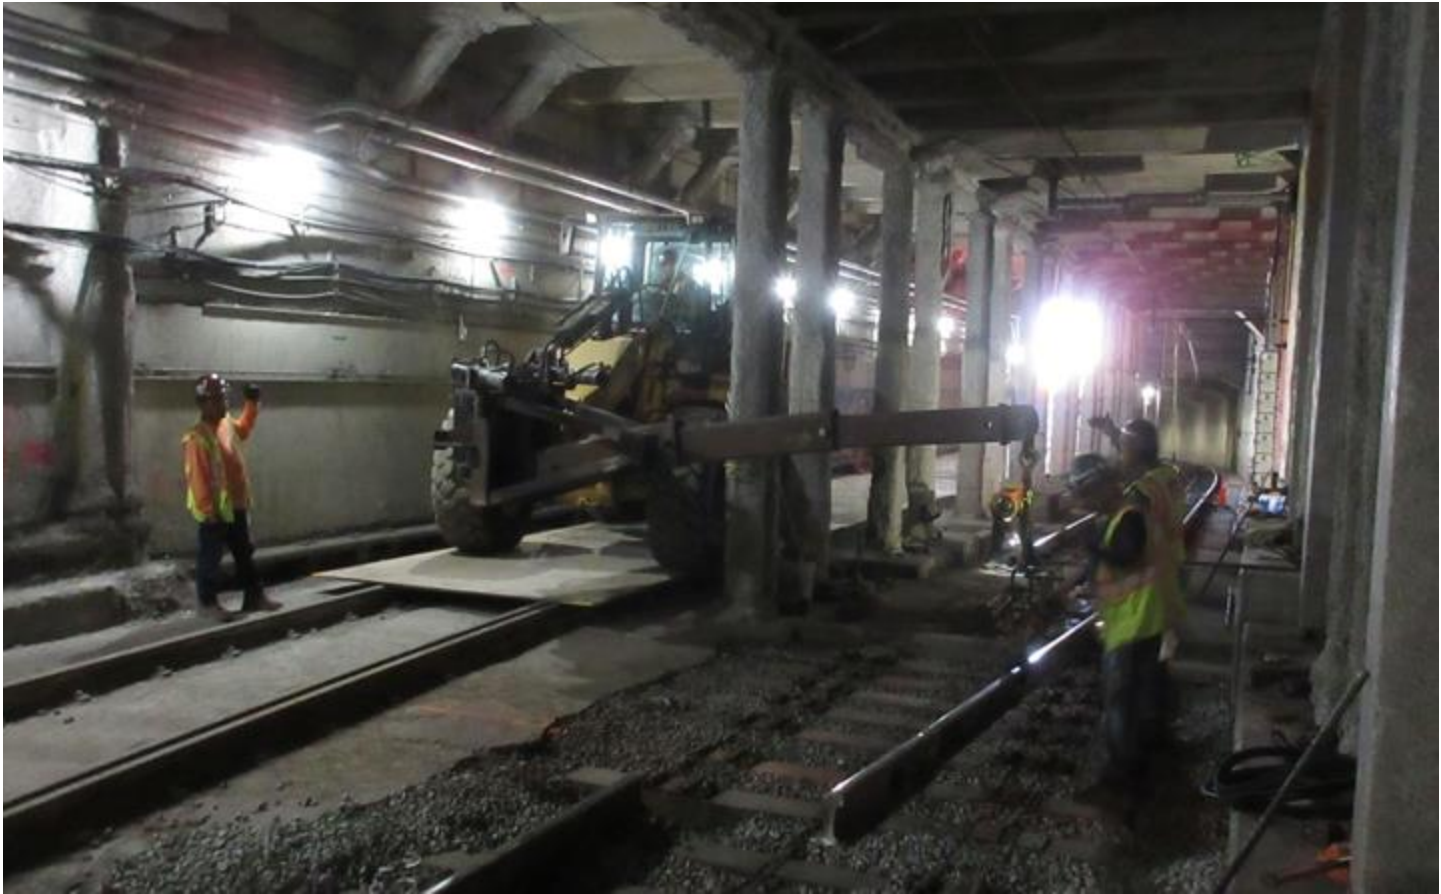
Removing/Installing Rail

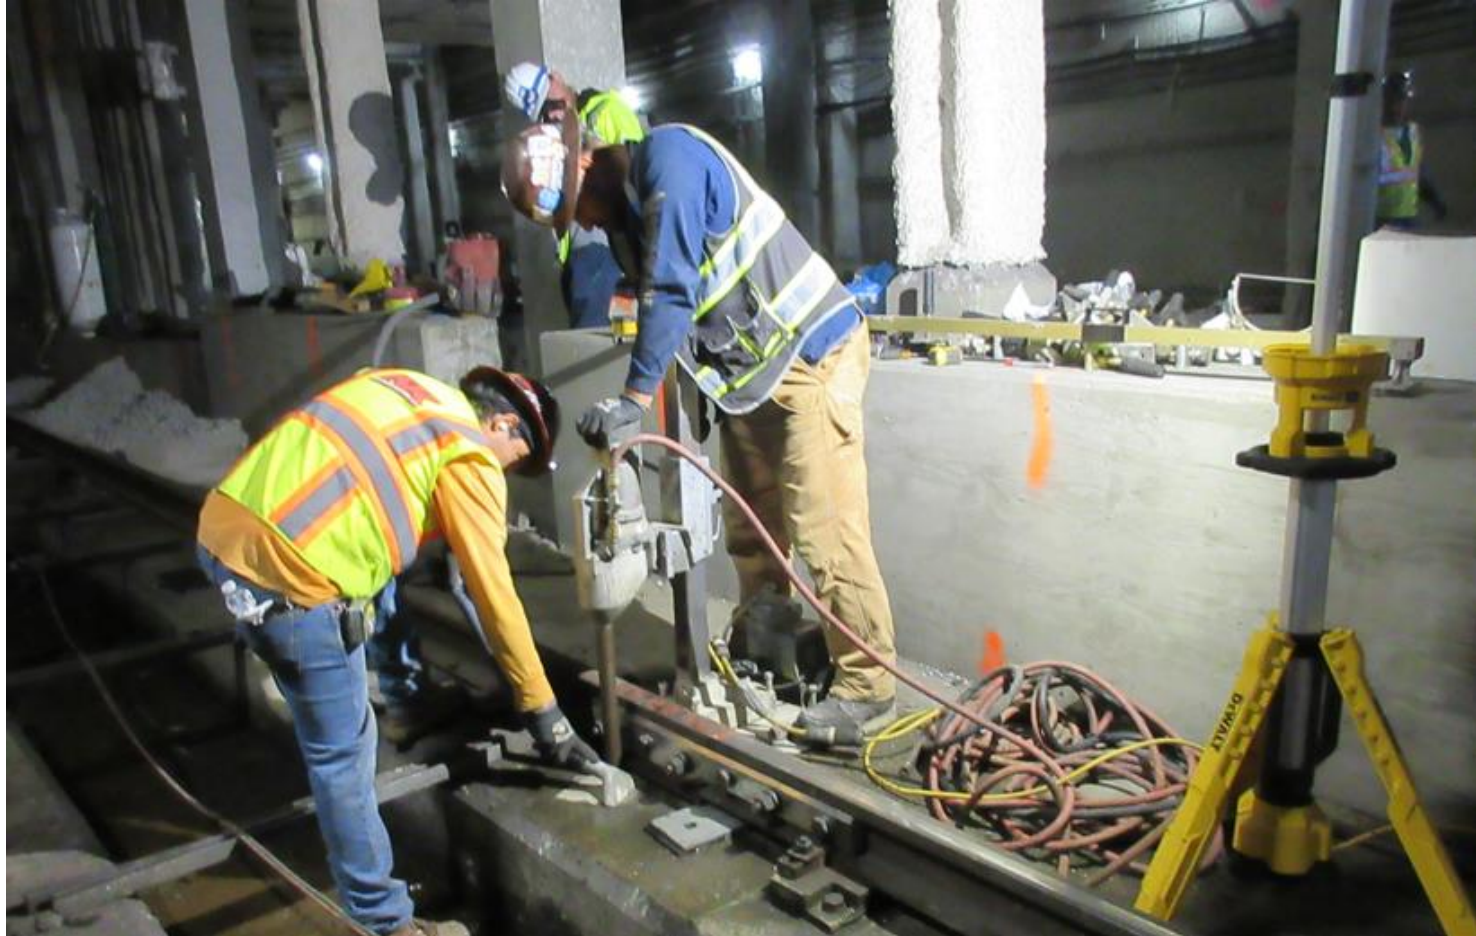
Installing New fasteners in concrete

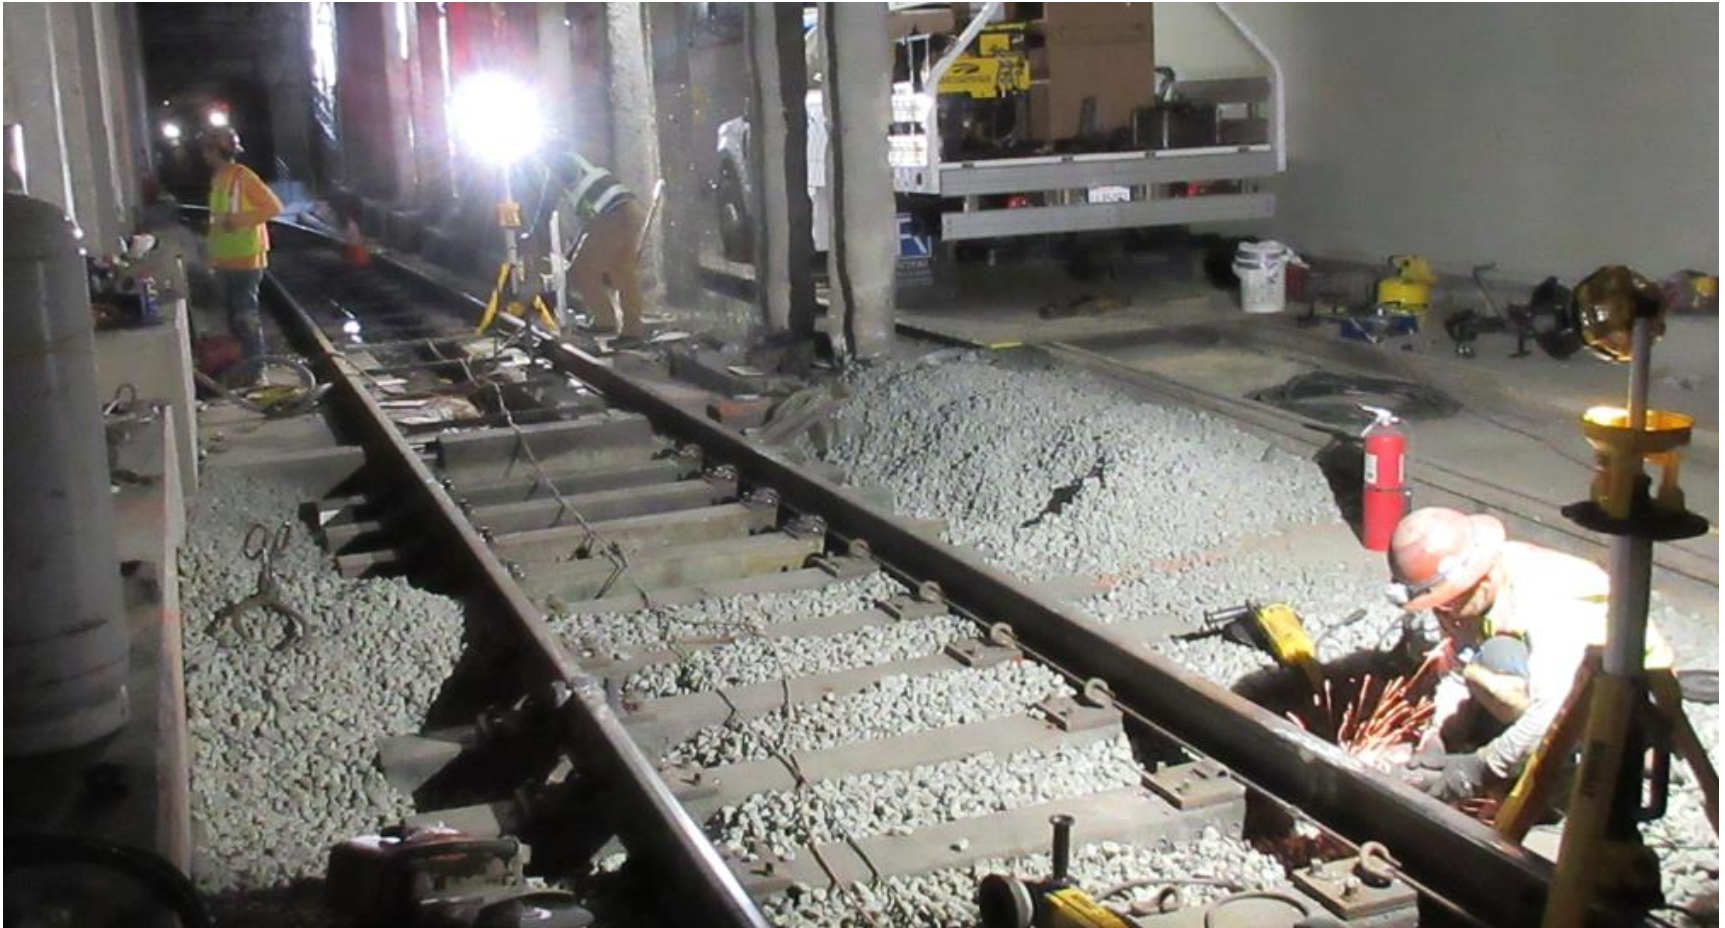
Installing New ties/fasteners and ballast

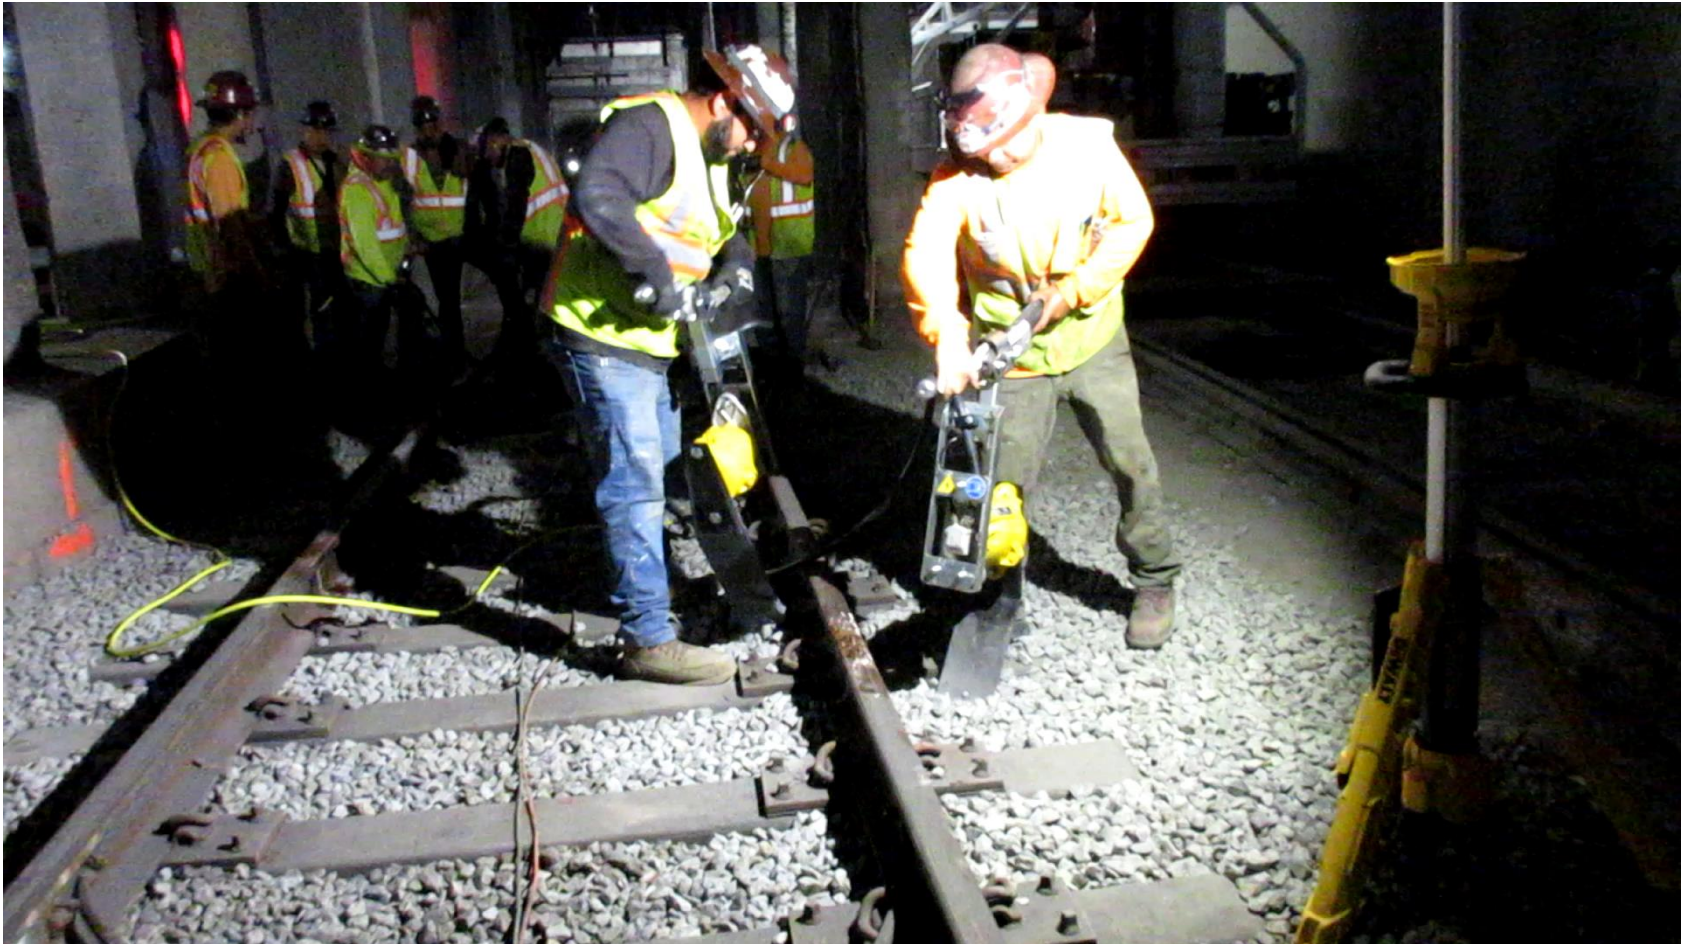
Tamp Ballast

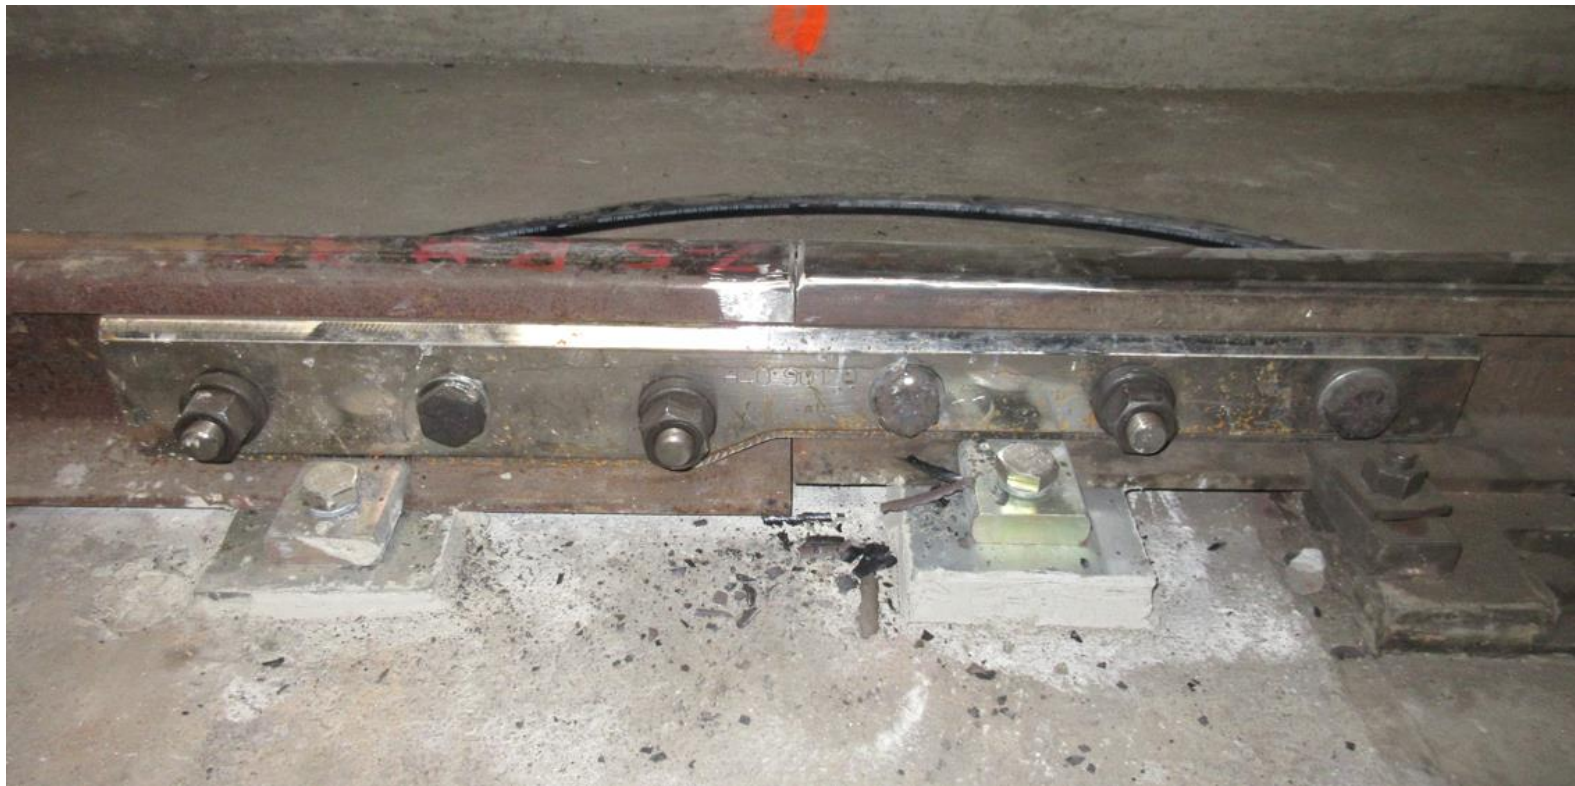
New Compromise Joint

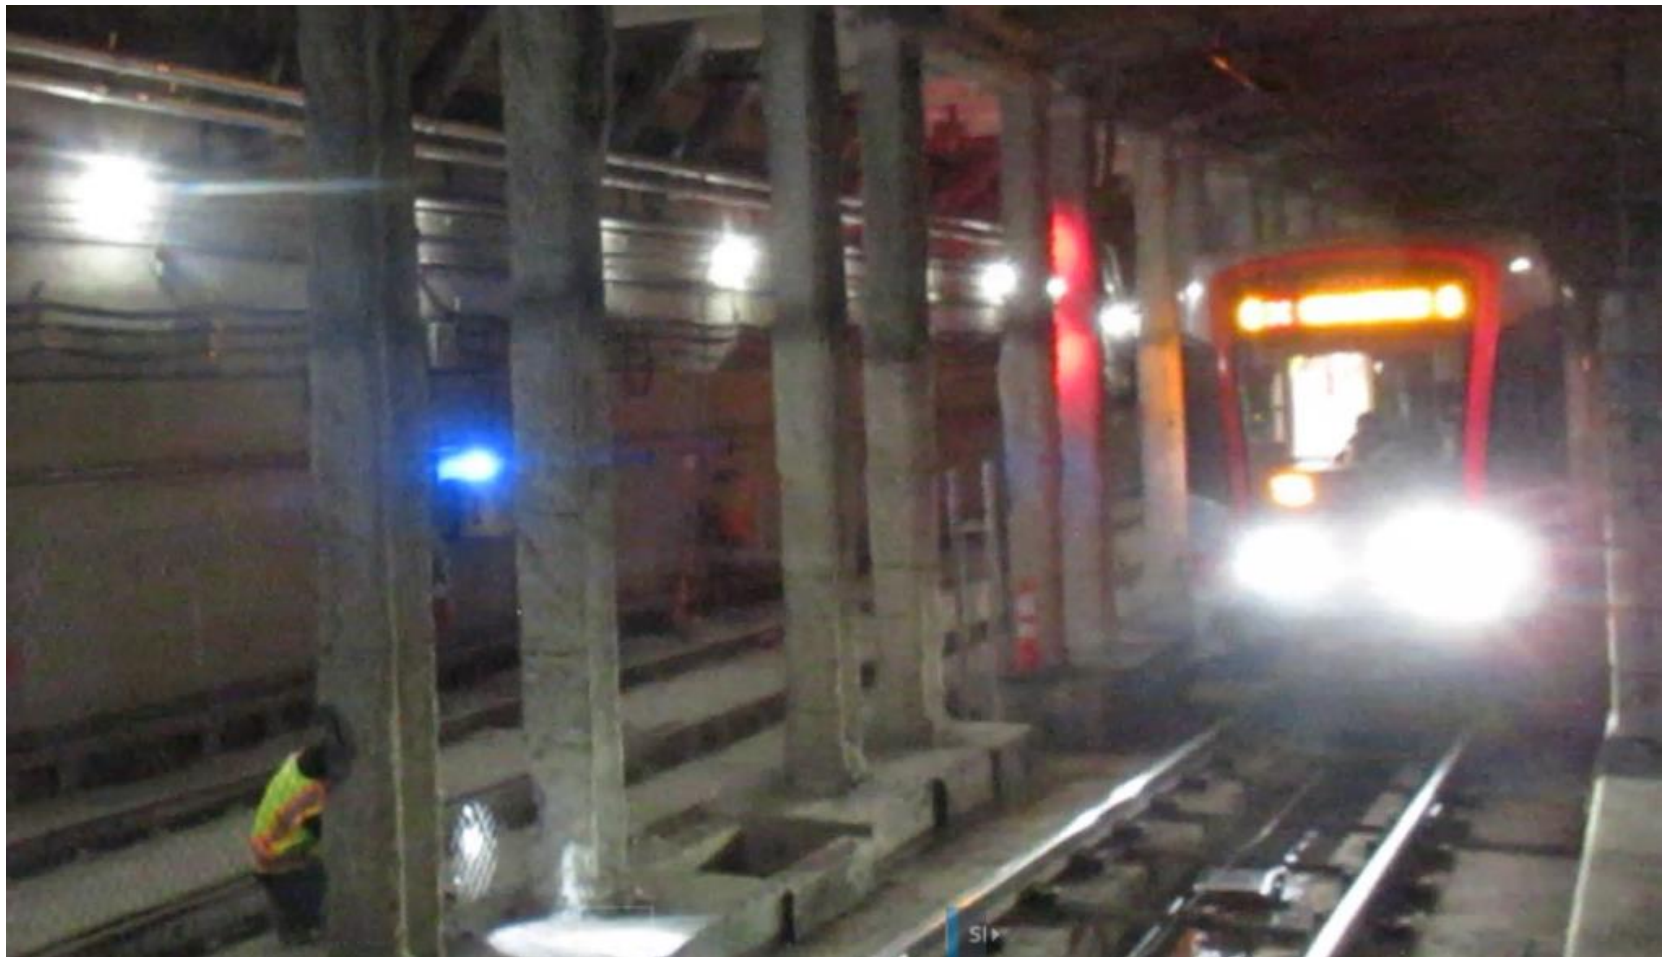
Train Test

- I. Survey/gauge check
- II. Reinstall ATCS and other equipment
- III. Train Test Criteria:
 - A. Manual
 1. 5 and 10 mph in forward and reverse
 - B. Automatic Mode (~30 to 35 mph) in forward and reverse
- IV. Observed:
 - A. Repaired tie ballast area
 - B. New compromise joint
 - C. New fasteners in concrete

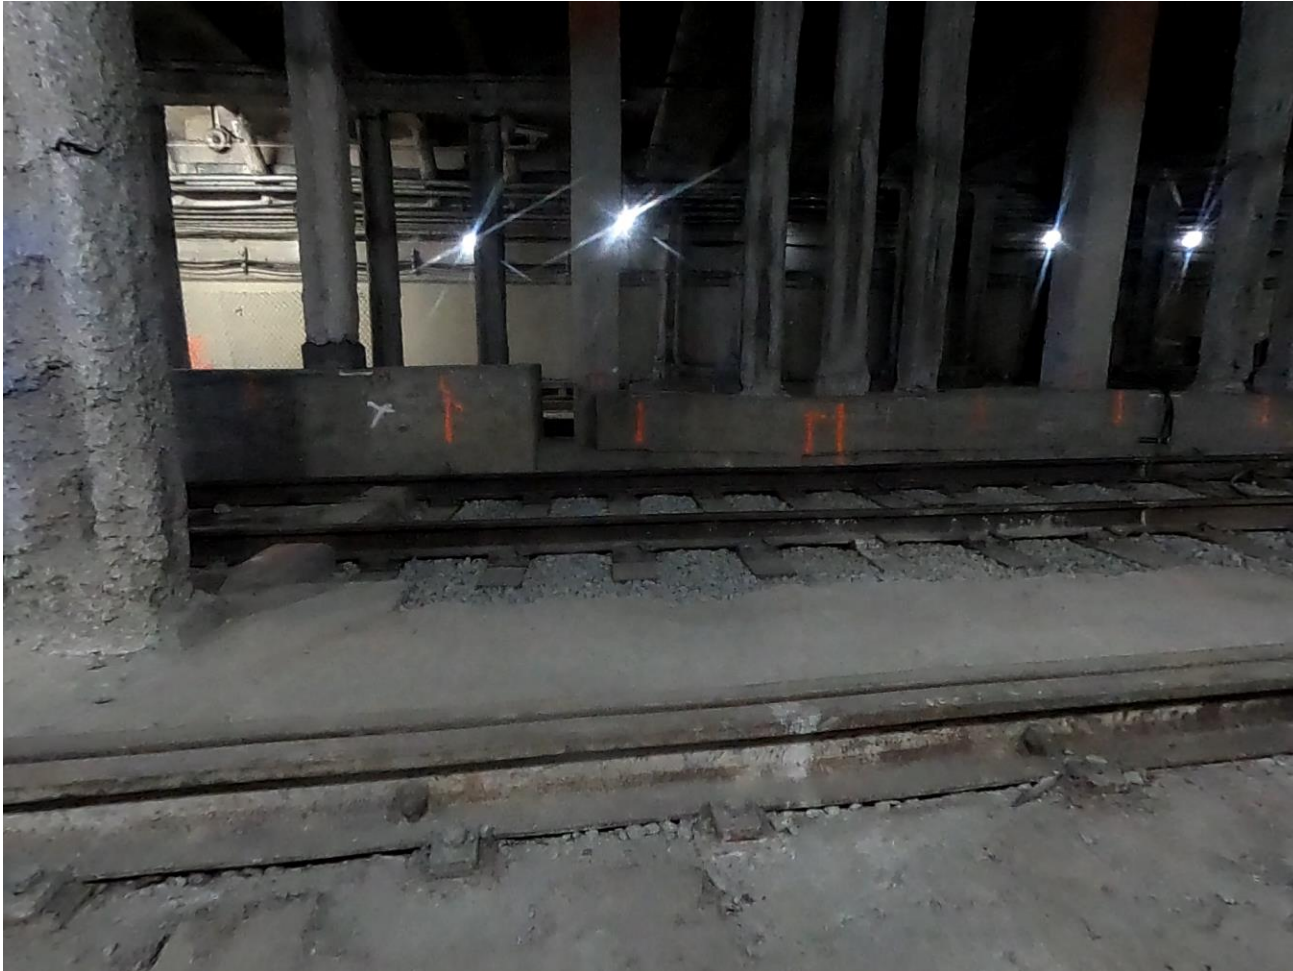
Ballast Area
