TOWNSEND STREET CORRIDOR IMPROVEMENT PROJECT

PROJECT FINDINGS - AT A GLANCE

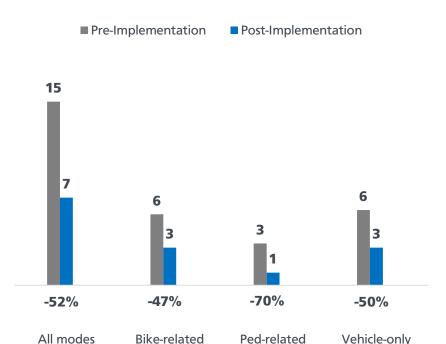
Annual Collision Rate

Traffic collisions were reviewed before the project was implemented and after the project was implemented. The pre-implementation condition uses three years of collision data before the project was installed (2017 through 2019) and the post-implementation condition uses the three full years after it was installed (2022 through 2024). Years 2020 and 2021 were omitted from the analysis.

The annual collision rates for all modes between pre-to-post conditions decreased by 52%, from an average of 15 collisions per year to 7. Bike-related collisions decreased by 47% and ped-related collisions decreased by 70%.
