Cable Car Barn Rehabilitation Project Update

SFMTA Citizens' Advisory Council (CAC)

April 24, 2024

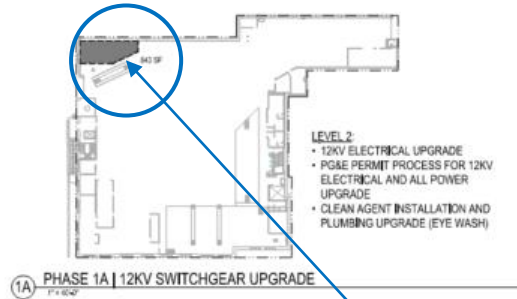
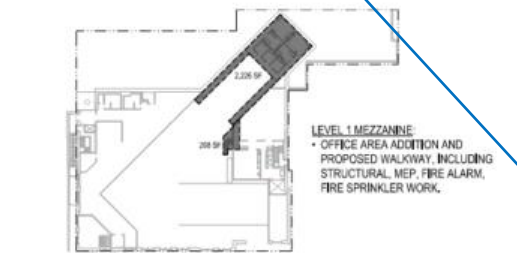
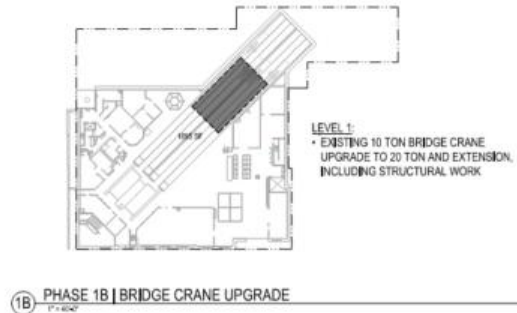
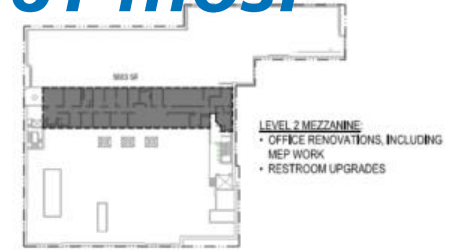
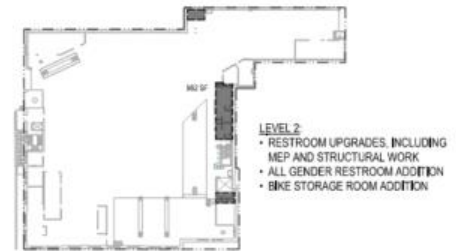
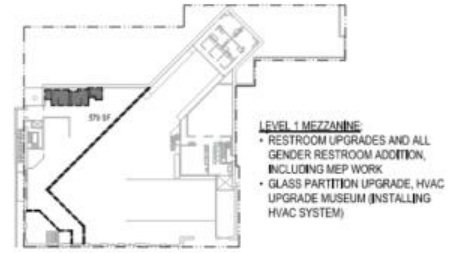
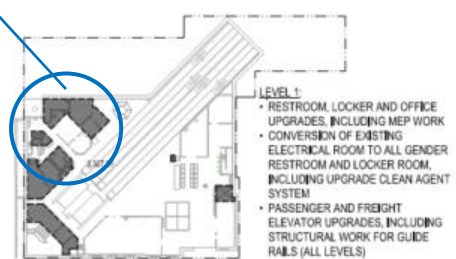
MP Phasing Plan (Phases 1 thru 5) 61 mos.

Phase 1A

- Level 2: 12kV electrical upgrade. PG&E permit process for 12kV electrical and all power upgrade. Clean agent installation and plumbing upgrade (eye wash)

Phase 1B

- Level 1: Existing 10-ton bridge crane upgrade to 20-ton and extension, including structural work
- Level 1M: Office area addition and proposed walkway, including structural, MEP, fire alarm, fire sprinkler work.

Phase 2

- Level 1: Restroom, locker and office upgrades, including MEP work. Upgrade fire suppression system (remove halon system)
- Level 1M: Glass partition upgrade, HVAC upgrade museum (installing HVAC system), restroom upgrades, including MEP work.
- Level 2: Restroom upgrades, including MEP work. Bike storage room addition
- Level 2M: Office renovations including MEP work
- All levels: Passenger and freight elevator upgrades, including structural work for guide rails (all levels)

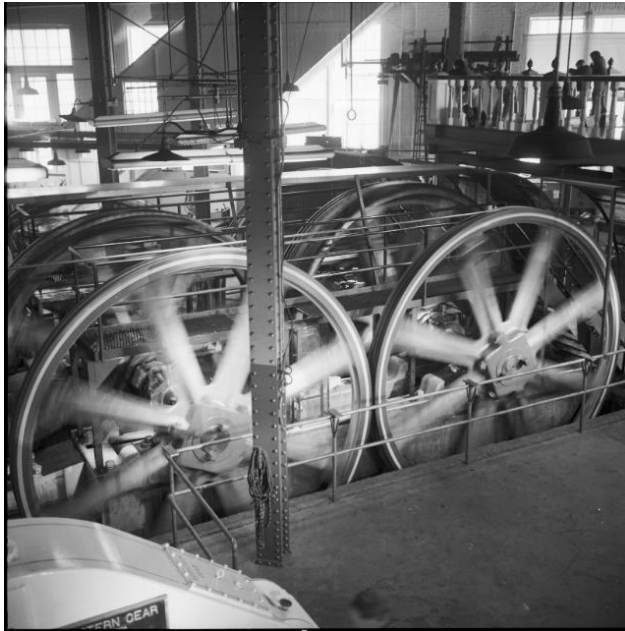
Cable Machinery Winding Wheels, 1970
SFMTA Photo Archives M0817_1

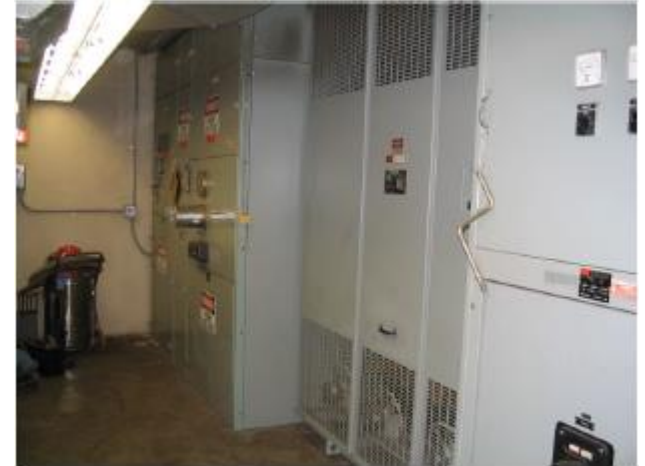
*Medium Voltage Service Entrance Switchgear, 2.5 MW
Medium Voltage Transformer and 480 V Switchboard*

- Main Medium Voltage Service Entrance Switchgear
- Medium Voltage Transformer
- Low Voltage Switchboard
- AC and DC Electrical Panel
- Remote Terminal Units (RTU) and Supervised Control and Data Acquisition (SCADA)
- Transfer Switch and Emergency Generator Hookups

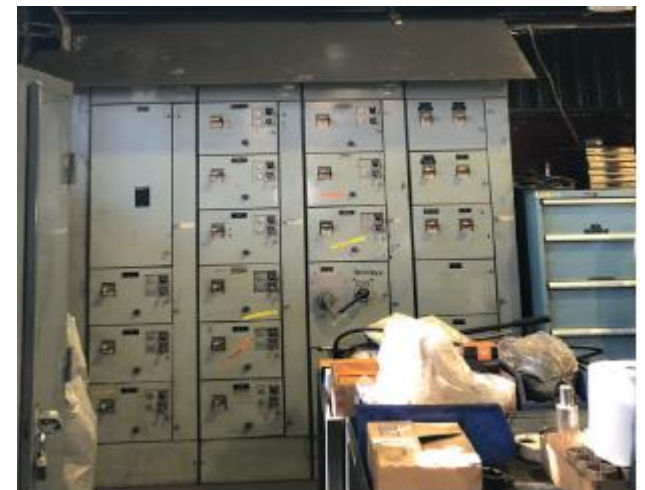
Motor Control Center (MCC)

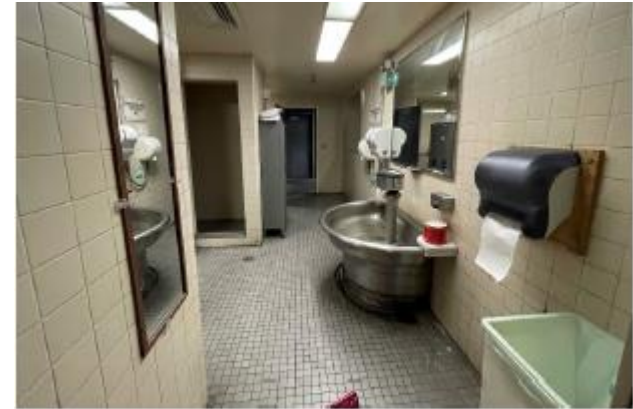
Non-compliant lavatory and shower (Men 203).

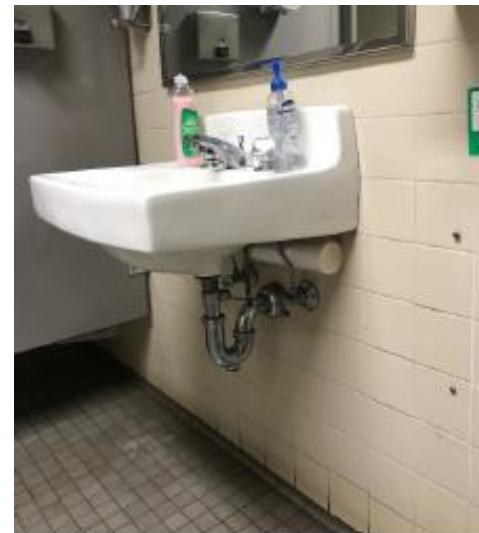
Non-compliant lavatory (Women 106).

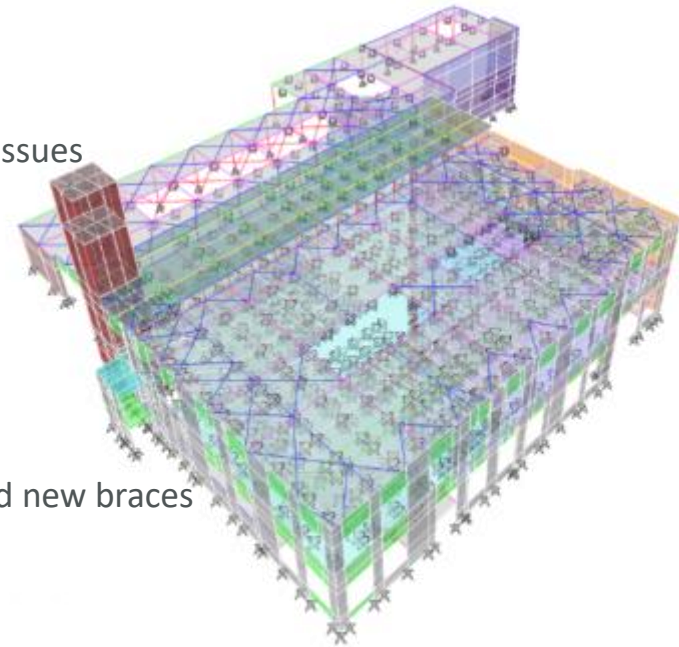
Fig. 4.2 Isometric 3D View of the ETABS Model

- South and east concrete wall strengthening
- Shear wall addition at the east side of the passenger elevator
- Shear wall addition for 2nd Fl wall reinforcement
- Stair bracing continuation next to the north wall
- Roof strengthening including existing diagonal brace upgrades and new braces
- Chimney separation through introduction of an expansion joint

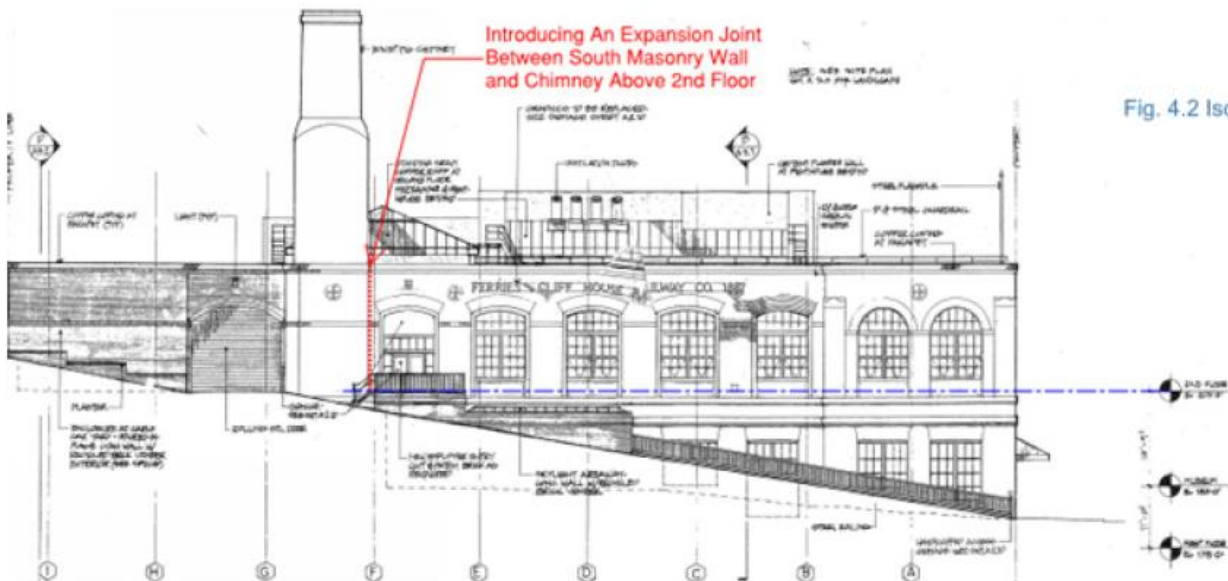
Chimney Separation
