**SFMTA**  
Municipal  
Transportation  
Agency

# Major Initiatives Update

Policy & Governance Committee  
July 15, 2016

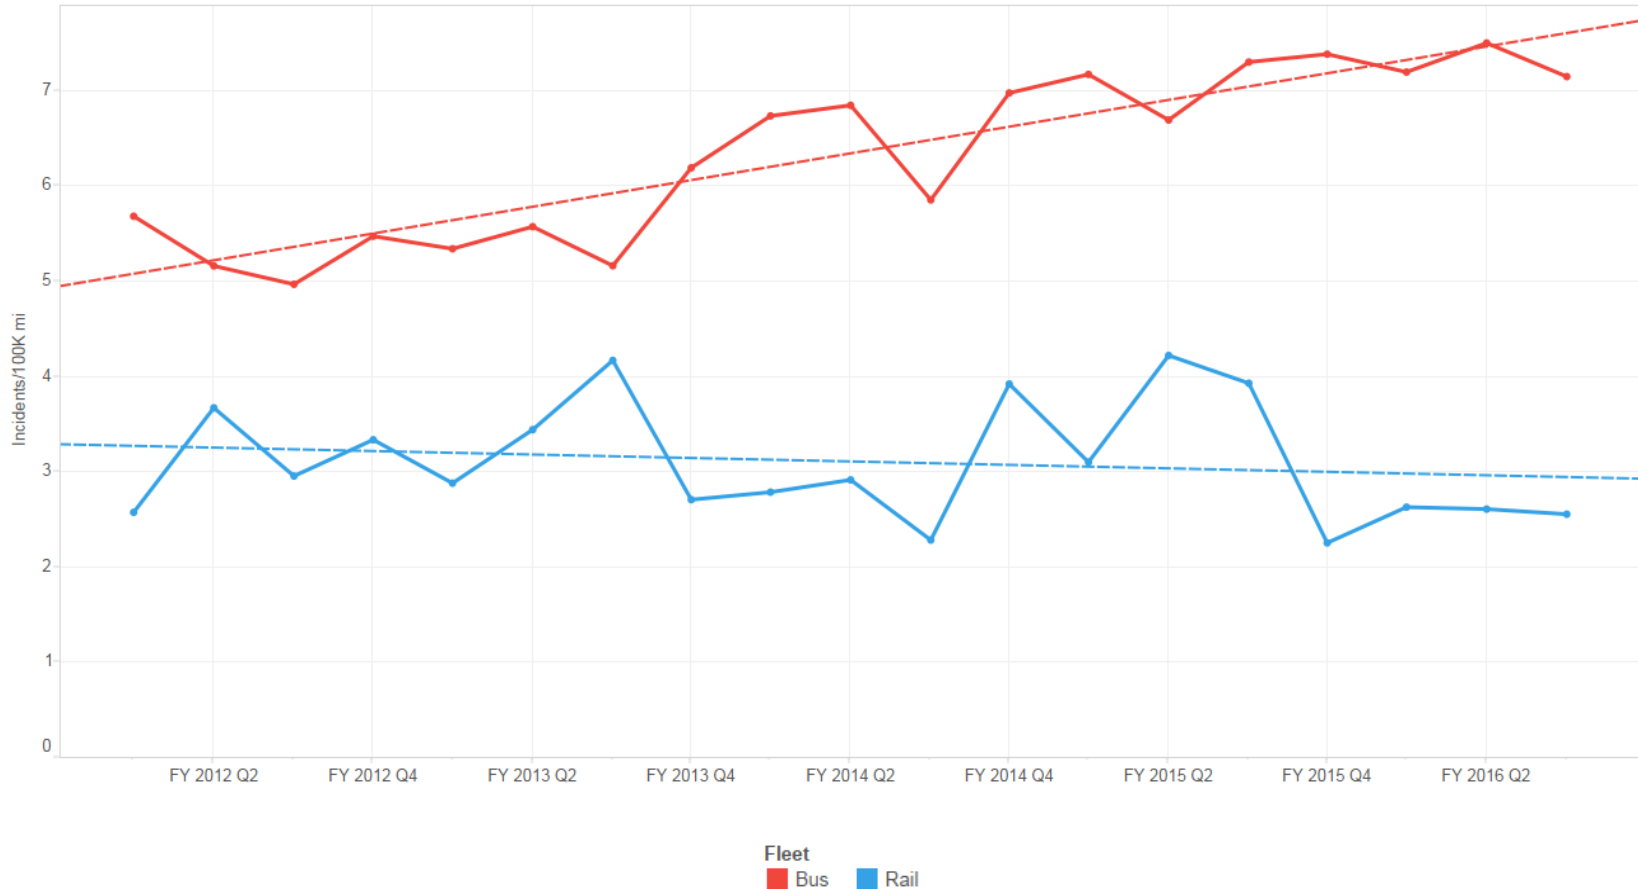
Quarterly Collisions per 100,000 Miles, 2010-2016

- Overall, collisions on rubber tire have increased by 25% per 100K/mi

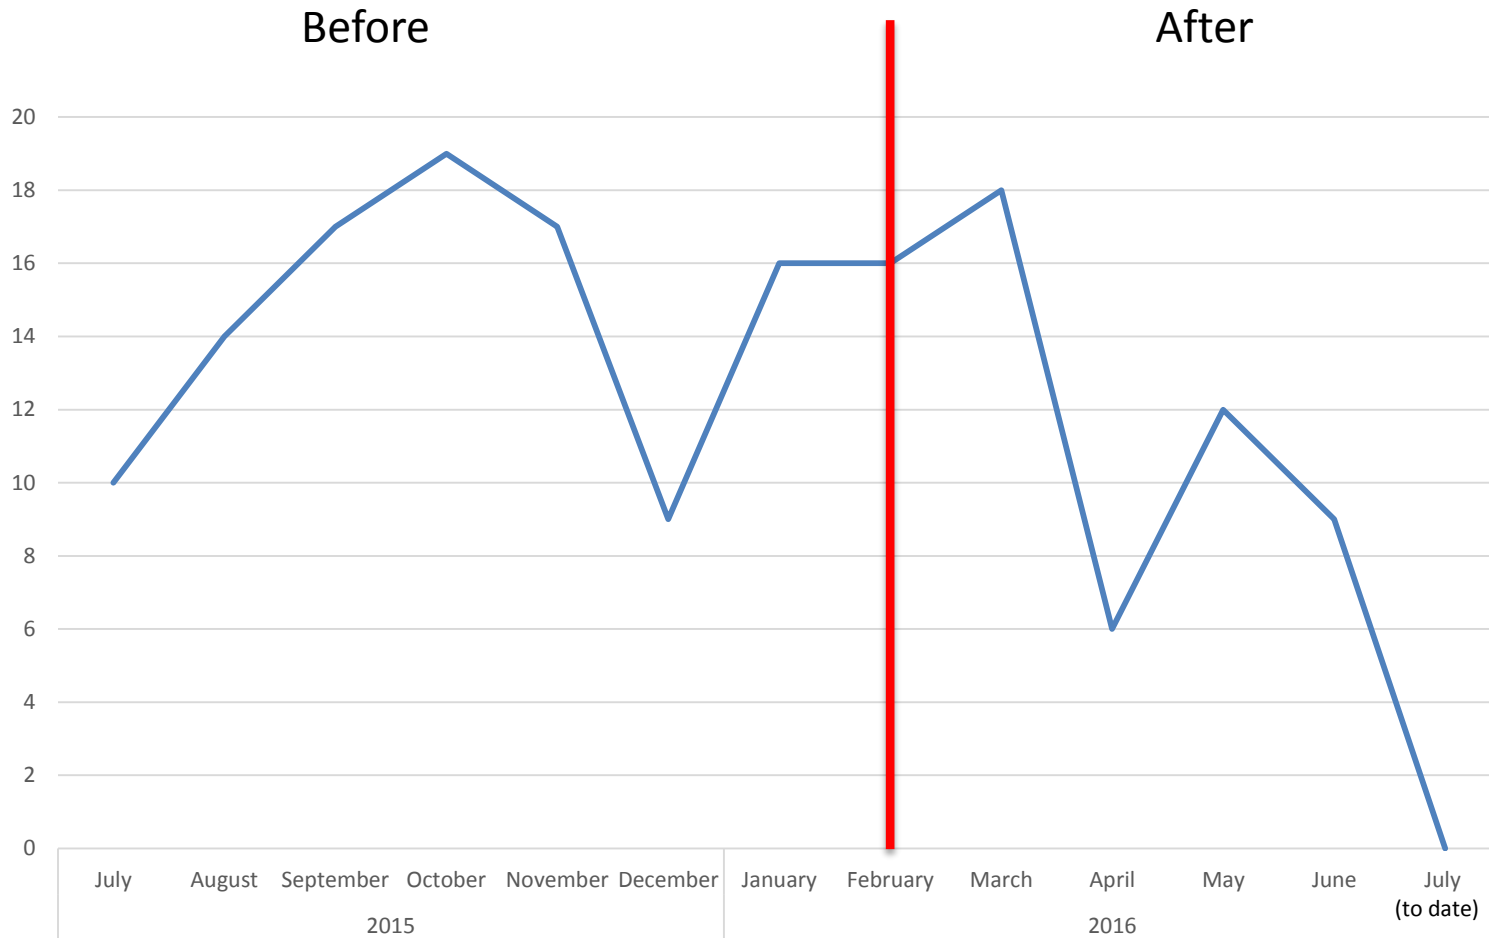
# Mission Street Update

Collisions on Mission Street Project Corridor are down since implementation

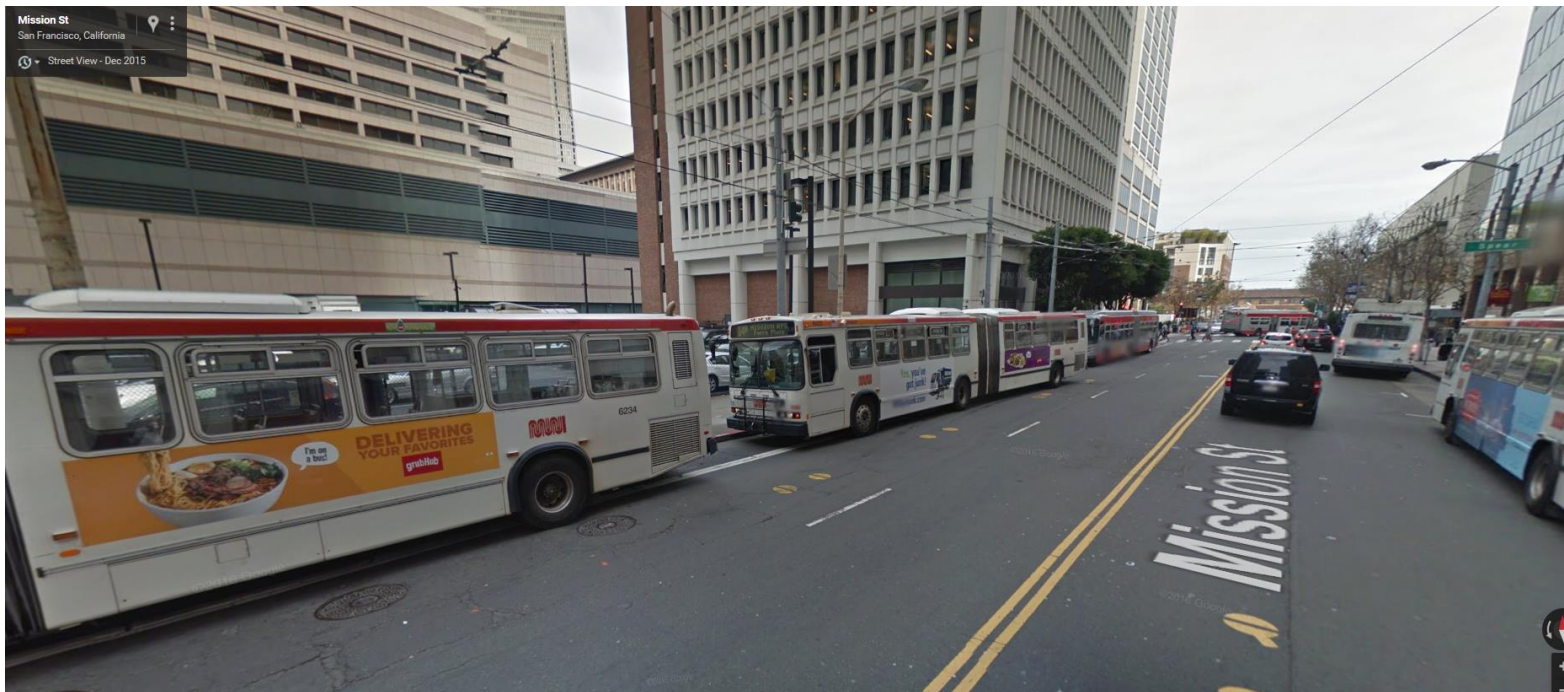
# Key Rubber Tire Location : Mission/Main

- Issue: Left sideswipes at bus terminal
- Solution: Move center line to widen lane or eliminate a travel lane to widen lane
  - Being assessed now

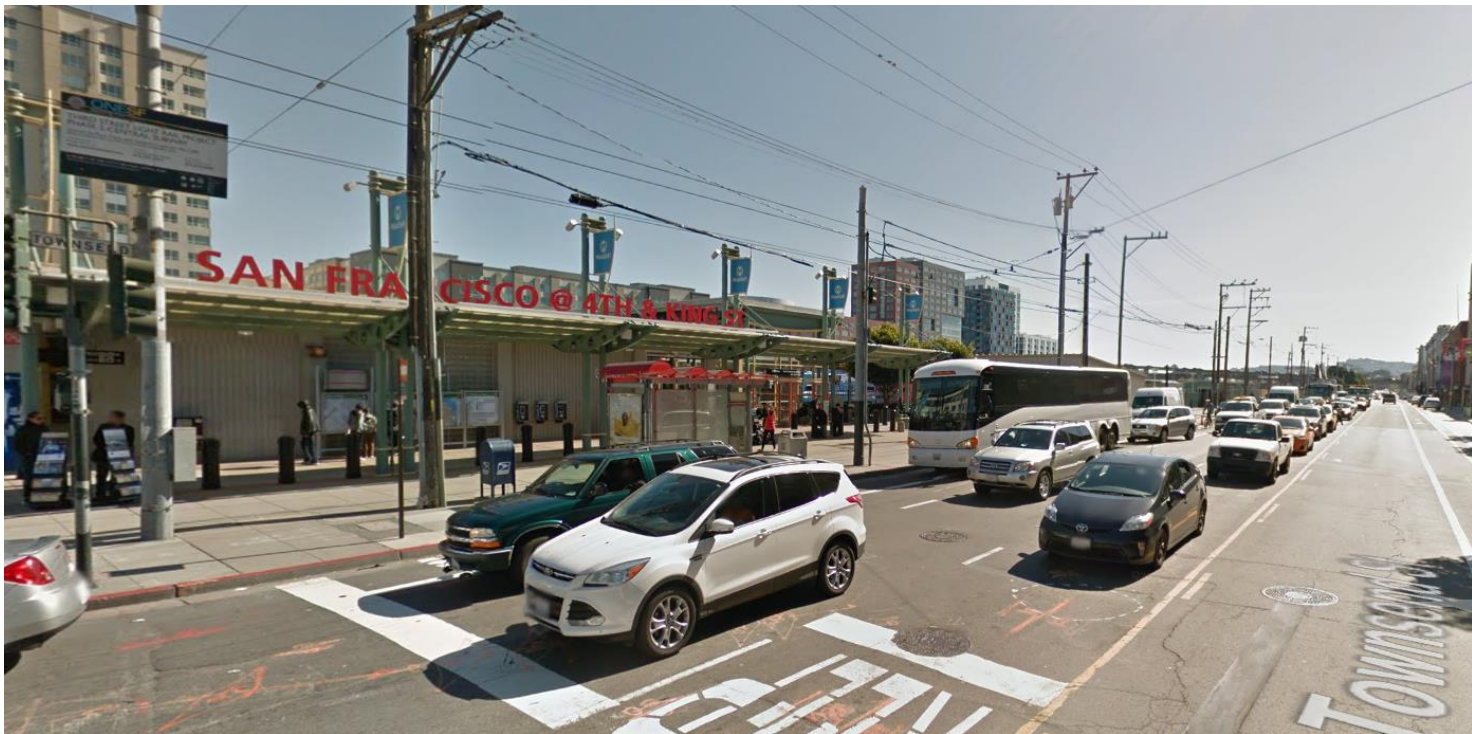
# Key Rubber Tire Location : Townsend/4th

- Issue: Right hand turning autos in front of bus at near side bus stop
- Solution: Move bus stop back

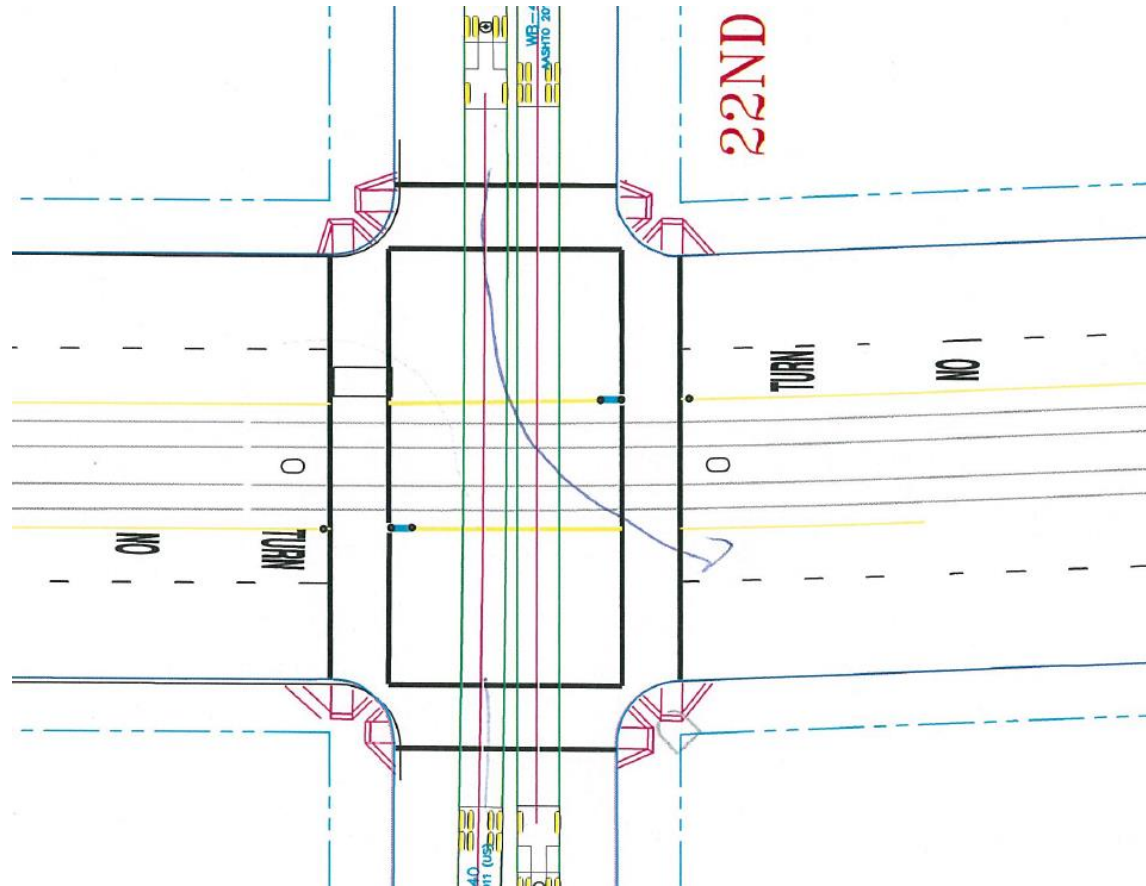
# Rail Collision Corridor: Third Street

- Three-month project proposed
  - Install vertical delineators at intersections
  - Easy to install, low cost

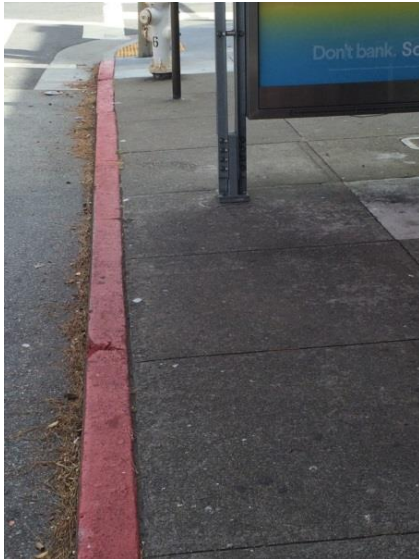
## 6<sup>th</sup> Ave and Geary

Bus shelter curb on 6<sup>th</sup> Avenue along the 44-O'Shaughnessy  
**Solution:** Assessing moving shelter back or forward

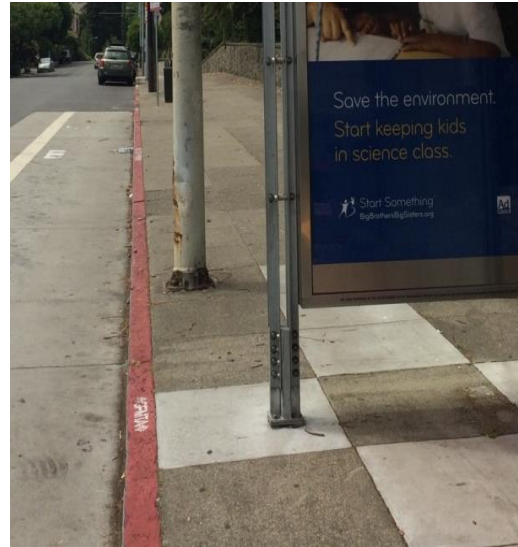
## Lyon and Greenwich

Scuffed/dented pole on Lyon Street along the 45-Union/Stockton IB  
**Solution:** Move shelter forward/Add reflective paint to pole

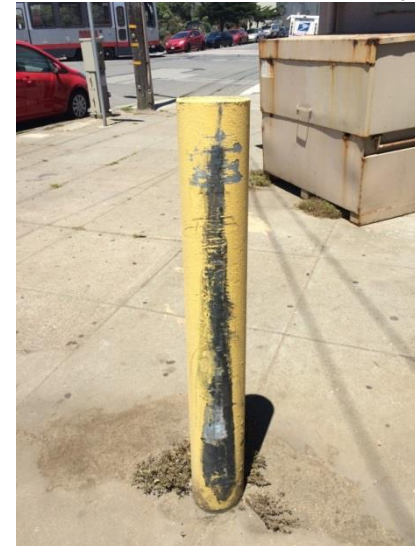
## Judah and La Playa

Scuffed light pole at Judah/La Playa turnaround  
**Solution:** Add reflective paint to pole/Turning guide line for buses
