SFMTA

Rail Operational Challenges during COVID

SFMTA Board

September 1, 2020

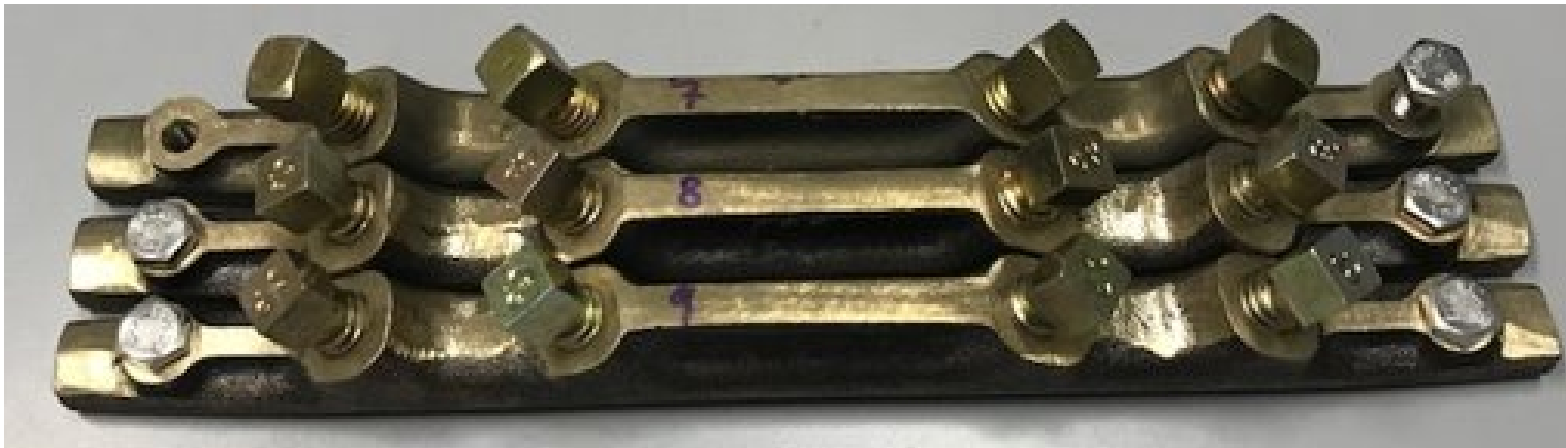
What is a splice?

- A *splice* is how we connect two pieces of overhead wire to one another
- Splices are customized to our system's specifications and require highly specialized manufacturing
- Splices should be stronger than the surrounding wires

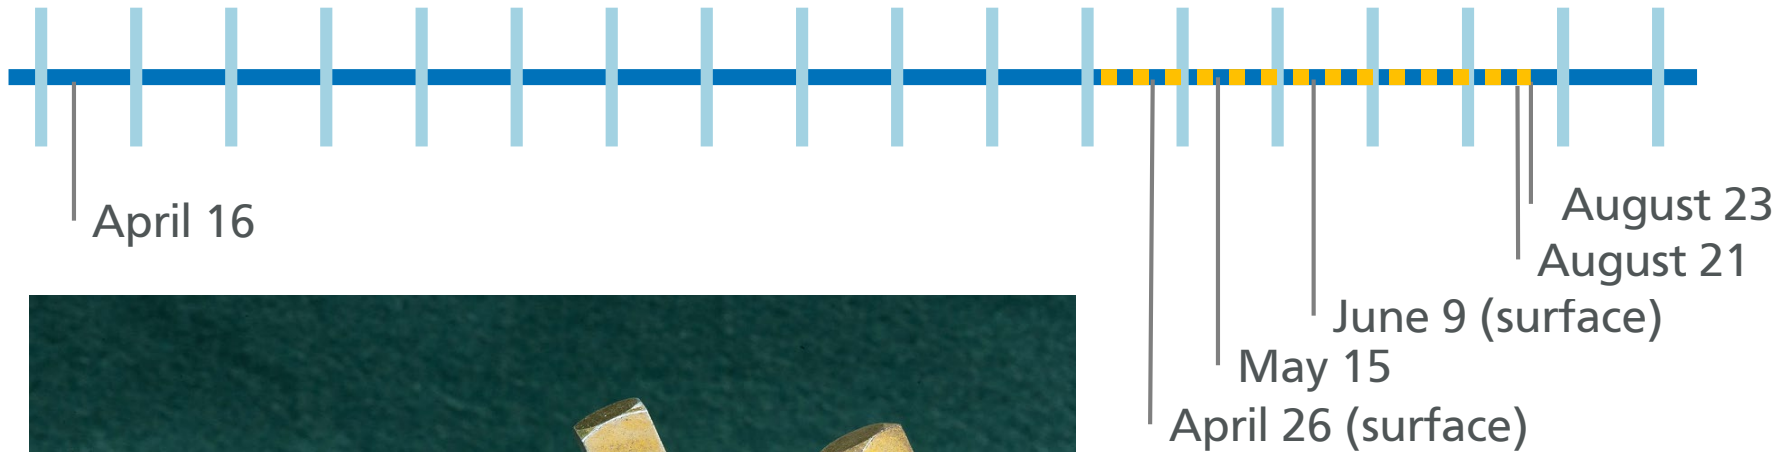
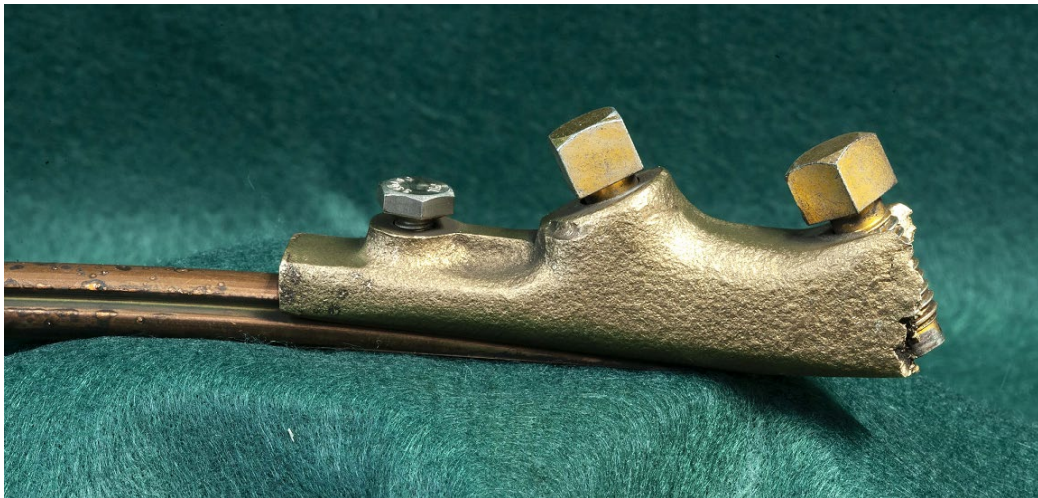
Background on Failed Splices

Failed splices

2019

2020

No subway service

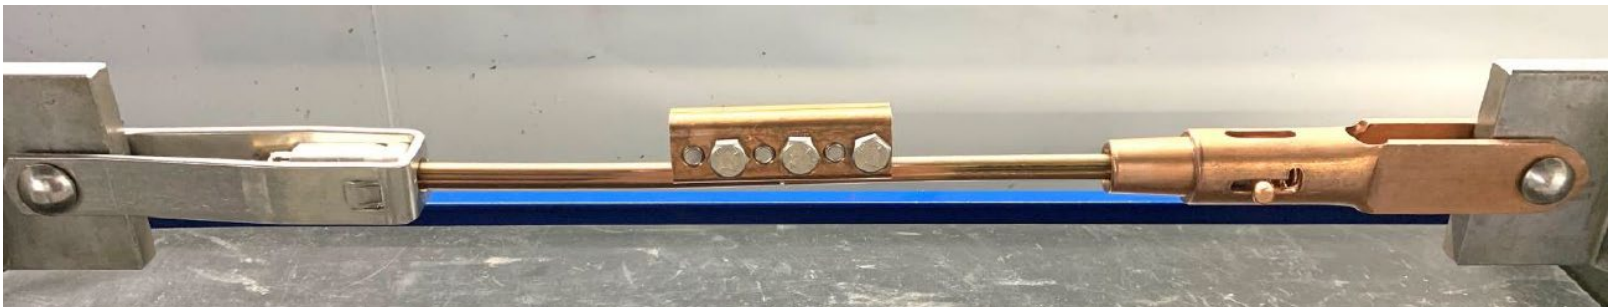
Poor Quality Led to Splice Failure

- Independent failure analysis determined that splices failed due to poor metallurgy quality - it contained low silicon levels which led to low tensile strength
- Splice did not fail because of state of good repair issues
- Splice problem not visible as part of our routine preventative maintenance inspections
- Splice is not a new design, and has been used in our system for over a decade
- We do not know how many splices in our system have poor metallurgy quality or when first bad batch arrived

Next Steps for Overhead Lines

- Map splice locations (subway completed, surface rail/trolley next)
- Procure replacement splices (estimated lead time 8 weeks, \$30K)
- By the end of the year, remove all problematic splices in the subway, replace with new splices or longer stretches of wire
- Develop plan for surface rail and trolley – *new rail splice is not trolley compatible*
- Construction support and other work to be reduced to allow in-house teams to focus multiple shifts per day on installation (estimated time 2-3 hours per splice)
