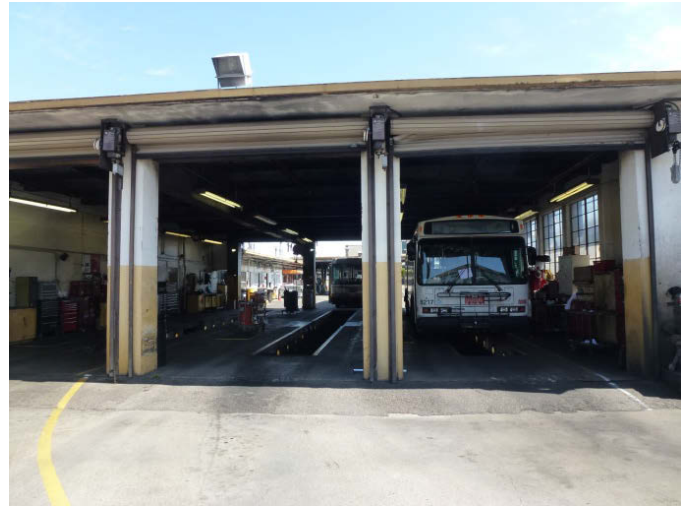
13. Maintenance Area
 - a. 3 pits in a canopy covered area
 - b. 1 designated area in the yard next to the maintenance canopy for lifting vehicles with portable lifts – area also used for pressure washing

Maintenance Bays

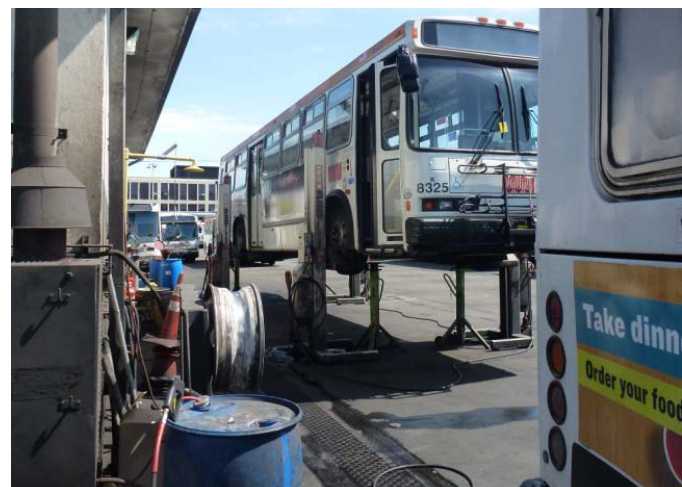
Portable Lifts and Pressure Wash Area

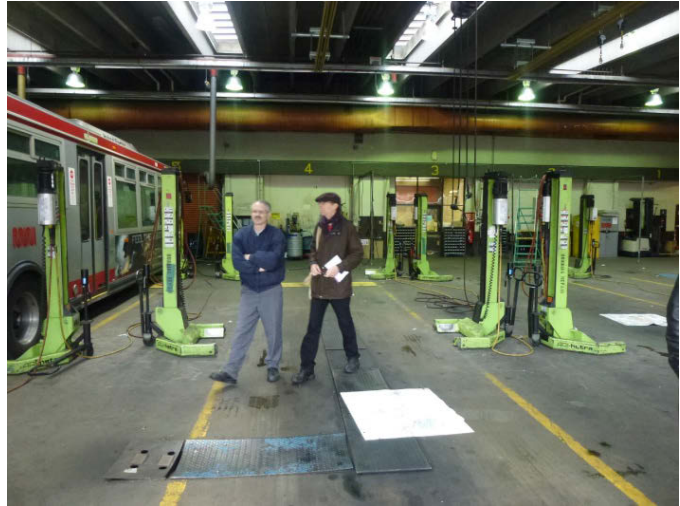
- iii. Bays 5 through 12: in-ground lifts non-operational, using portable lifts instead
 - c. Using portable lifts due to many in-ground lifts being down, some works still operate, but are unreliable due to leaking hydraulic fluid.

Portable Lifts in Maintenance Area

- a. In ground lifts are the safest and most efficient method of working on buses. Vehicle Lifts are typically replaced every 15 years. The current in-ground lifts are over 30 years old. A wholesale lift replacement project would greatly improve the facility maintenance capacity.

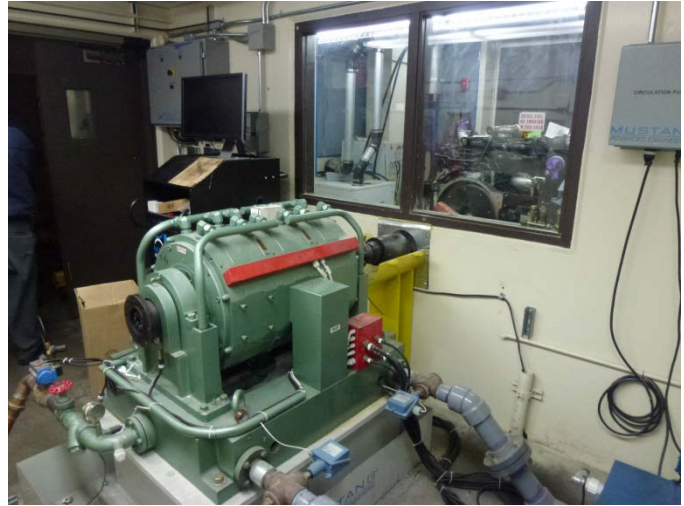
- a. New dyno in process of being installed, has been down over 3 years

- b. Engine load is in same room as controller – safety issue
- 9. Transmission Dyno Room
 - a. Test all transmission rebuilds
 - b. Overhead monorail for loading transmission into dyno
 - c. Currently also storing portable welders here

Engine Dyno

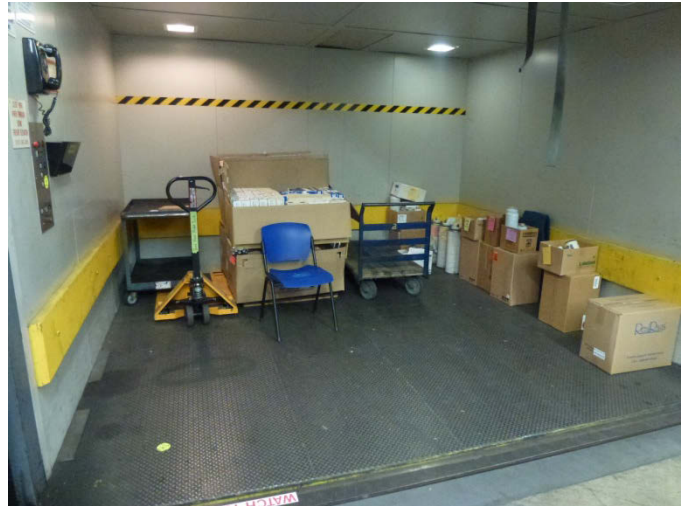
- g. Senior storekeeper offices on second floor (2 workstations)
- h. Use freight elevator and dumbwaiter to move parts between floors
- i. 2nd floor can handle forklifts storage is set up for pallet jacks
- j. Some parts stored in elevator (1k Inspection materials)
- k. Remote storage of slow moving inventory is located near the body shop

Parts Storage in Freight Elevator

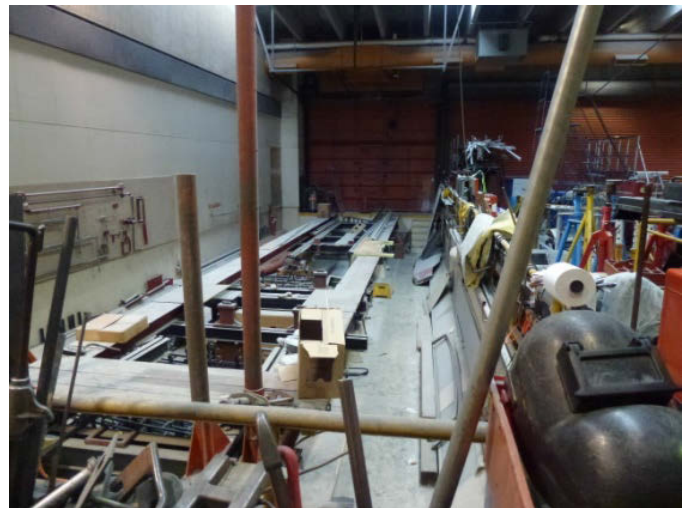
- a. Handles glass and body repair for all rubber wheel vehicles
- b. Large glass storage area and panel fabrication area
- c. 7 bays total (2 with in-ground lifts, 3 flat, 1 pit, 1 frame straightener)
- d. 1 frame straightening bay which is seldom used
- e. 1 bay with pit – not being used and has parts stored around pit
- f. 1 Paint prep area – also used for small spray jobs which may be a safety violation. Bay has compressed air drops and portable dust collection. Poor lighting in area
- g. Paint booth with cross-draft ventilation and water-based filtration serves 40' and 60' buses as well as trolleys: 60' difficult to fit and work around. Roofs accessed via ladders

Frame Straightening Bay in Body Repair

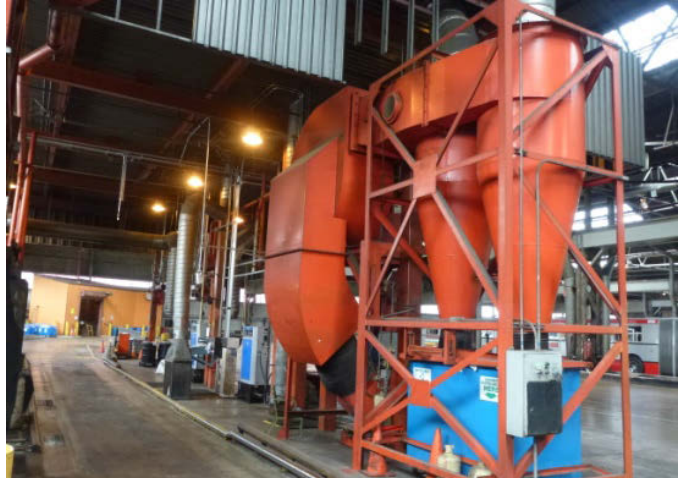
- a. 2 fuel lanes
- b. 4 fuel positions
- c. Only 1 set of reels to replenish fluids on both lanes – unable to track accurately track vehicle fluid using Fleet Watch due to inability of system to tell which lane is receiving fluids
- d. Canopied and exhausted area
- e. Diesel generator to run the fuel lanes in emergencies

Bus Fuel Lane and Vacuum System

1. Replace the outdated cyclone vacuum system with a standard hose vacuum system to reduce maintenance costs, improve cleanliness of the vehicle, reduce the man hours required, and clear up additional facility space

2. Add a fuel hose gantry to increase efficiency in fueling processes
3. Add a second bank of fluid reels in the fuel lane to allow for faster fluid replacement and accurate fluid tracking by vehicle

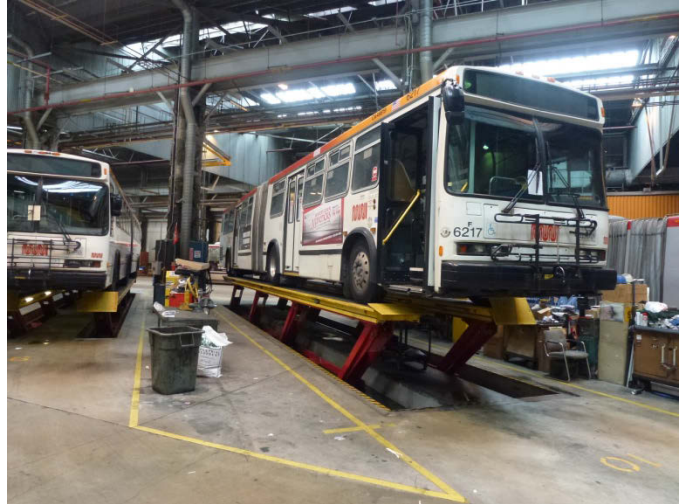
- d. Makeup air in the maintenance bays provides positive pressure to keep exhaust from the parking area separate
- e. Drains in the parallelogram lifts have been plugged to keep spills and runoff out of the sewer system. The pits must occasionally be pumped out and cleaned
- f. In-ground systems generally require far more repairs to the rear post due to the excess

Parallelogram Lifts

- weight of the rear engine buses
- g. Reels for coolant, engine oil, transmission fluid, air, grease, gear oil, and power steering fluid between the rear of repair bays
- h. Reels for electricity, light, and air between the front of repair bays
- i. 3 sets of waste oil and coolant in-ground collection drains on the facility wall near the inspection pit

6. Verify age of all lifts. Begin a planned replacement program for the lifts as they reach the end of their useful lifecycle.
7. Plan for maintenance implications of diesel exhaust fluid (DEF) in any new fleet acquisitions:

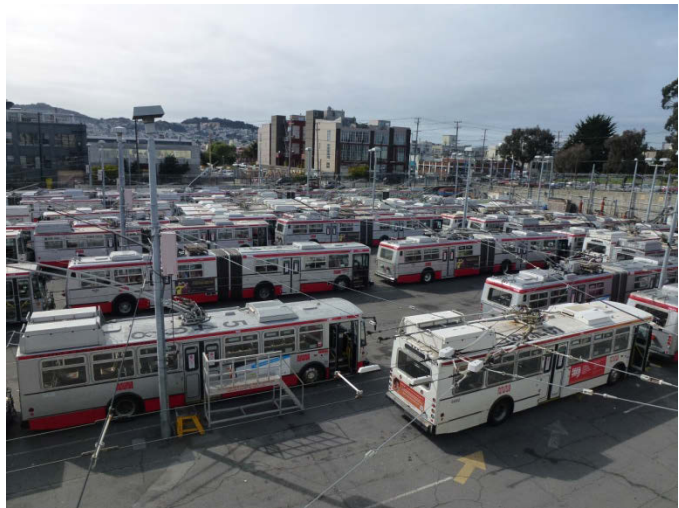
Trolley Parking - Lower Yard

- a. Upper Yard – 40’ trolley bus parking
- b. Lower Yard – 60’ trolley bus parking
- c. Vehicles are parked on the PM and Wash lines inside the facility at night due to a lack of parking

- d. Site cannot handle the current fleet. Buses are parked on the street and in the maintenance building.
2. Alternatives should be studied for a replacement facility to accommodate the anticipated expanding fleet of articulated electric trolley buses.

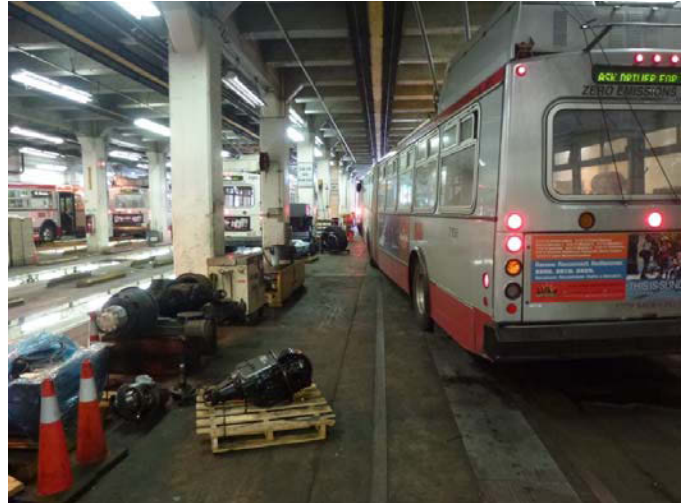
- a. 2 tracks with pits
- b. Drop motors and make other heavy duty repairs in this area
- c. No overhead clearance to lift

Heavy Maintenance Lanes

- d. vehicles
- e. No fall protection
- f. Not all overhead lines can be switched off

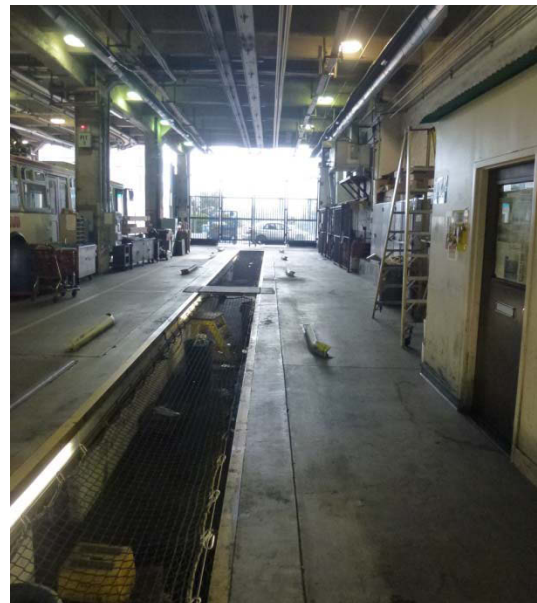
Repair Bay Pit

- b. Pits do not have drainage and are difficult to clean
 - c. Pit does not have drainage and is difficult to clean
 - d. New lighting recently installed

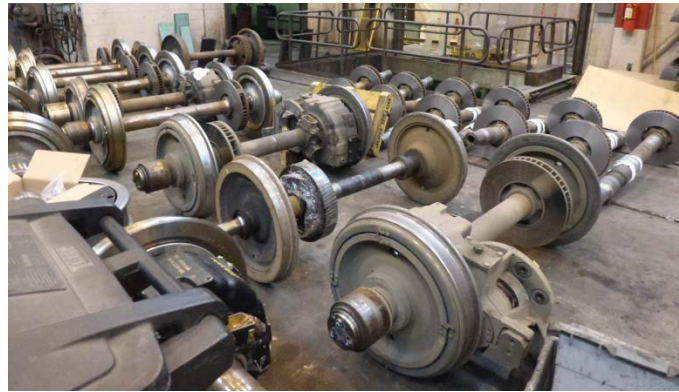
Component Storage

20. Component staging takes up considerable floor space.
21. Machine Shop and Motor Shop are covered by two 3-ton bridge cranes.
22. Machine Shop has numerous old manual lathes and mills. Fewer modern CNC mills, lathes and water jets could be provided in lieu of older machines to reduce shop area requirements and work setup times.
23. Motor Shop:

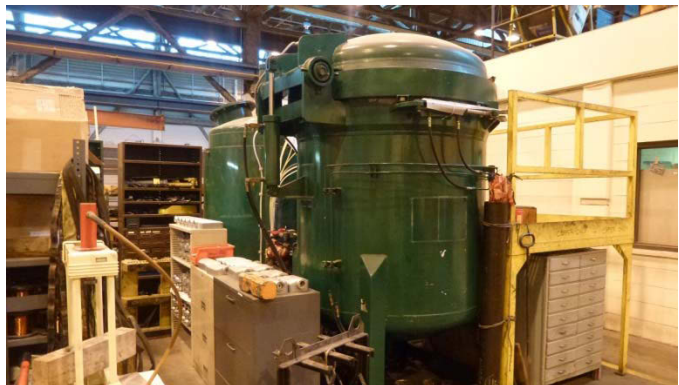
Motor Shop - Dip Tanks

- a. Motor Shop has storage racks for 36 pallets of repaired motors.
- b. Motor Shop performs testing, but does not have a dynamometer.
- c. Motor Shop includes two dip tanks for armatures. Two large ovens. Maintain all types of motors, including trolley buses.

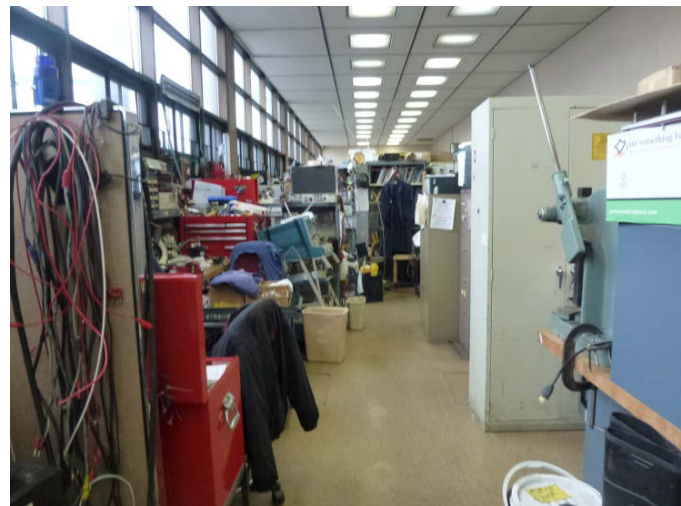
- c. Space is heated via central heat, however, the HVAC system is not functioning well.
 - d. Area is very warm and humid during the summer – poor environment for electronic equipment

- e. Parts continuously cycling through the shop and then either out to a vehicles or to the Burke Warehouse for storage
 - f. Arriving components awaiting repair must often be staged outside due to space

- iv. Ionized water cleaning station unable to fit in the cleaning area
 - i. Building compressed air lines have water in them which has caused issues with using them to clean electrical components

- i. Compressed air system in the facility is also insufficient to operate some equipment which the Electronics Shop needs to use
 - ii. Building uses compressed air to manipulate HVAC louvers but they leak badly

- k. Ideally each tech would have their own workstation capable of handling all basic test/repair functions and a few dedicated workstations for specialized equipment that could be shared

- l. Workstations should ideally have power supply, light fume extraction, tool storage, magnification, bright lighting, antistatic surface, computer
 - m. Always a large backlog due to constant demand for electronics repairs

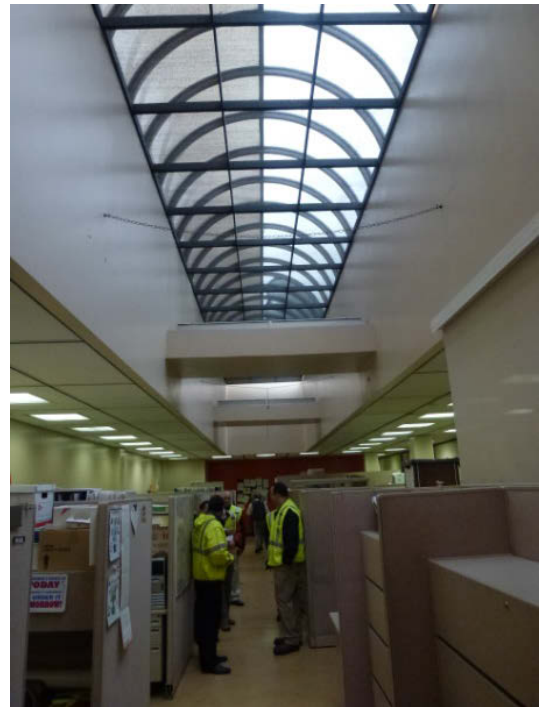
Administrative Offices - Skylight

- Skylight covered with paint and a screen along top floor
- HVAC system in electrical shop fails to ventilate, cool, and dehumidify
- One office on the upper floor is incredibly loud
- T12 lighting in many areas
- Heating hot water system serving air systems

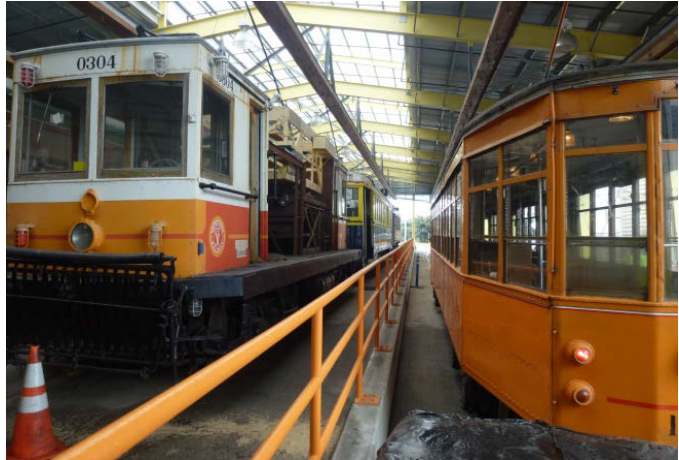
Vehicle Parking Canopy

1. Parking Area
 - a. 6 tracks capable of holding 4 cars each under a canopy
 - b. Majority of the cars under the canopy are currently out of service
2. Muni currently runs 24 historic cars per day
3. Historic rail service began in 1995
4. More out of service cars are currently stored at Marin in various states – hope to eventually refurbish these cars
5. All historic cars run on the same gauge as Muni’s LRV’s
6. Green facility handles the heavy duty repairs and any maintenance requiring lifts

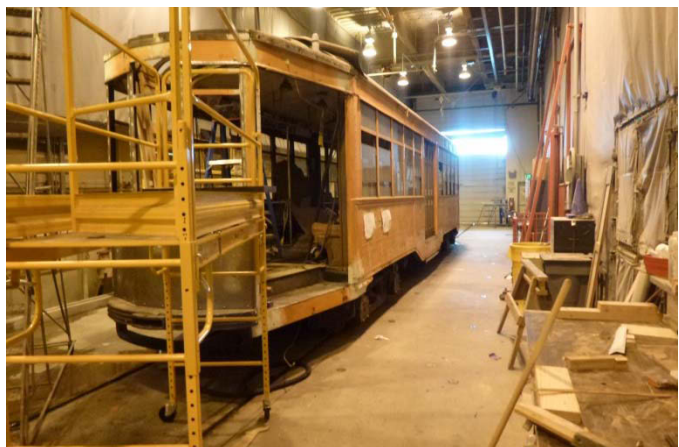
Body Repair

- ii. Carpentry Shop 1
 - d. Ceiling leaks in this area and has started to rust out the side of the paint booth

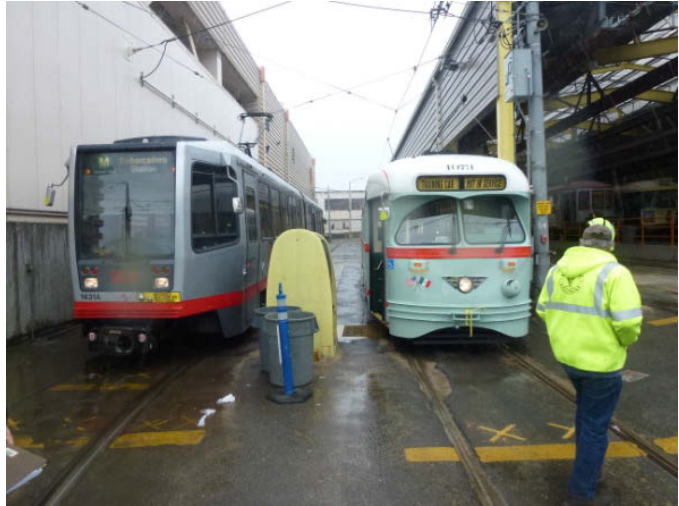
Tracks 13 & 14

22. Carbons are checked twice a week.
(daily during rainy conditions)
 - a. Mechanic must climb a portable ladder in the yard to check the carbons
23. M Line (LRV) and F Line (historic rail) use track 14 in the Cameron Beach Yard to pull through and layover
24. Using track 13 instead of 14 would avoid slowdowns caused by the shared use, but LRV operators have been instructed not to use track 13 because the turn is too sharp and can derail the vehicle
25. Approximately 4 vehicles can fit on track 13 at a time

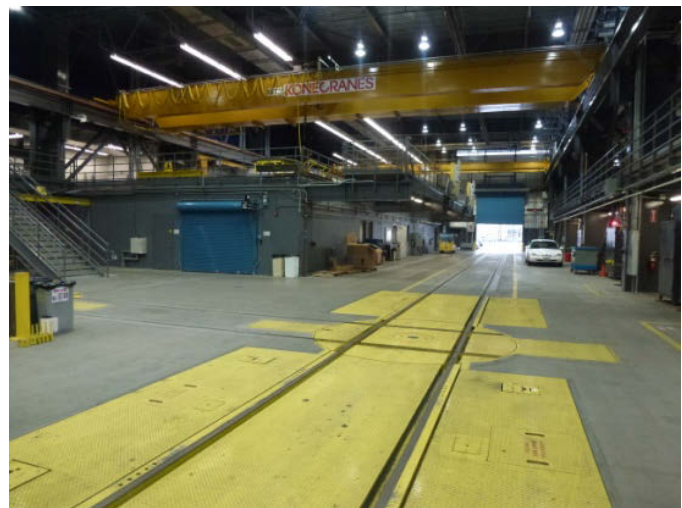
Heavy Repair Track

16. Heavy Repair Track:
 - a. Heavy repair track is not equipped with overhead power.

- b. Heavy repair track is equipped with two in-ground hoists capable of dropping trucks.
- c. Heavy repair track is partially outfitted with a car rooftop access platform that is adjacent to the mezzanine located HVAC and pantograph shops.
- d. Heavy repair tracks are covered by two 25-ton bridge cranes.
- e. Occasional component change-outs are being performed by staff from Green.
- f. The fall protection tie-off cable for the heavy repair track car rooftop access platform is too low for adequate clearance of personnel getting onto the tops of cars. The height of the cable may also be too low to allow for proper usage of fall protection system.
- g. One set of portable lifts is provided.
- h. Auxiliary power with notification systems is provided for vehicles at every position.

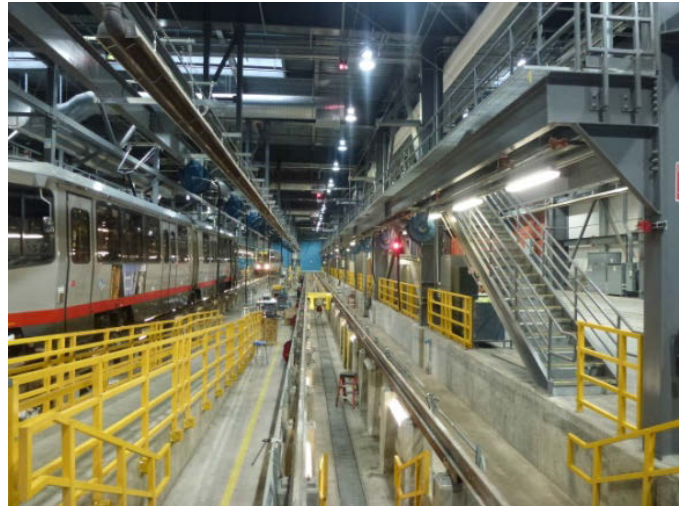
Running Repair Tracks

- a. Running repair tracks are being used for PM's. PM cycles are at 10, 20 and 40 thousand miles. Each PM takes 8, 12 and 16 hours respectively using a staff of 5 mechanics. Each track has 3 repair positions. Area is configured with posted rail and car rooftop access platforms. Fall protection is provided on each running repair track.
- b. Auxiliary power with notification systems is provided for vehicles at every position.
- c. Overhead power is divided into three sections per track.
- d. Vacuum reels are provided on the running repair tracks.
- e. Roof access platforms have locked gates keyed to power supply.
- f. Half of the running repair tracks are covered by 3-ton monorails to service or change-out vehicle rooftop components.

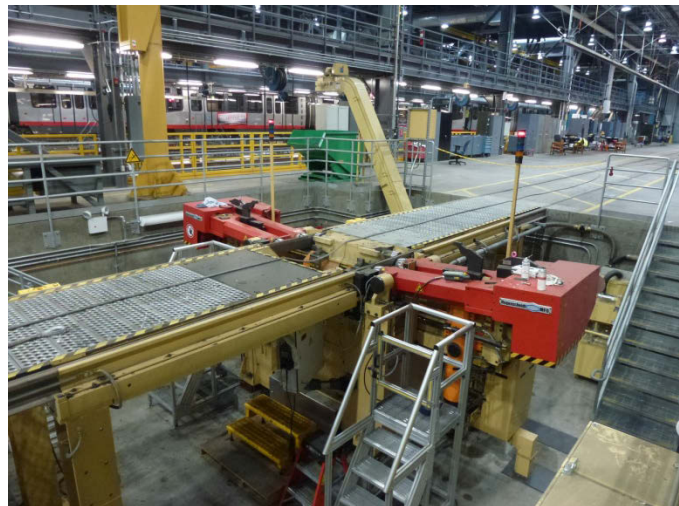
Wheel True Track

- a. Track long enough to accommodate an entire LRV.
- b. Wheel truer is a lathe type machine.
- c. An in-ground car progression system is provided.
- d. Pit is covered by 1/2-ton bridge crane for machine maintenance.
- e. Both LRV's and Streetcars are being trued at MME.
- f. A 40k wheel truing program has been started.

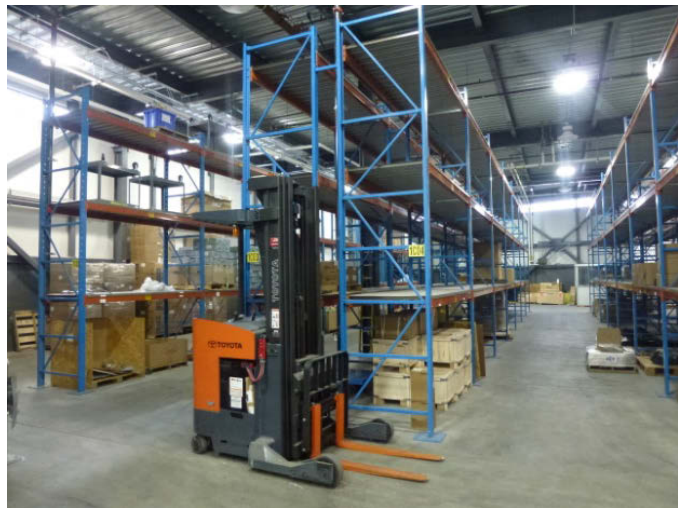
Parts Storeroom

- a. The Material Management department runs the MME storeroom.
- b. MME storeroom has good vertical clearance for the storage of palletized loads. The room is only being partially utilized. Burke provides consumables. Car parts are provided directly by vendor or Green. Only ready stock items are being stored. 79, 3-beam pallet racks with in-rack fire suppression. 28, 9-drawer storage units. 175 (3'x2') shelving units.
- c. Storeroom is supplied through Green twice weekly.
- d. Two hazmat buildings are provided outside.

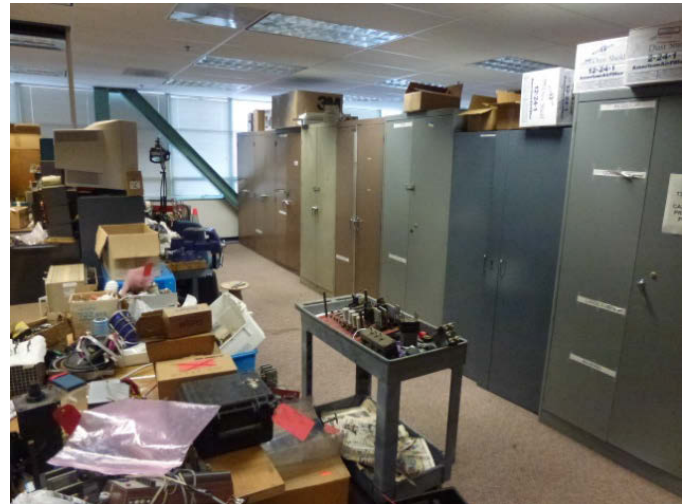
- m. Most parts used are small components and stored in one of the 13 parts cabinets in the current space – drawer units could store these parts more efficiently and allow easier access

Transit Signal Shop and Parts Storage Cabinets

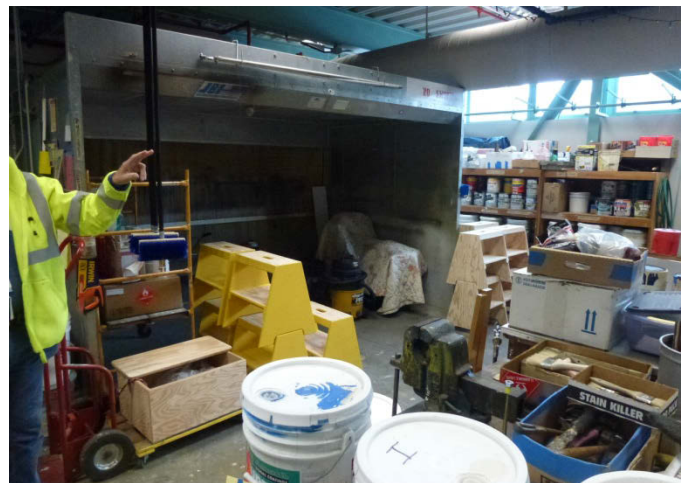
Paint Shop

- d. Office and crew room HVAC does not work
- e. 1 paint spray booth, paint storage, stencil racks
- 10. Lock Shop
 - a. 1 locksmith for all of SFMTA
- 11. Custodial
 - a. Clean facilities for all of SFMTA (does not include shop spaces)
 - b. 3 shifts 7 days a week – crew of 43 with 2 supervisors
 - c. Each facility houses its own cleaning supplies in a janitor closet
 - d. Custodial items are stored at Burke and inventoried, handled, and delivered by their own shopkeeper separate from Material Management
- 12. Cable Car Special Machine Shop
 - a. Builds cable car trucks and other metal components
 - b. Assists other machine shops as required
 - c. Crew of 5 – 3 machinists, 1 fabricator, 1 welder
 - d. Wheels are purchased from an outside vendor
 - e. Very large space with multiple duplicate machines
 - f. 3 large overhead cranes

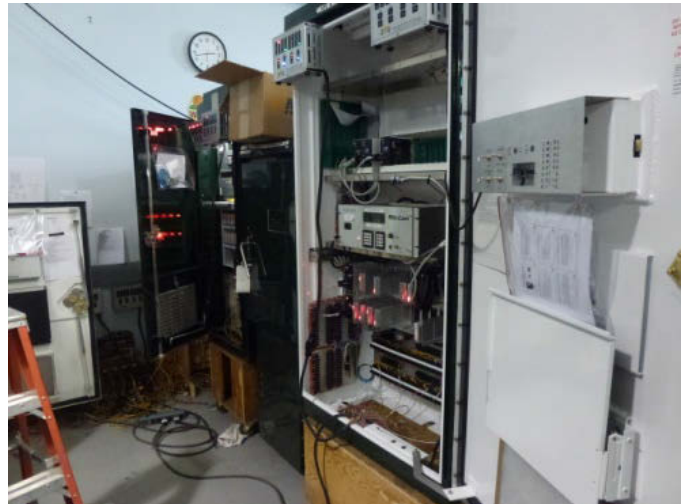
Traffic Signal Cabinet in the Programming Area

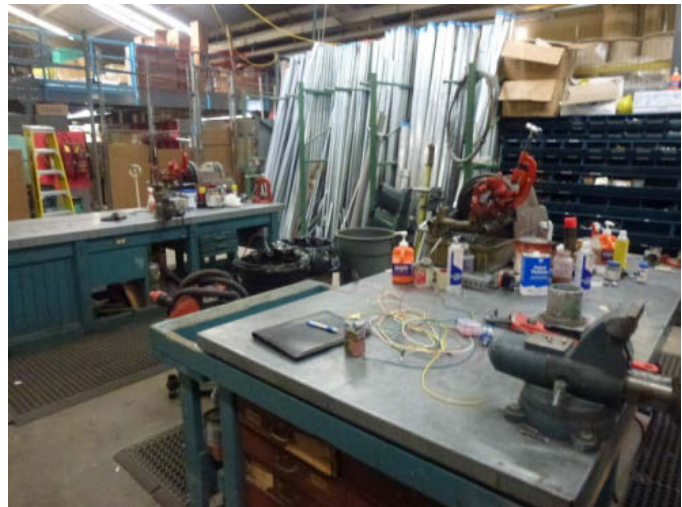
- a. Build as many standard frames as possible for storage to reduce response times
 - i. Ideally 2 to 3 prebuilt frames of 10 varieties would be stored (20-30 frames palletized)
 - ii. Individual frames do not exceed 300 lbs.
- b. Many intersections require custom frames to meet specific needs
- c. 2 workstations for frame fabrication
- d. The area needs a 1 ton overhead crane to move materials
- e. Storage for approximately 35 to 40 pallets containing parts, lights, materials are stored in the parts area of Rankin (fair representation of standard storage needs)
- f. Shelving racks store legacy equipment (eventually clearing these out)
- g. Large wire spools are stored haphazardly due to space limitations – Space needs to be designed to properly store and organize this area

Signal Fabrication Area

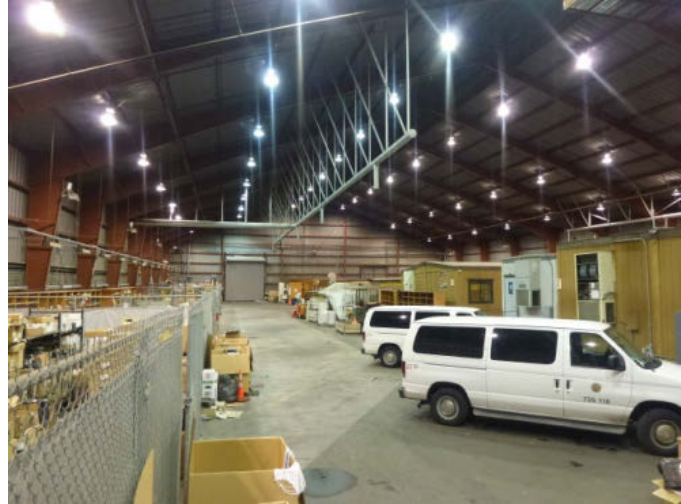
- d. Exhaust reels and other equipment remains from past use as a vehicle service facility
 - e. 1 storage container housed indoors
 - f. Multiple locked storage cages holding random and unidentified items

Interior Storage and Video Shop Buildings

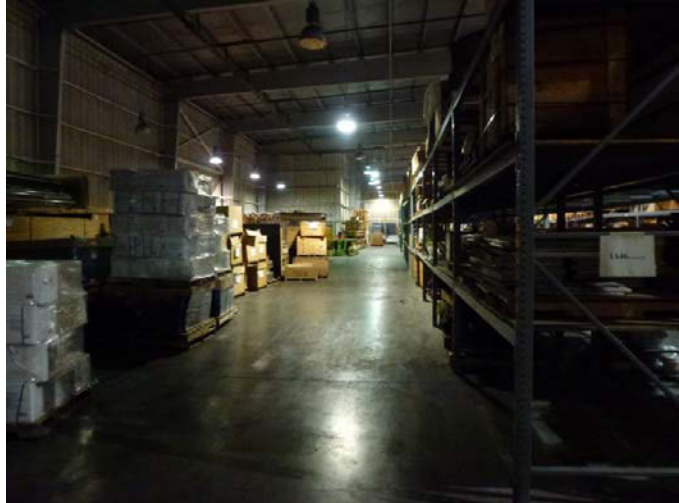
Pallet Storage along Exterior Walls

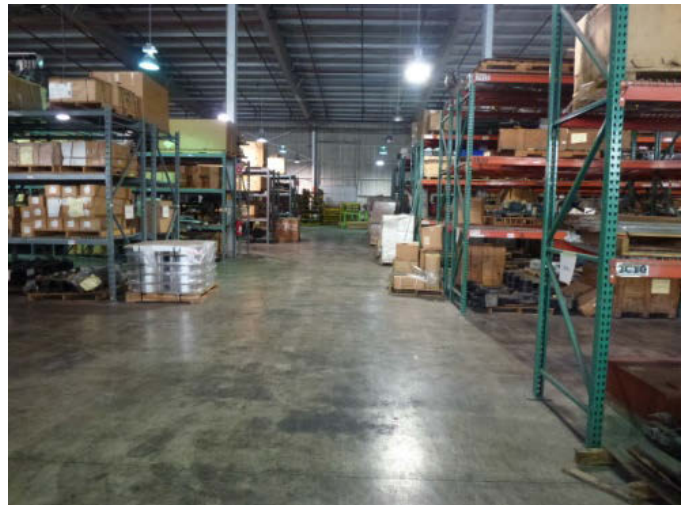
Central Storage Racks

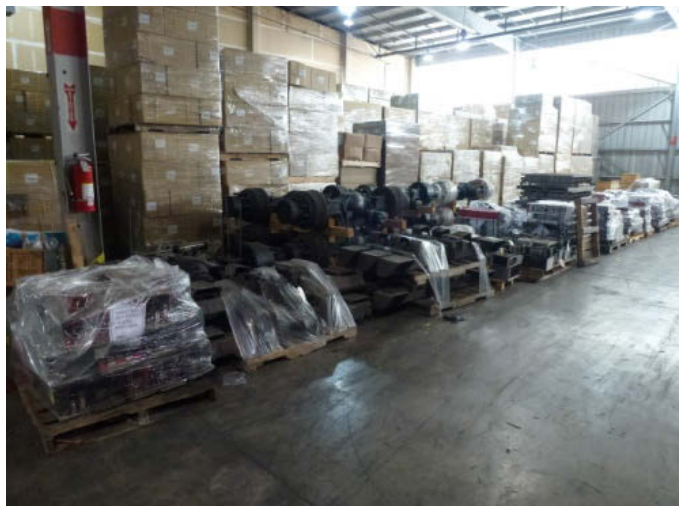
East Wing Group Storage Area

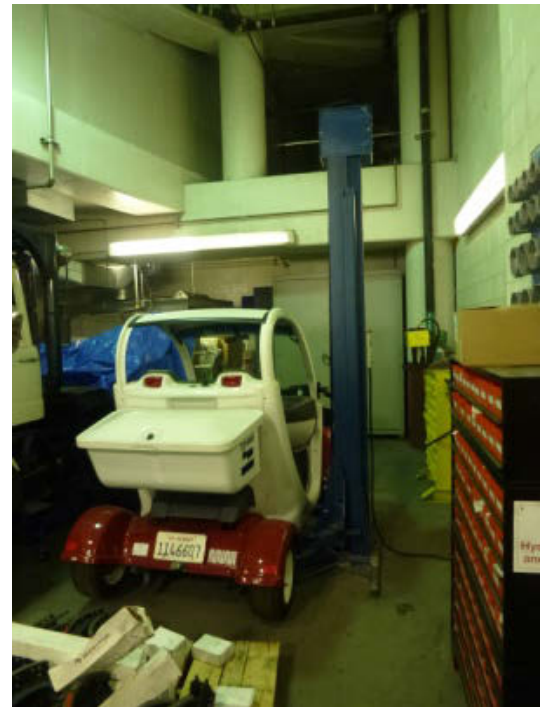
2: Scooter / Small Equipment Maintenance Area

1. Claim a portion of the parking garage area on the 1st level of the parking deck for conversion into a scooter/cart repair facility
2. Reconfigure ground floor to provide more repair bay space and better access to the parts storeroom
3. The following chart shows the number of repair bays required to accommodate the current SFMTA non-revenue vehicle fleet. The existing facility needs an additional 8 repair bays in order to properly accommodate all of SFMTA's non-revenue vehicles. Accommodating additional City NRV's is not feasible within the existing facility.

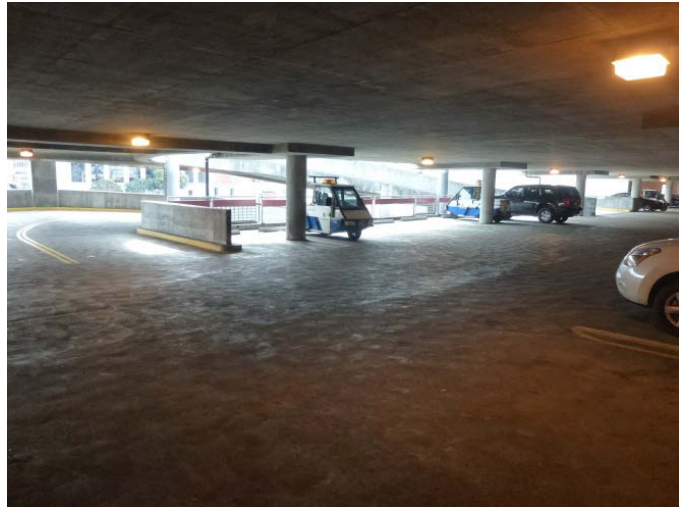
3: Parking Garage
