SFMTA

Tunnel Structure Program At CP&C

Twin Peaks Tunnel Inspection

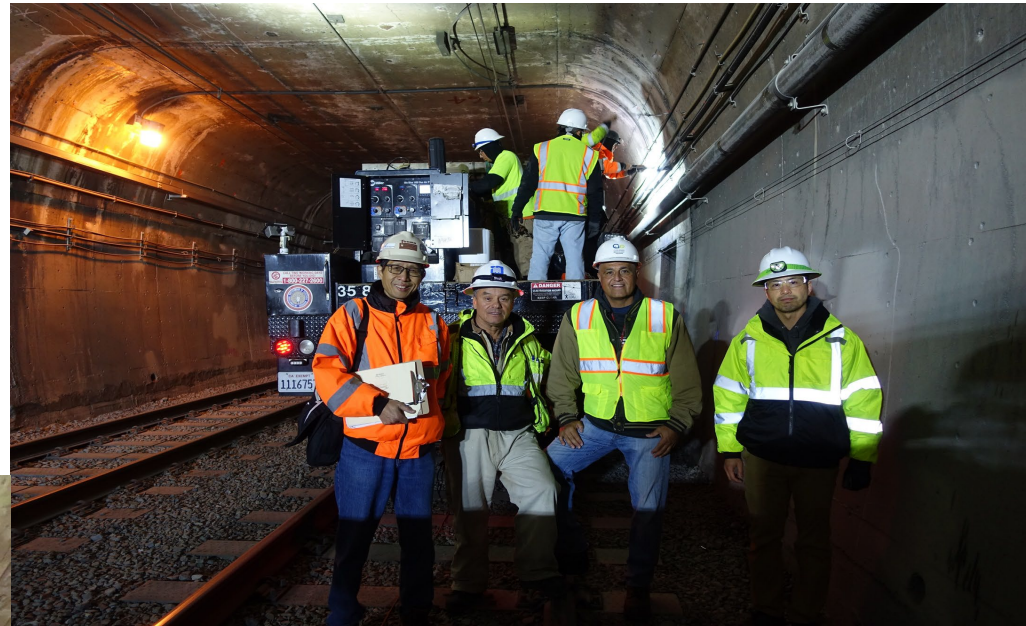
- Completed the most extensive inspection of the Twin Peaks tunnel in almost 50 years, including the walls, ceiling, and plenum.
- Inspectors addressed issues such as loose concrete spalls in real time.

- One of the key findings of the inspection: over the 100-year life span of the tunnel, pressure due to ground water in the soil has caused movement in two identified critical sections of the Tunnel between West Portal and Forest Hill Station.

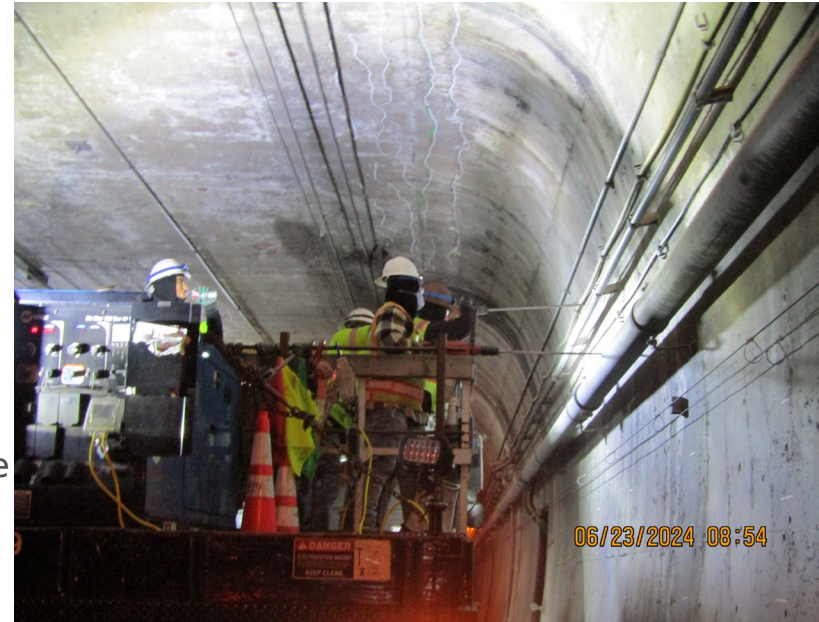
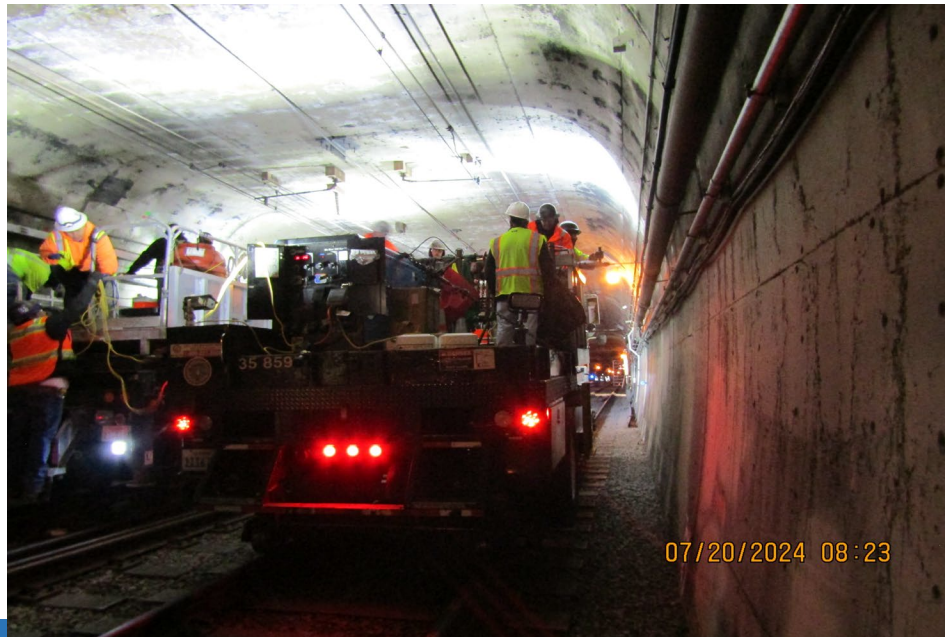
- While there are no immediate safety concerns, the inspection revealed significant state of good repair issues that will be costly to address and require tunnel shutdowns in the coming years.
- Plans for long-term repairs will be done in consultation with policymakers and the affected community.
- 5-Year Capital Plan will include ongoing/periodic inspections as well as seismic evaluation of the entire tunnel.
- Monitoring of the tunnel will be conducted quarterly to ensure status quo of the tunnel structure.

- We have identified and are working with a contractor to address/impece the movement at two locations between West Portal and Forest Hill Stations during planned shutdown this Summer.
- The work will consist of a combination of contact grouting to fill any possible voids and tie-rod installation to mitigate for this movement.
- Shutdowns this summer consisted of two-weekend shutdowns back in June 22/June 23rd; July 20th/July 21st; and an 8-day shutdown planned from August 22nd through August 29th.
- A Bus Substitution/Bridge was/will be provided during the three shutdown windows.

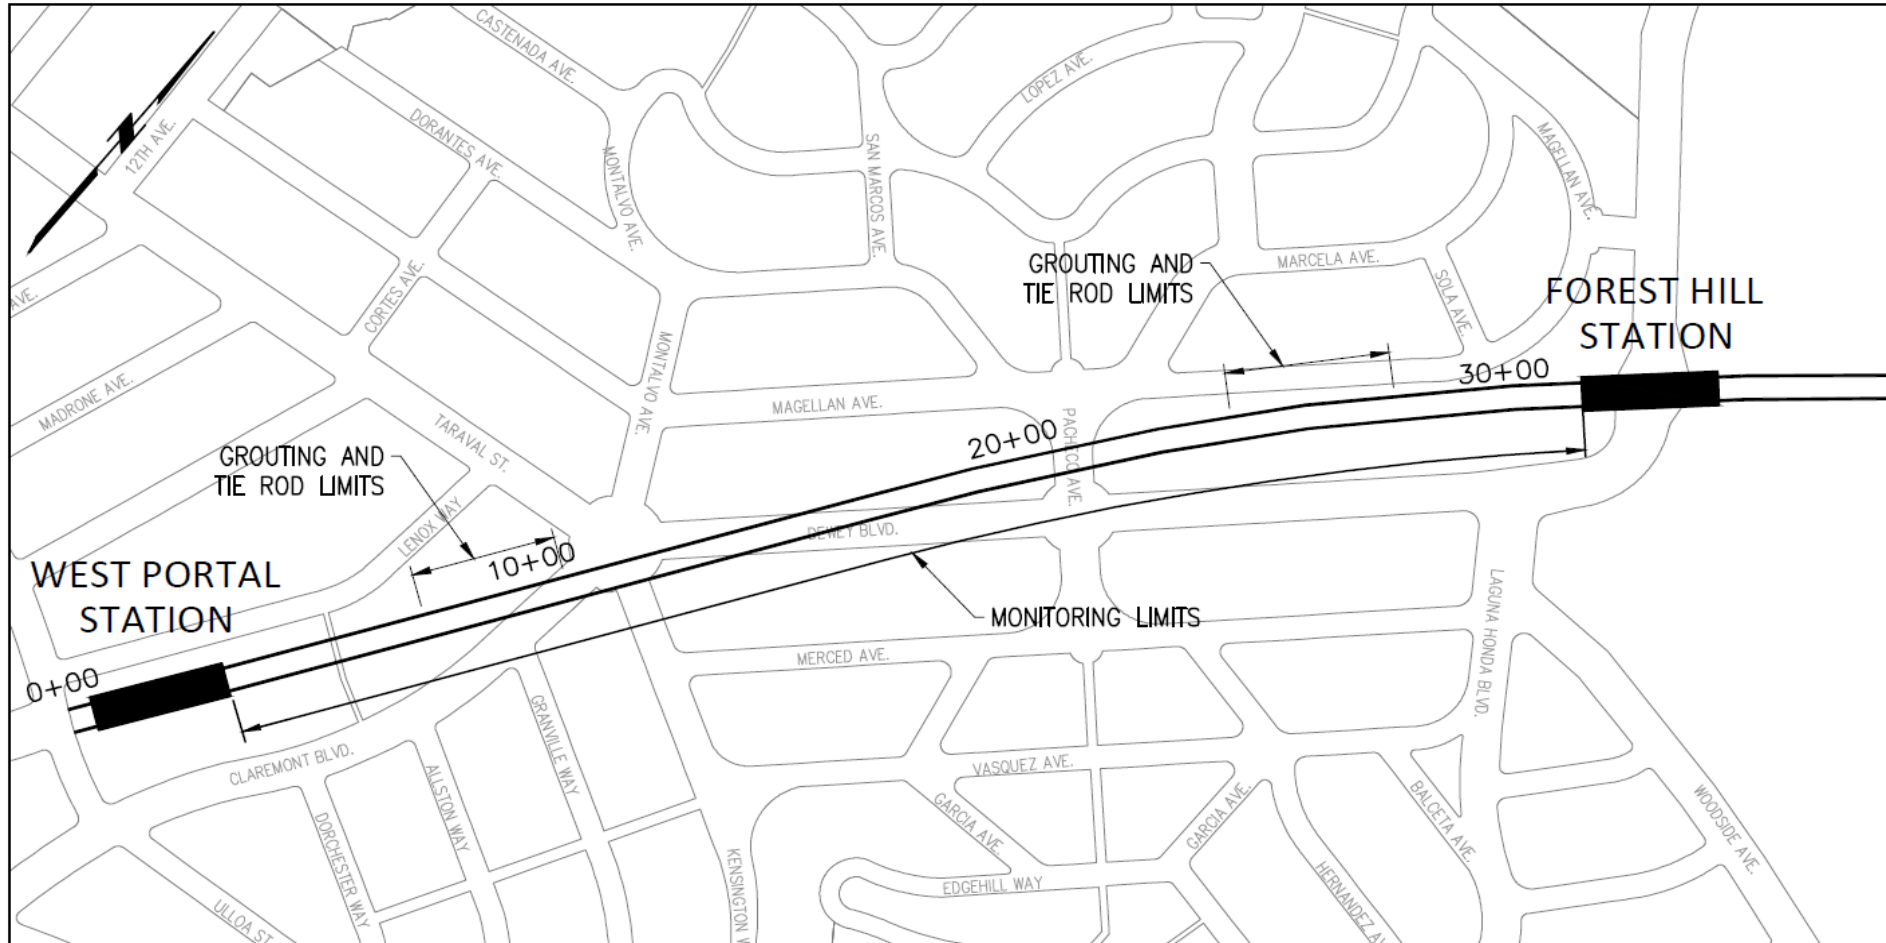
KEY MAP

Two Locations Of Short-Term Mitigation
