SFMTA - TASC SUMMARY SHEET

Location: Kearny Street and Sutter Street

Subject: Left Lane Must Turn Left, Rescind Peak TOW AWAY Lane

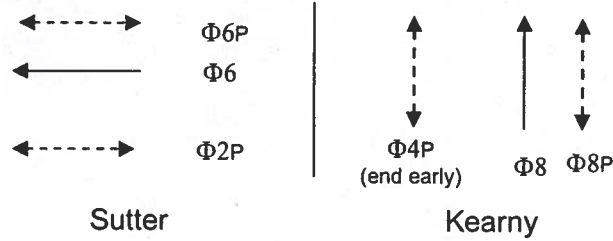
PHASE DIAGRAM

Are there conflicting protected left turn phases? n/a

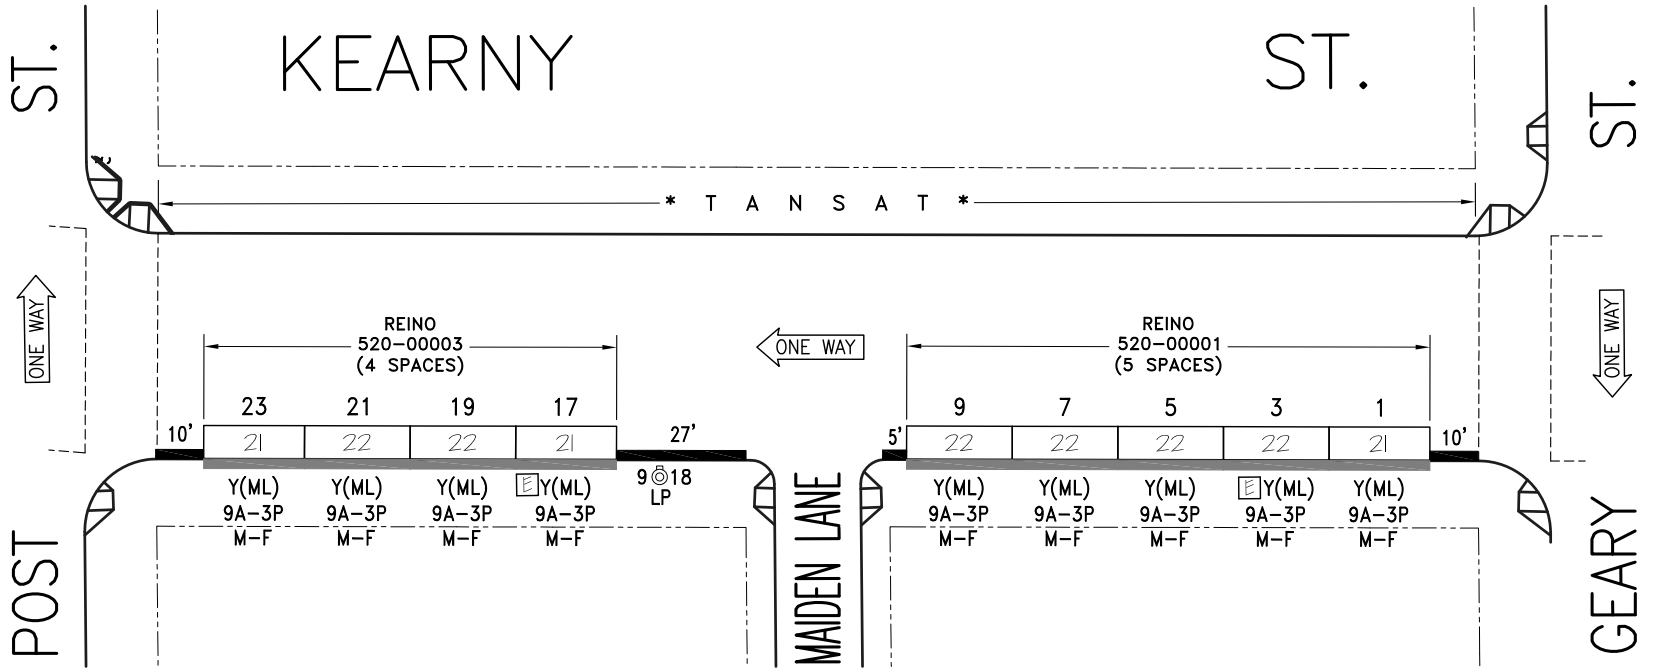
Existing Meter Drawing

SAN FRANCISCO MUNICIPAL TRANSPORTATION AGENCY
CITY AND COUNTY OF SAN FRANCISCO
 PARKING METER SPACES
