Chinese Immersion School at DeAvila

Walk Audit Report

Walk Audit held May 17, 2022

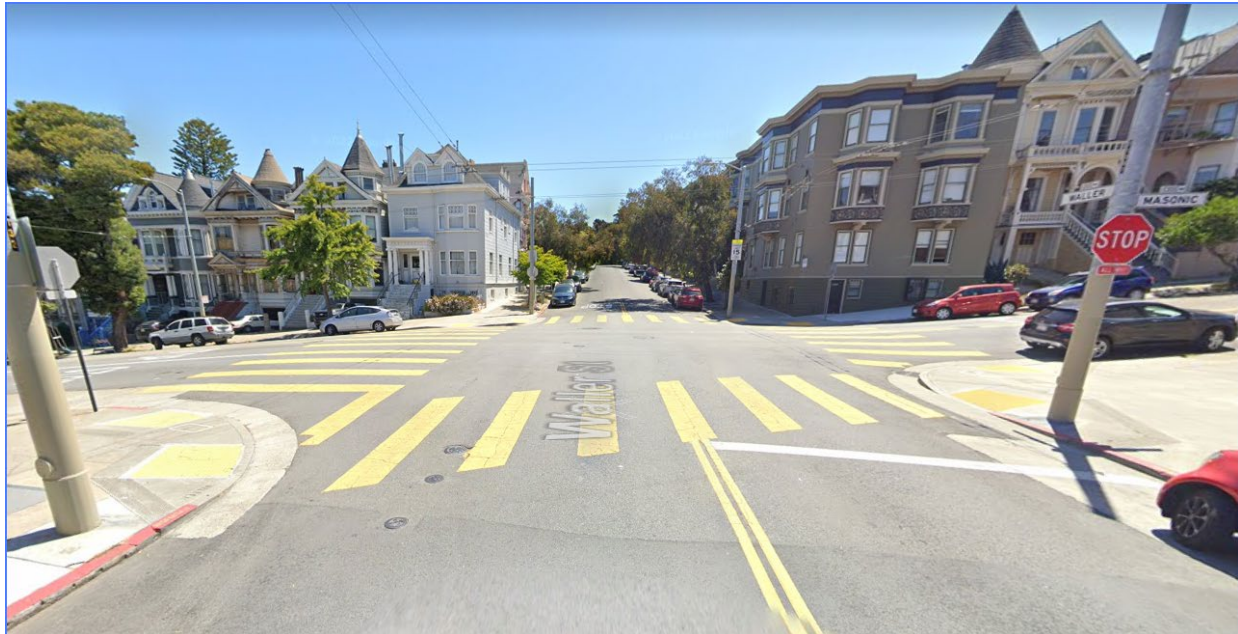
Waller Street at Masonic Avenue

- Need better visibility at crosswalks
- School signs are obscured by trees
- Needs crossing guard
- Curb paint is faded
- Drivers make U-turns in this intersection
- Drivers often speed on Waller
- Cars queue all the way to Buena Vista and double park on Waller during pick-up/drop-off
- Vehicles don't stop behind the crosswalks
- Street cleaning on Tuesday mornings coincides with morning drop-off time

- Ask SFPW to trim trees around school signs
- Refresh passenger loading zone curb paint
- Request crossing guard for this intersection

- Review intersection for a No U-turn restriction
- Install one speed hump on Waller, Central - Masonic
- Review passenger loading zone in front of school to alleviate congestion on Waller during morning drop-off and afternoon pick-up
- Can we extend time of passenger loading zone to 6:00 PM?
- Request Residential Permit Parking be extended to area around school
- Request that street cleaning shift to a time after school begins (shift from 8 – 10 am to 9 – 11am)

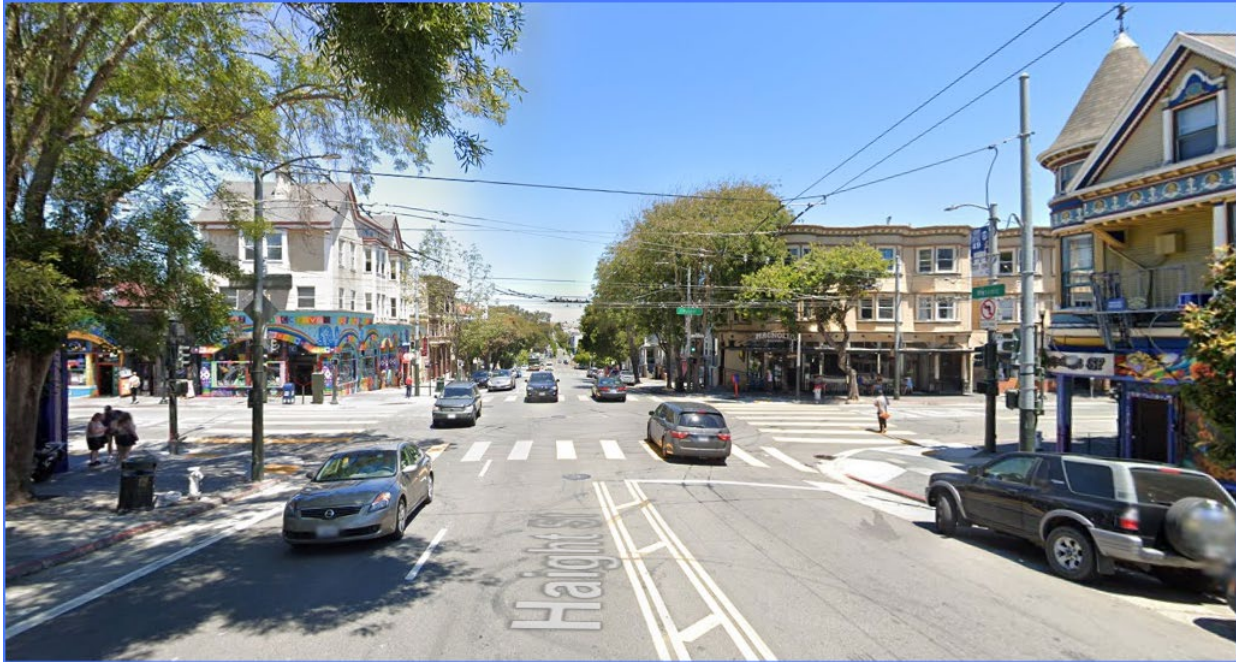
Masonic Avenue at Haight Street

- Cars drive too fast on Masonic
- Students wait at Muni stop on Haight
- Cars do U-turns in this intersection
- Sidewalks are filthy
- Back entry to school on Haight is closed because of safety concerns
- Street cleaning on Tuesday mornings coincides with morning drop-off time leading to conflicts

- Install one speed cushion on Masonic, Waller - Haight
- Can we restrict U-turns?
- Request sidewalk cleaning (SFPW)
- Can a passenger loading zone be installed on the Haight Street fronting of school
- Request that street cleaning shift to a time after school begins (after 9am)

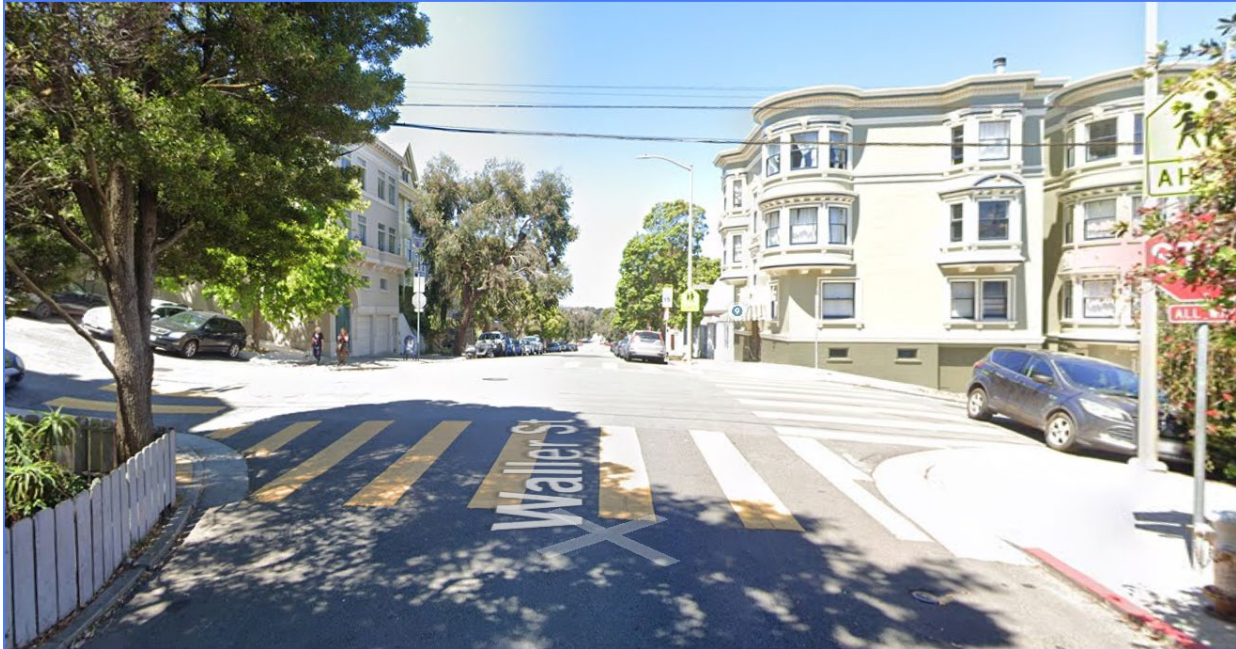
Central Avenue at Waller Street

- Drivers make U-turn here during drop-off/pick-up times
- Trees obscure school sign
- Cars drive fast on Waller
- Congestion on Waller during morning drop-off and afternoon pick-up leading to unsafe driving practices
- Vehicles don't stop behind the crosswalks

- Shorten crossing distance

- Review installation of “No U-turn” sign on Waller at Central
- Request SFPW to trim trees near signs
- Extend white zone on Waller to Central
- Daylight northbound and southbound approaches (10’)
- Install speed humps on Waller
- Review passenger loading (white) zone to relieve congestion during morning drop-off and afternoon pick-up

- Shorten crossing distance with sidewalk extensions
